Report for: Christian Gray  
97 Green St.  
Apartment. G21  
Brooklyn, NY 11222

Prepared by: Edward Olmsted, CIH, CSP

Subject: Mold Inspection  
97 Green St. Apartment #G21 Brooklyn, NY 11222

Inspection Date: June 15, 2020

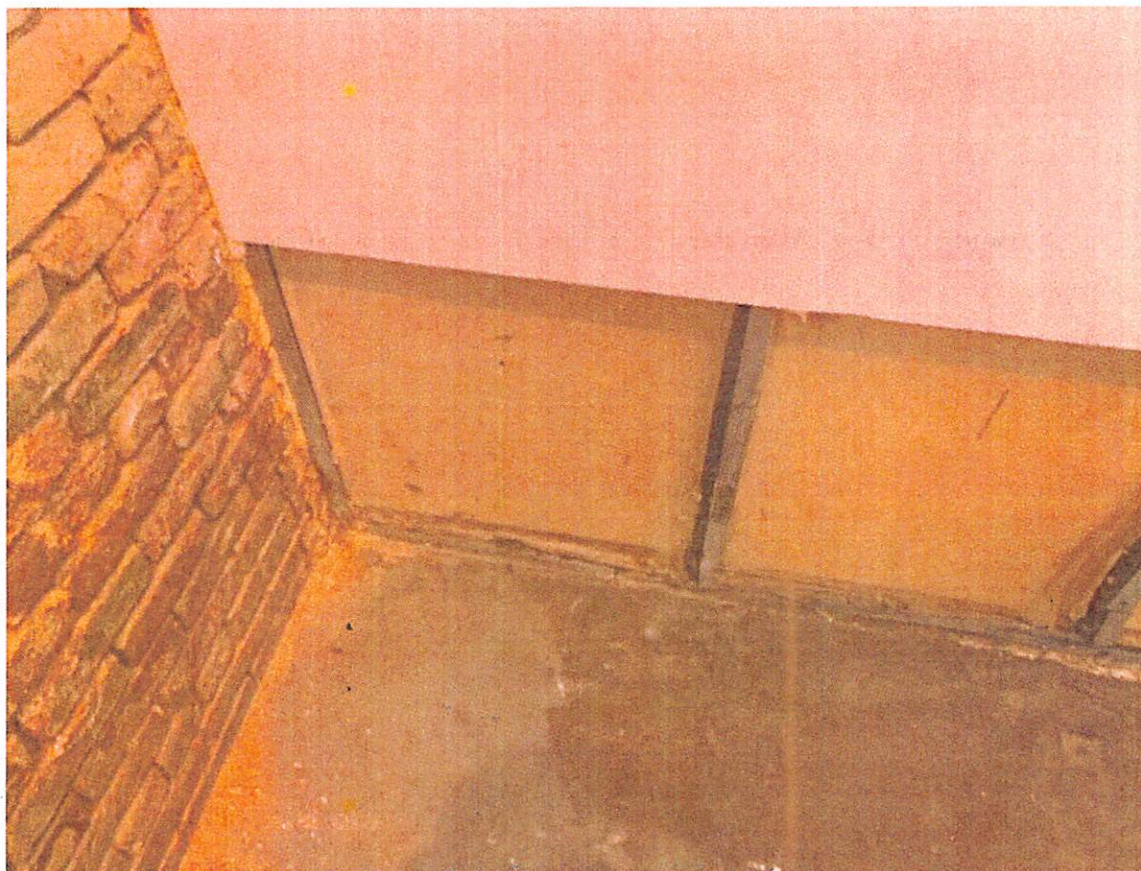
6. Living Room – A tape lift sample from inside the open wall cavity was analyzed by Ed Olmsted and tested positive for growth of mold. All of the sheetrock and insulation should be removed from this wall and the remaining sheetrock in the wall cavity should be cleaned and encapsulated. There is no visible mold growth in the living room. A wipe sample was collected from above the sheetrock around the columns to test the area above the sheetrock ceiling. The wood deck and insulation area above and were impacted by the flood. The wipe sample, number 97G-13, had massive levels of spores at over 5 million CFU per square inch. The sample was had *Aspergillus sydowii*, *Aspergillus versicolor*, *Penicillium*, and *Trichoderma longibrachiatum*. This is indicative of mold growth above the ceiling. Another wipe was collected from the top of the wall between the living room and adjacent studio. There was water damage but no visible mold. The sample had 740,000 CFU/in<sup>2</sup> dominated by *Penicillium*. This is indicative of mold growth. These results indicate there is mold growth in the wall and ceiling cavities and at the upper parts of the walls and not just the base of the walls. The walls should be demolished in the living room and studios.

| LOCATION | RESULT |
|---|---|
| 97G-1 in the living room area inside the wall cavity | Spores, hyphae and conidiophores of <i>Alternaria</i> indicating mold growth |

Inside the living room area wall cavity – tape lifts revealed light mold growth is present

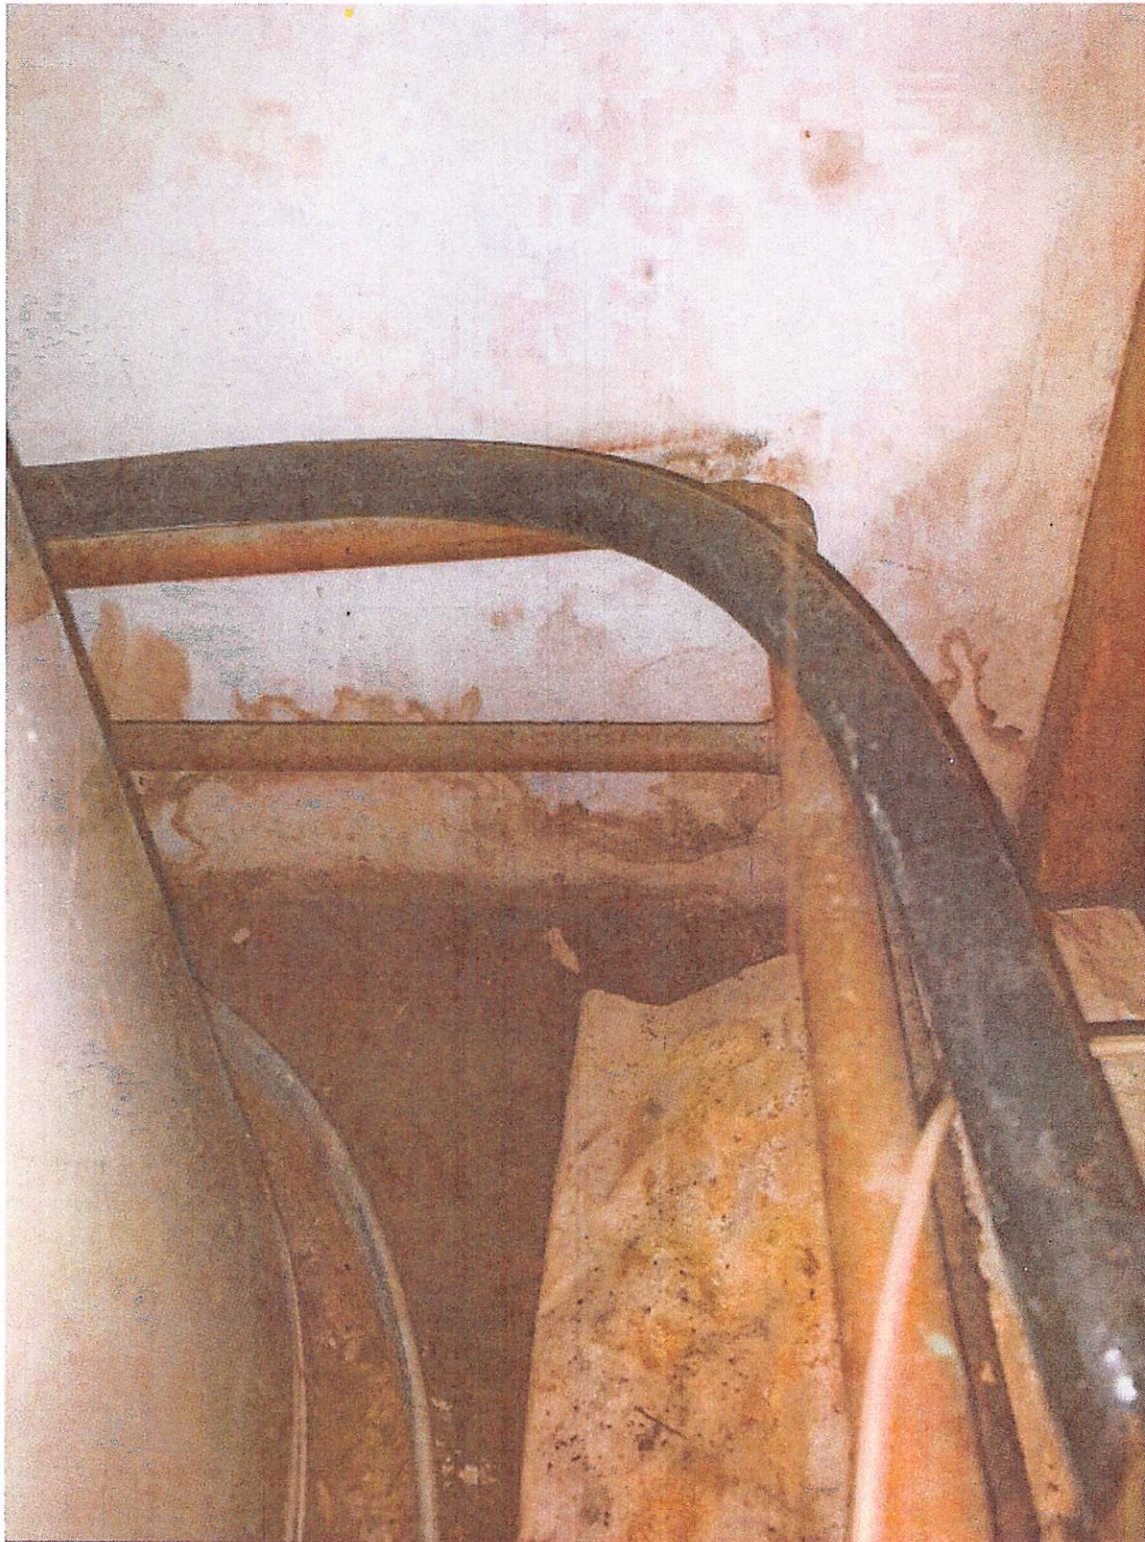
4. Bathroom - The raised wood floor in the bathroom has evidence of water damage to the wood in the hot water tank area adjacent to the bathtub. There is also mold growth on the wall between the bathroom and the kitchen. A tape lift from the raised

wood floor in the bathroom, number 97G-6, was analyzed by Ed Olmsted and Prestige. The sample had growth of *Scopulariopsis*. There is surely greater amounts of mold growth under the raised wood floor where water was trapped. The wall cavity between the bathtub and the kitchen has visible mold growth. A bulk sample from the bathroom wall in the area by the hot water tank, number 97G-4, was analyzed by culture methods and found to have 780,000 colony forming units per gram (CFU/g). The sample was dominated by *Aspergillus calidoustus* at 690,000 CFU/g. This is indicative of mold growth. The raised floor and bathtub should be demolished in the bathroom. The wall shared with the kitchen should be opened and the back of the kitchen cabinets and wall cavity should be cleaned with HEPA vacuuming and damp wiping with a strong biocide.

| Prestige #<br>Client sample ID<br>Location | Sample<br>dimension | Fungal ID | Fungal structures observed | Fungal<br>density | Notes |
|---|---|---|---|---|---|
| 200618-06-060<br>97G-6<br>Raised wood floor<br>HW heater room | 3/4" x 1" | <i>Scopulariopsis</i> | spores, conidiophores, hyphae | 5 | Fungal growth; mites, insects<br>and their fecal matter<br>observed. |

The hot water tank next to the bathtub – there is mold growth on the raised wood floor and on the wall shared with the kitchen

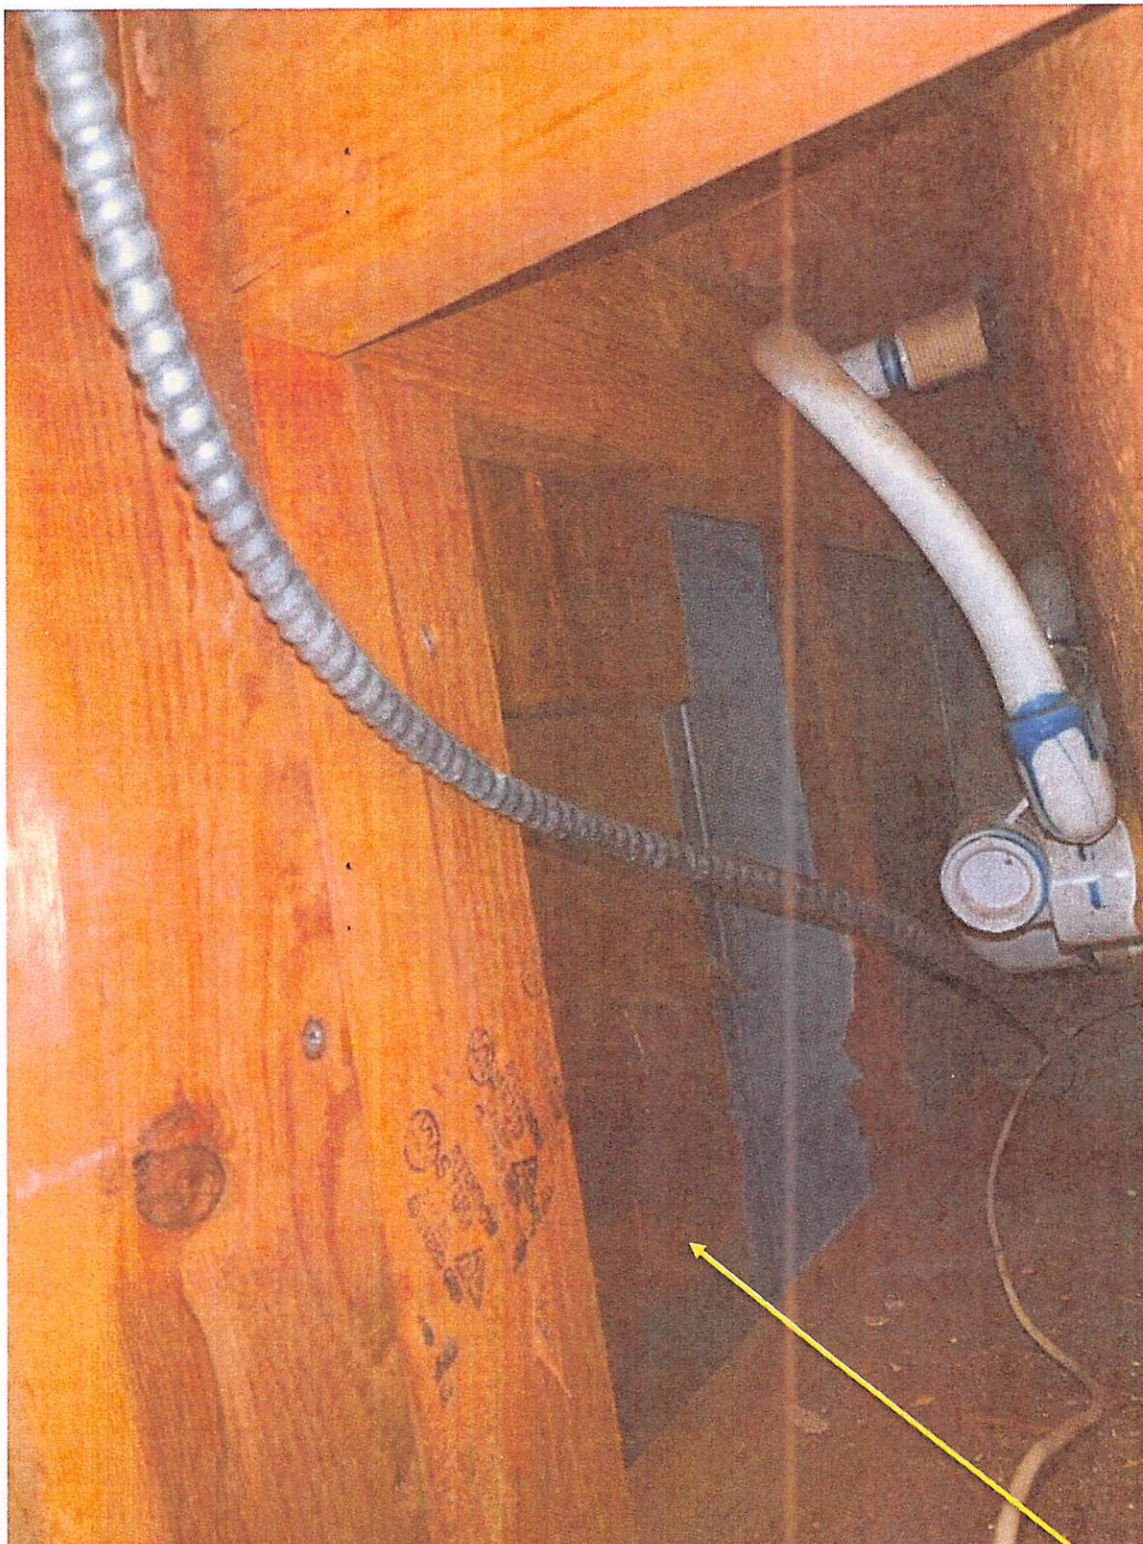
There is water staining and mold growth on the bathroom wall shared with the kitchen.

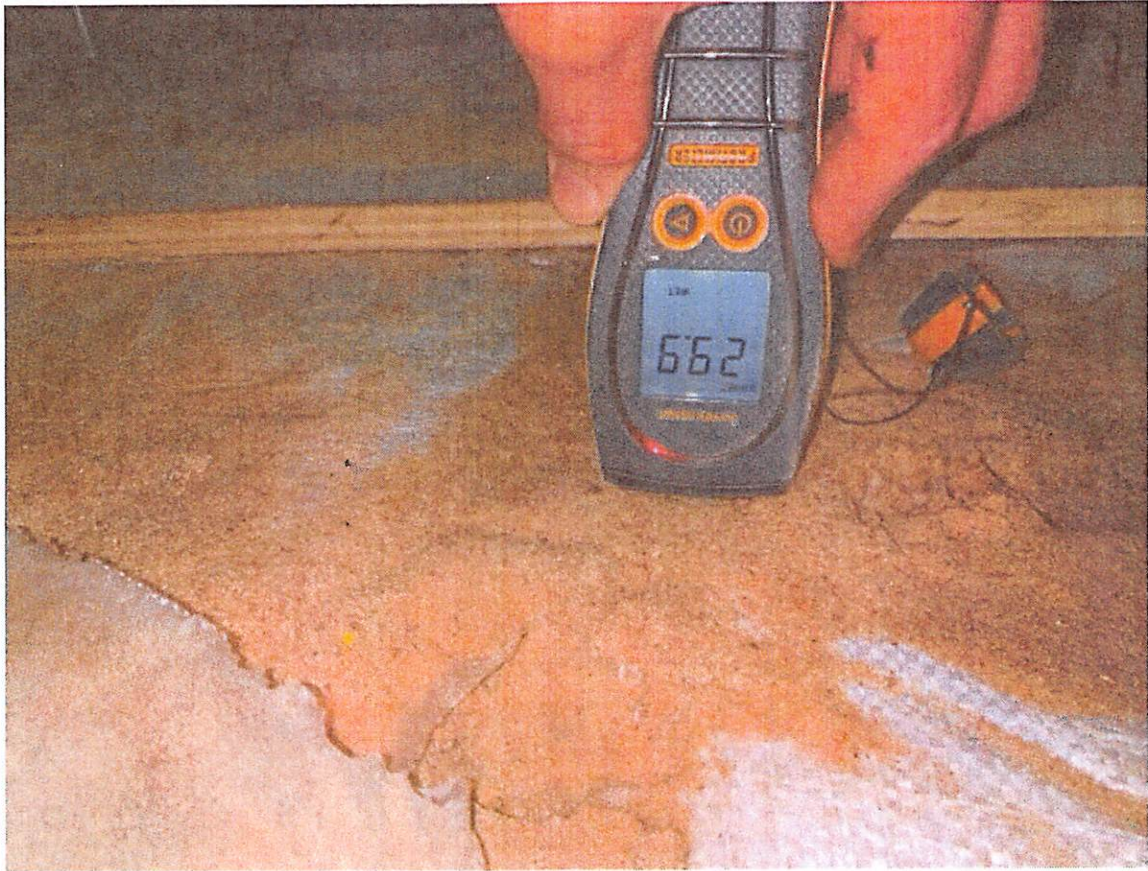
- b. The underside of the raised floor in one room of the studio area is slightly damp. The joists are damp measuring 30 to 40%. The sand also measured damp at 40%. This was due to the flood. The sand absorbed the water and the plastic lining the flooring and bags of sand trapped the water. This area has been wet for over 8 months. It should be assumed water was trapped under all of the floors including the finish floors in the other two rooms of the studio area, the raised floor in the bathroom, and the layers of wood flooring in the kitchen.

5. Studio Area Room 3 – This room has a raised wood floor with sand under the floor. The sand and wood is covered with plastic sheeting. Both the wood and sand tested wet with a moisture meter. The wood floor should be removed in this room and the sand removed as well as all plastic sheeting. The joists should be cleaned and dried.

The sand is wet under the raised floor

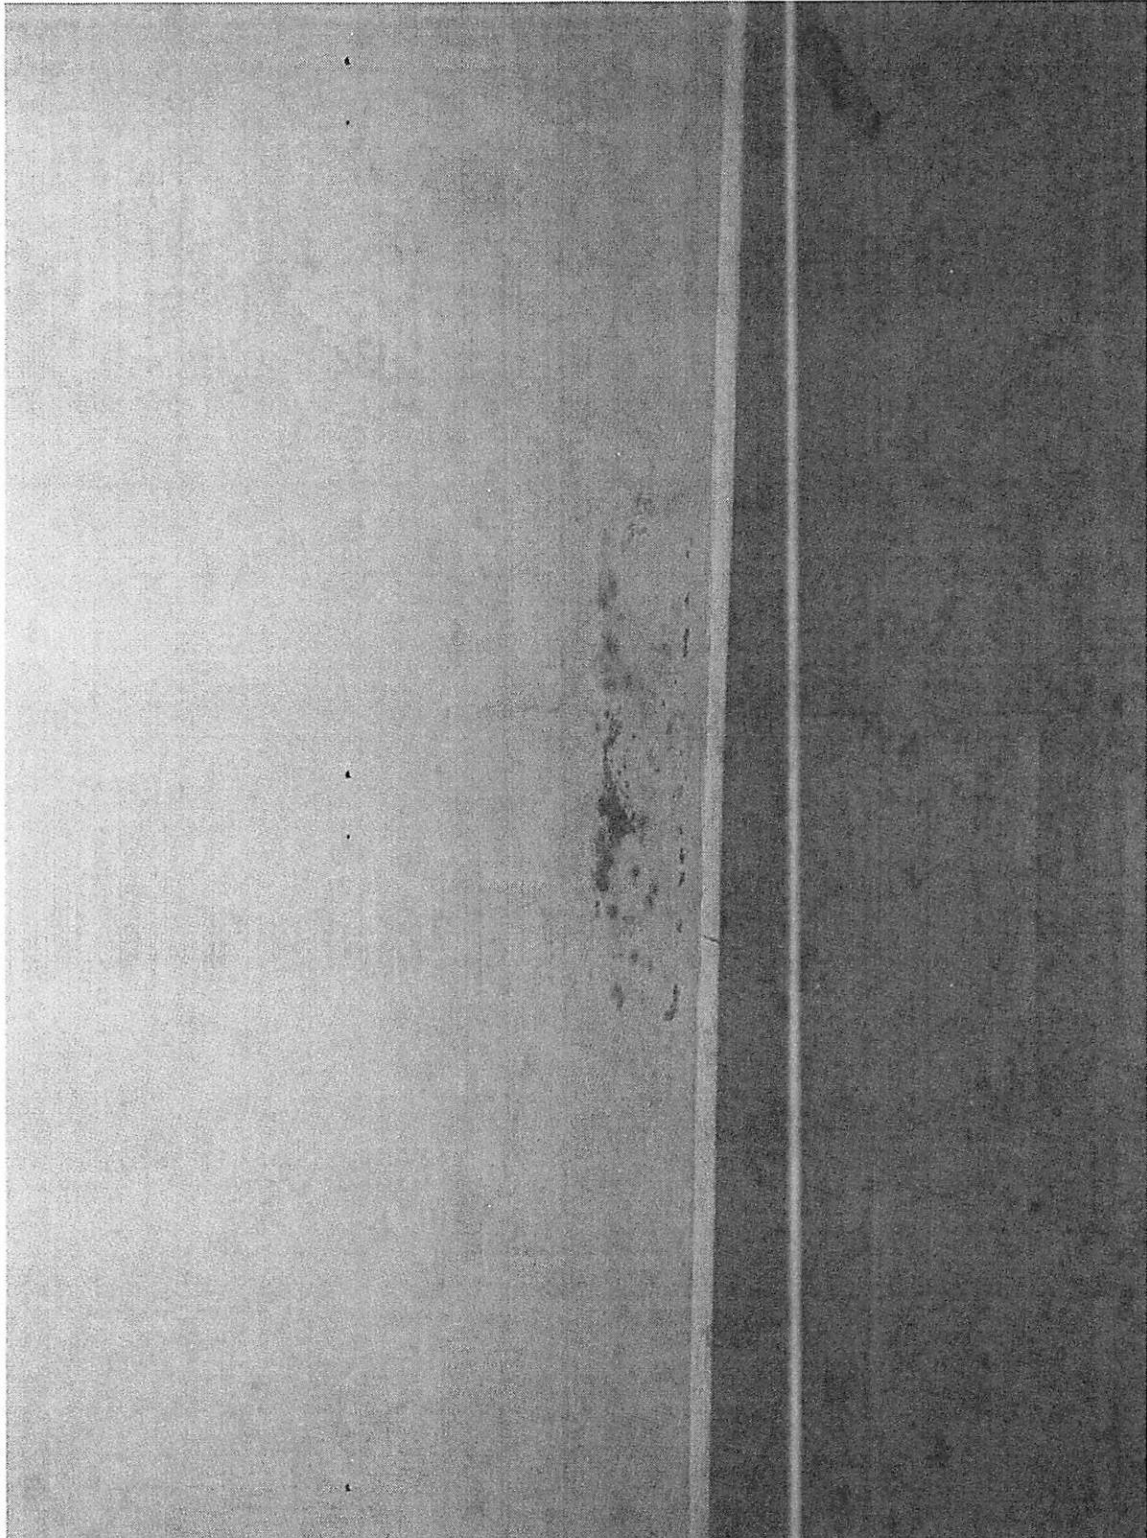
| LOCATION | RESULT |
|---|---|
| 97G-8 studio area visible mold at the base of the wall | Ascospores, asci and ascomata of <i>Chaetomium</i> |

Visible mold on the base of the wall in studio area

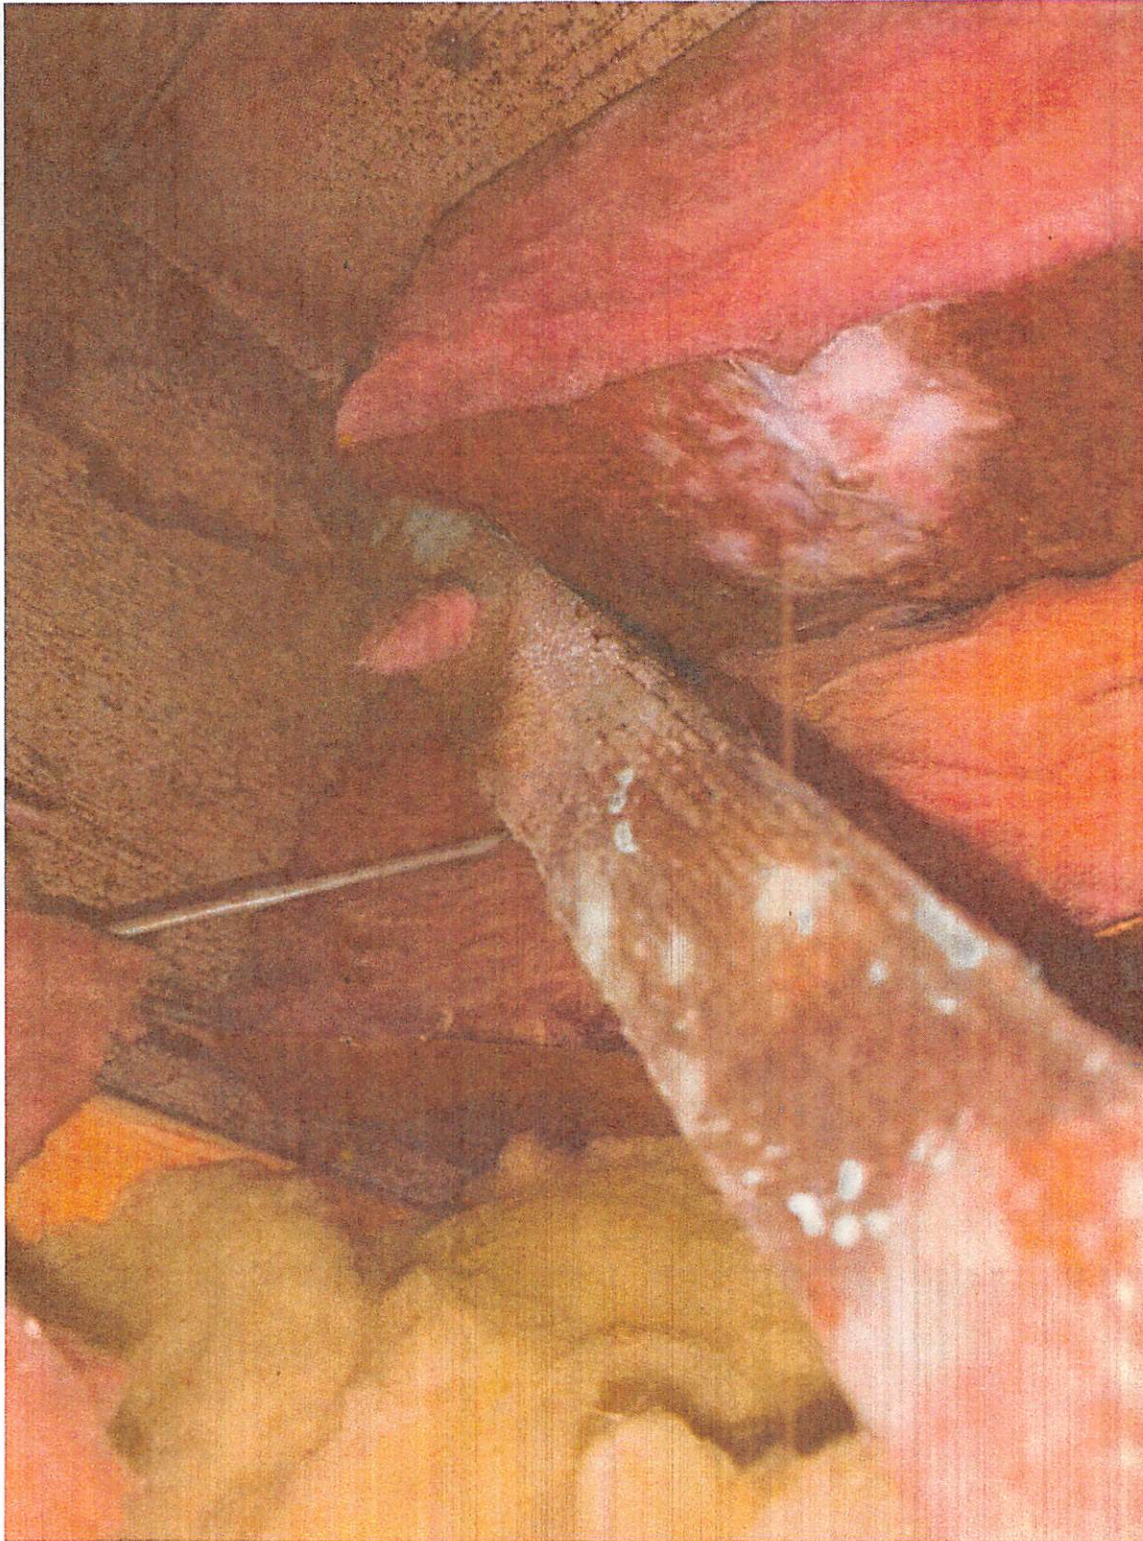
| LOCATION | RESULT |
|---|---|
| 97G-19 wood deck above the insulation in the loft above the studio | Spores, hyphae and conidiophores of <i>Penicillium</i> indicating mold growth |

| Prestige #<br>Client sample ID<br>Location | Sample<br>dimension | Fungal ID | Fungal structures observed | Fungal<br>density | Notes |
|---|---|---|---|---|---|
| 200618-06-059<br>97G-19<br>Wood deck above<br>insulation in loft<br>area | 3/4" x 1 1/4" | <i>Aspergillus</i><br><i>Penicillium</i> | spores, conidiophores, hyphae<br>spores, conidiophores, hyphae | <1<br>5 | Fungal growth; insects and<br>their fecal matter observed. |

Mold growth on insulation and wood joists on the underside of the floor above
