Subject: Post Remediation Verification (PRV)

Location: 226 Franklin Street, Apartment G21, Brooklyn, NY 11222

Inspection Performed At:

July 28, 2021

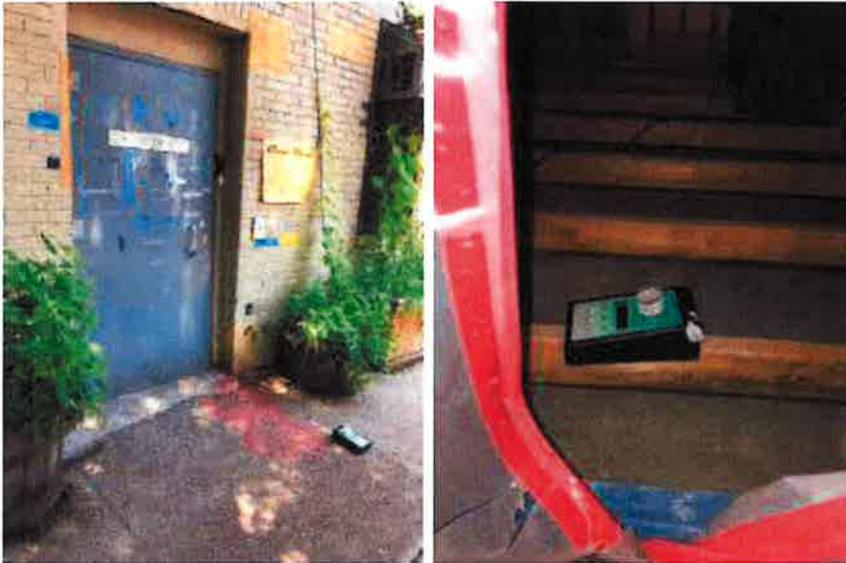
Above Left: Entrance 97 Green Street, Outdoor Air Sample Location
Above Right: Studio 3: Air Sample Location

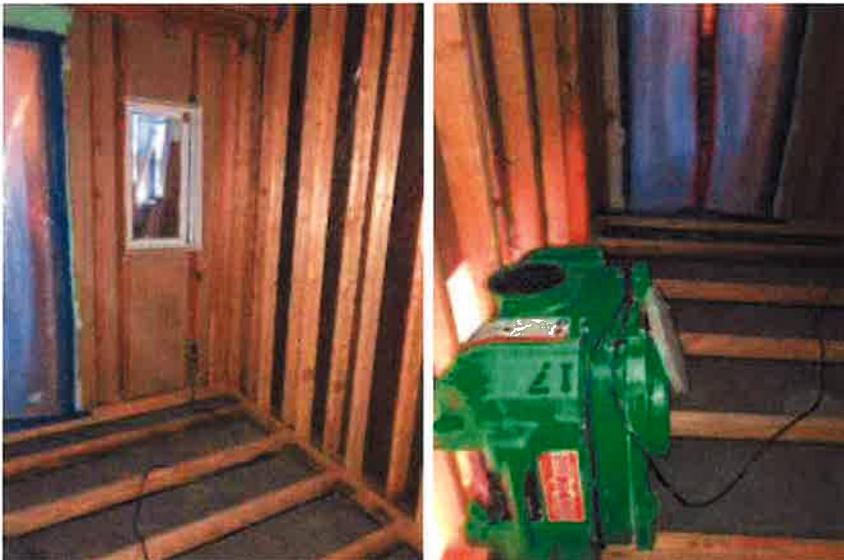
Above Left: Studio 3
Above Right: Studio 3

Studio 3: Up to 2ft of wall removed on wall b and wall c of hallway side; walls and ceiling removed. Studs and beams HEPA and detergent cleaned. The area is free and clean of VMG and odors.

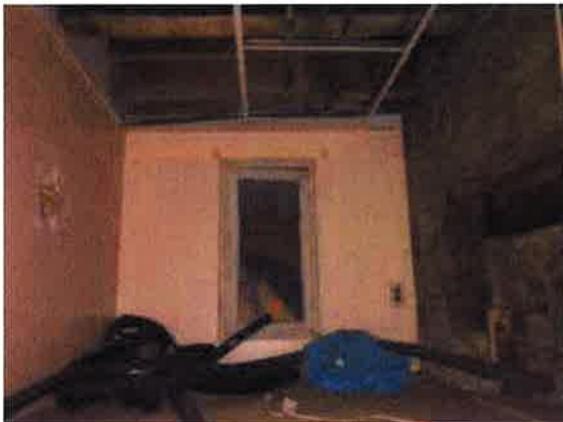
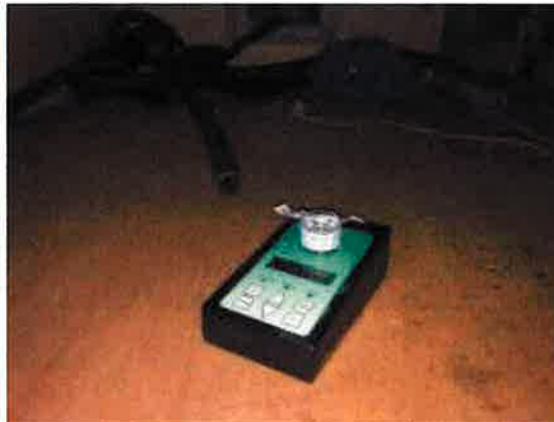
Upper Level Studio 3: The ceiling tiles were removed. The area is free and clean of VMG or odors.

Above Left: Upper Level Studio 3

Above Right: Upper Level Studio 3: Air Sample Location

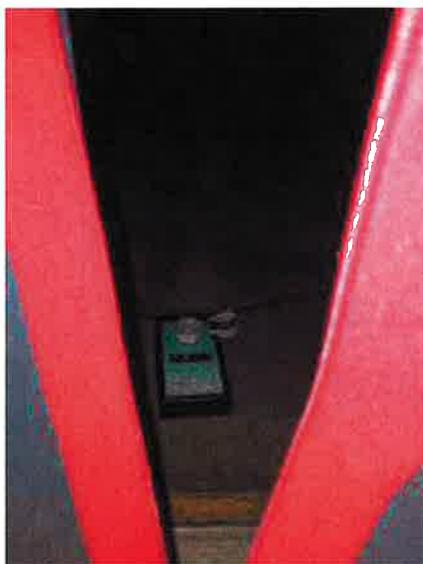
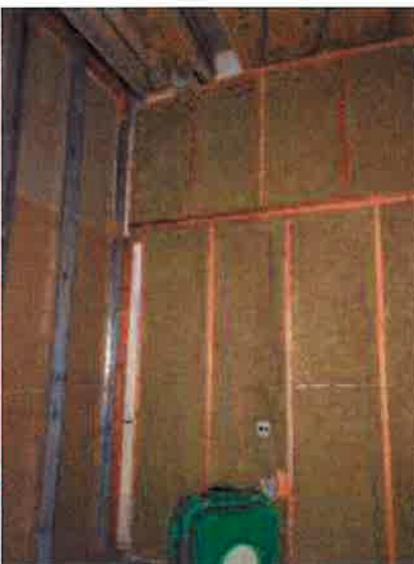
Above Left: Studio 2

Studio 2: The carpeting, ceiling, and walls were removed. The area is free and clean of VMG or odors.

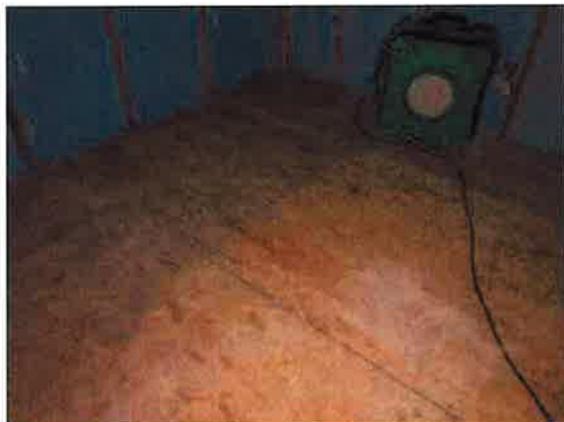
Above Left: Studio 1

Studio 1: The walls, ceiling, and floor were removed as per work scope. The area is free and clean of VMG or odors.

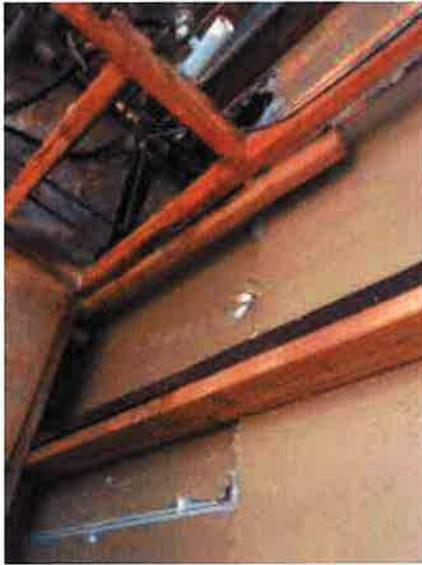
Bathroom: The shower wall was removed, gypsum wall 3 ft. from the floor was removed, the water heater, sink, bathtub, tiles, and raised floor were removed. The area is free and clean of VMG or odors.

Above Left: Bathroom (Shower wall, Water Heater and Bathtub removed)

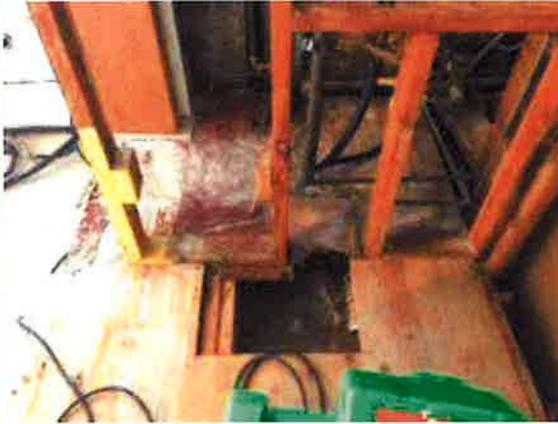
Above Right: Bathroom (Raised floor, Water Heater and Bathtub removed)

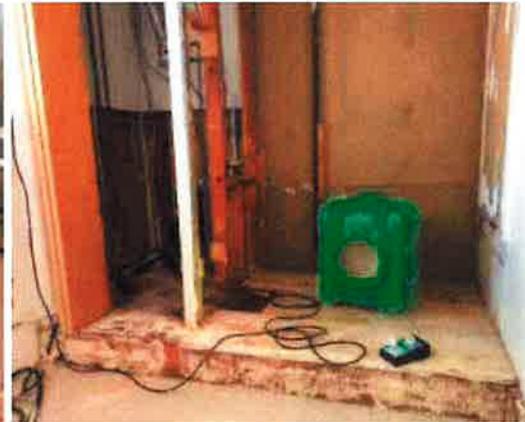
Above Right: Bathroom (Water Heater, Bathtub, Shower wall removed)

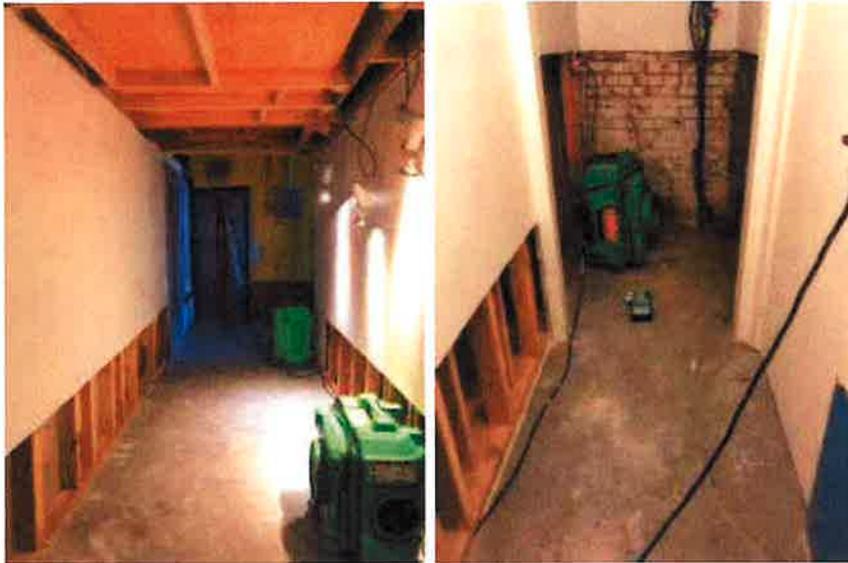
Hallway/washer dryer area: The washer and dryer were removed; ceiling and 2 ft. of wall from the floor were removed (brick exposed). The area is free and clean of VMG or odors.

Above Left: Hallway

Above Right: Hallway with Washer and Dryer Removed

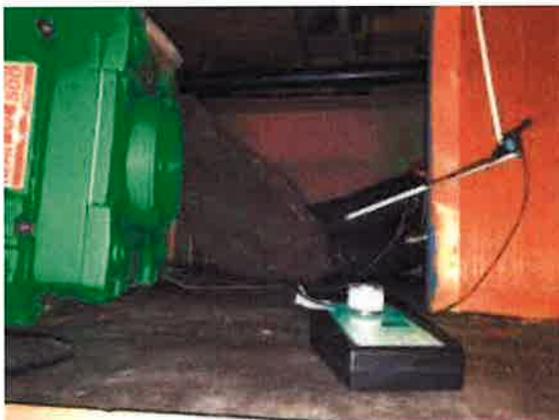
Above Left: Upper level Hallway: Air Sampling Location
