Report Date: August 18, 2021

Prepared by: Edward Olmsted, CIH, CSP
New York State Mold Assessor 00026

**Subject: Mold Inspection and Testing After Abatement
97 Green Street Apt #G21 Brooklyn, NY 11222**

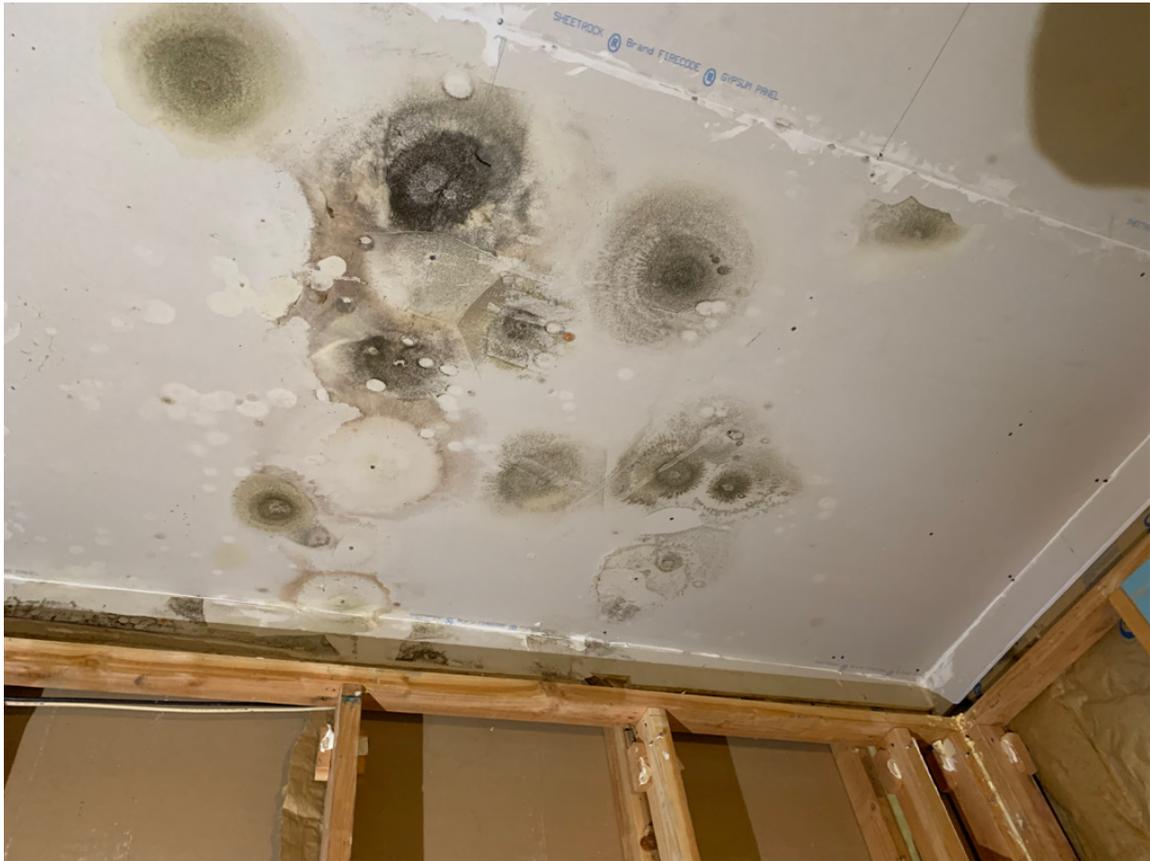
3. Room 1 – The outer layer of wallboard was removed from the walls and ceiling exposing the foam panels, which were left in place. Removal of the foam panels revealed visible mold on wallboard and especially the ceiling. There is insulation behind the foam board on the walls in some areas which also has mold growth along the top and bottom. A sample of the insulation, number 97G-9, was found to have

ROOM 1 CEILING behind foam panels that were removed during this survey

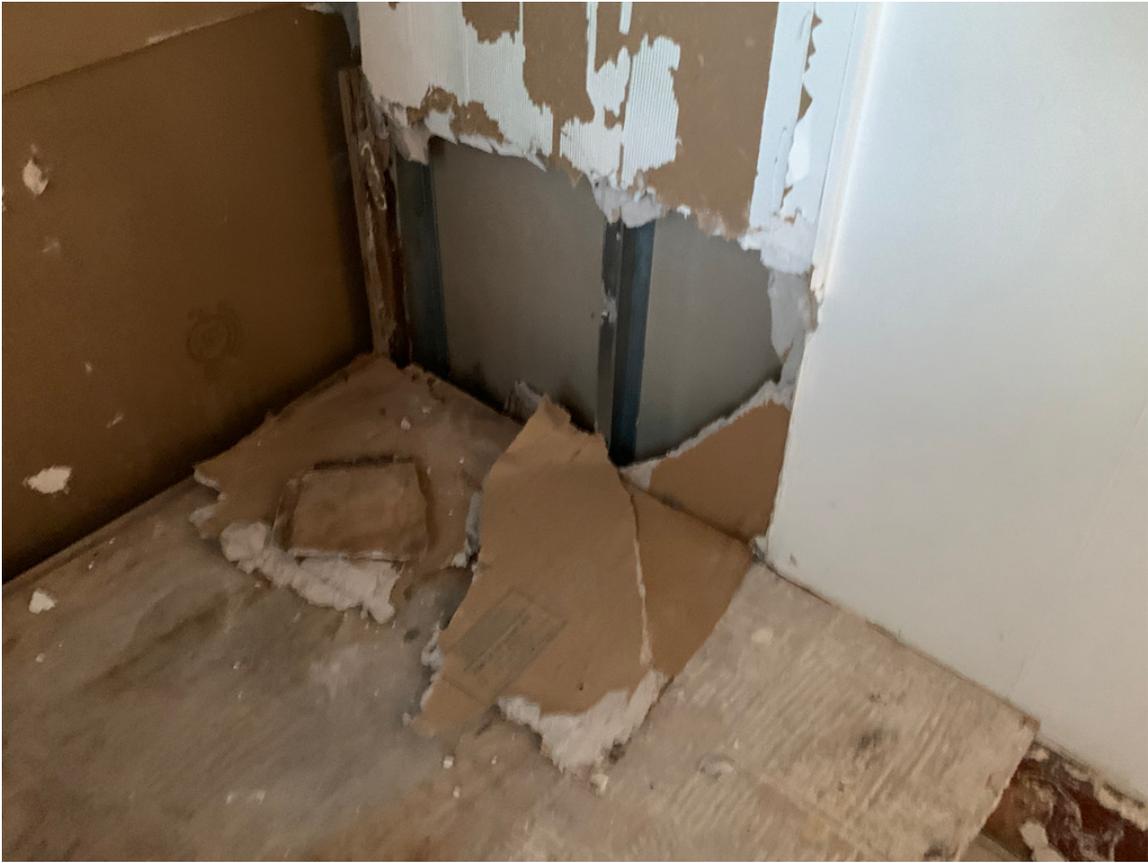
4. Bathroom – There is visible mold on the base of the sheetrock wall between the bathroom and living room. A tape lift sample, number 97G-1, had heavy growth of *Aspergillus*. The raised wood floor was left in place. A bulk sample from the wood, number 97G-6, had mycelium and hyphae indicating trace growth.

Bathroom wallboard has mold in the wall cavity
