OLMSTED ENVIRONMENTAL SERVICES, INC

Report Date: August 18, 2021

**Subject: Mold Inspection and Testing After Abatement
97 Green Street Apt #G21 Brooklyn, NY 11222**

Inspection Dates: August 16 and 17, 2021

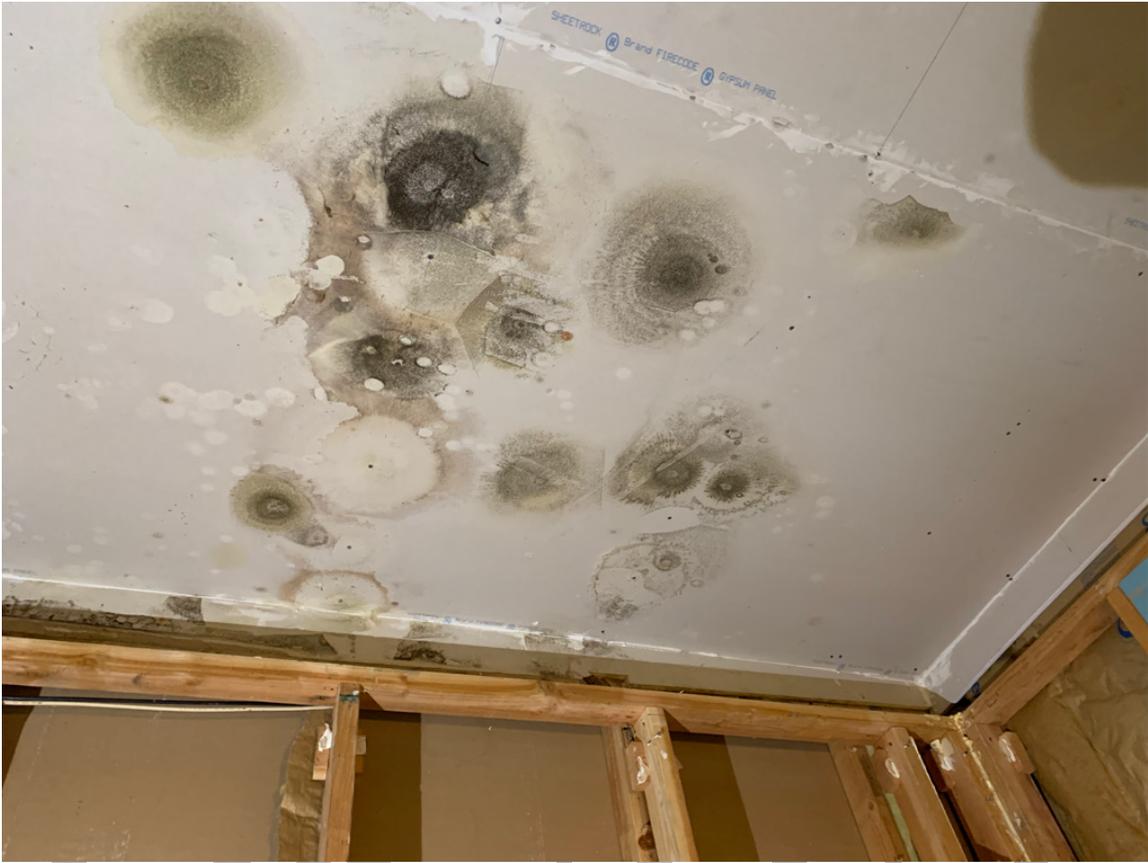
3. Room 1 – The outer layer of wallboard was removed from the walls and ceiling exposing the foam panels, which were left in place. Removal of the foam panels revealed visible mold on wallboard and the ceiling. There is insulation behind the foam board in some areas which also has mold growth along the top and bottom. A sample of the insulation, number 97G-9, was found to have growth of *Chaetomium*

ROOM 1 CEILING behind foam panels that were removed during this survey

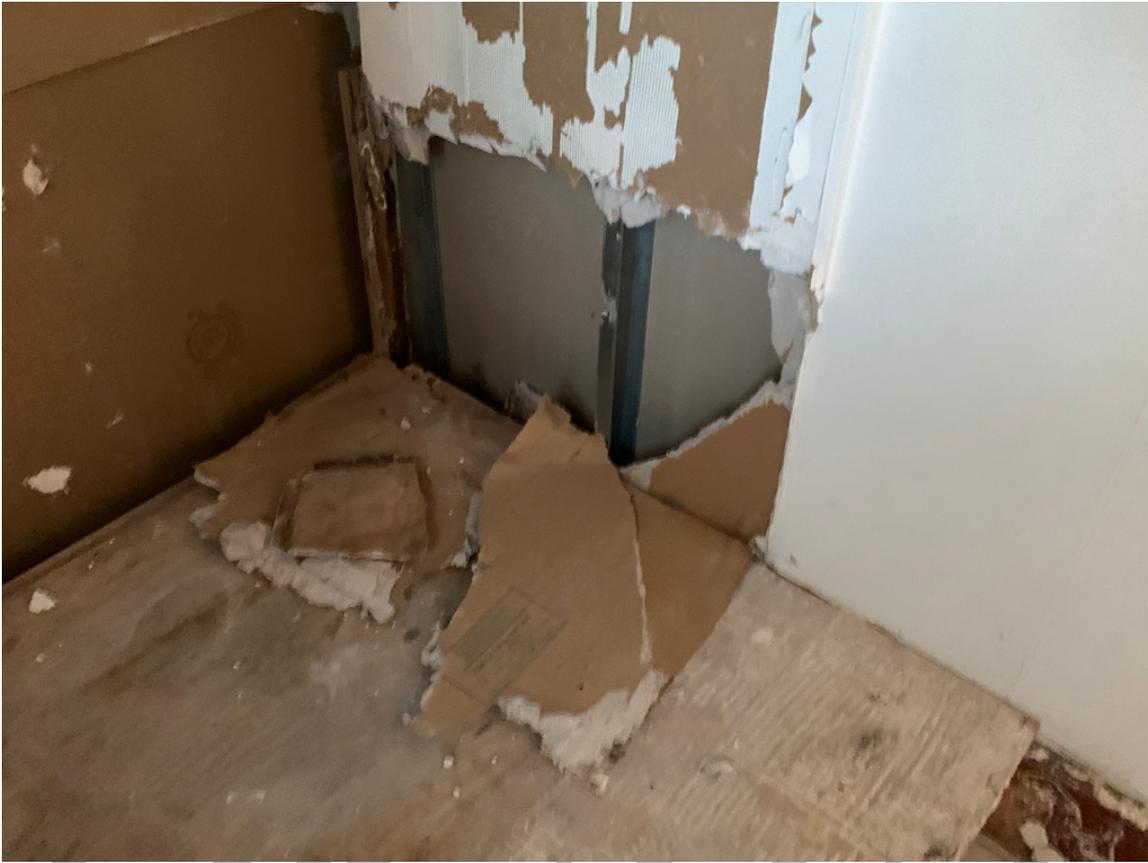
4. Bathroom – There is visible mold on the base of the sheetrock wall between the bathroom and living room. A tape lift sample, number 97G-1, had heavy growth of *Aspergillus*. The raised wood floor was left in place. A bulk sample from the wood, number 97G-6, had mycelium and hyphae indicating trace growth.
5. Room 2 – The wall between room 2 and the hall had visible mold between the sheetrock layer and wood finish layer. A sample, number 97G-4, had heavy growth of *Chaetomium*, *Acremonium*, *Aspergillus*, *Penicillium* and *Trichoderma*.

Bathroom wallboard has mold in the wall cavity

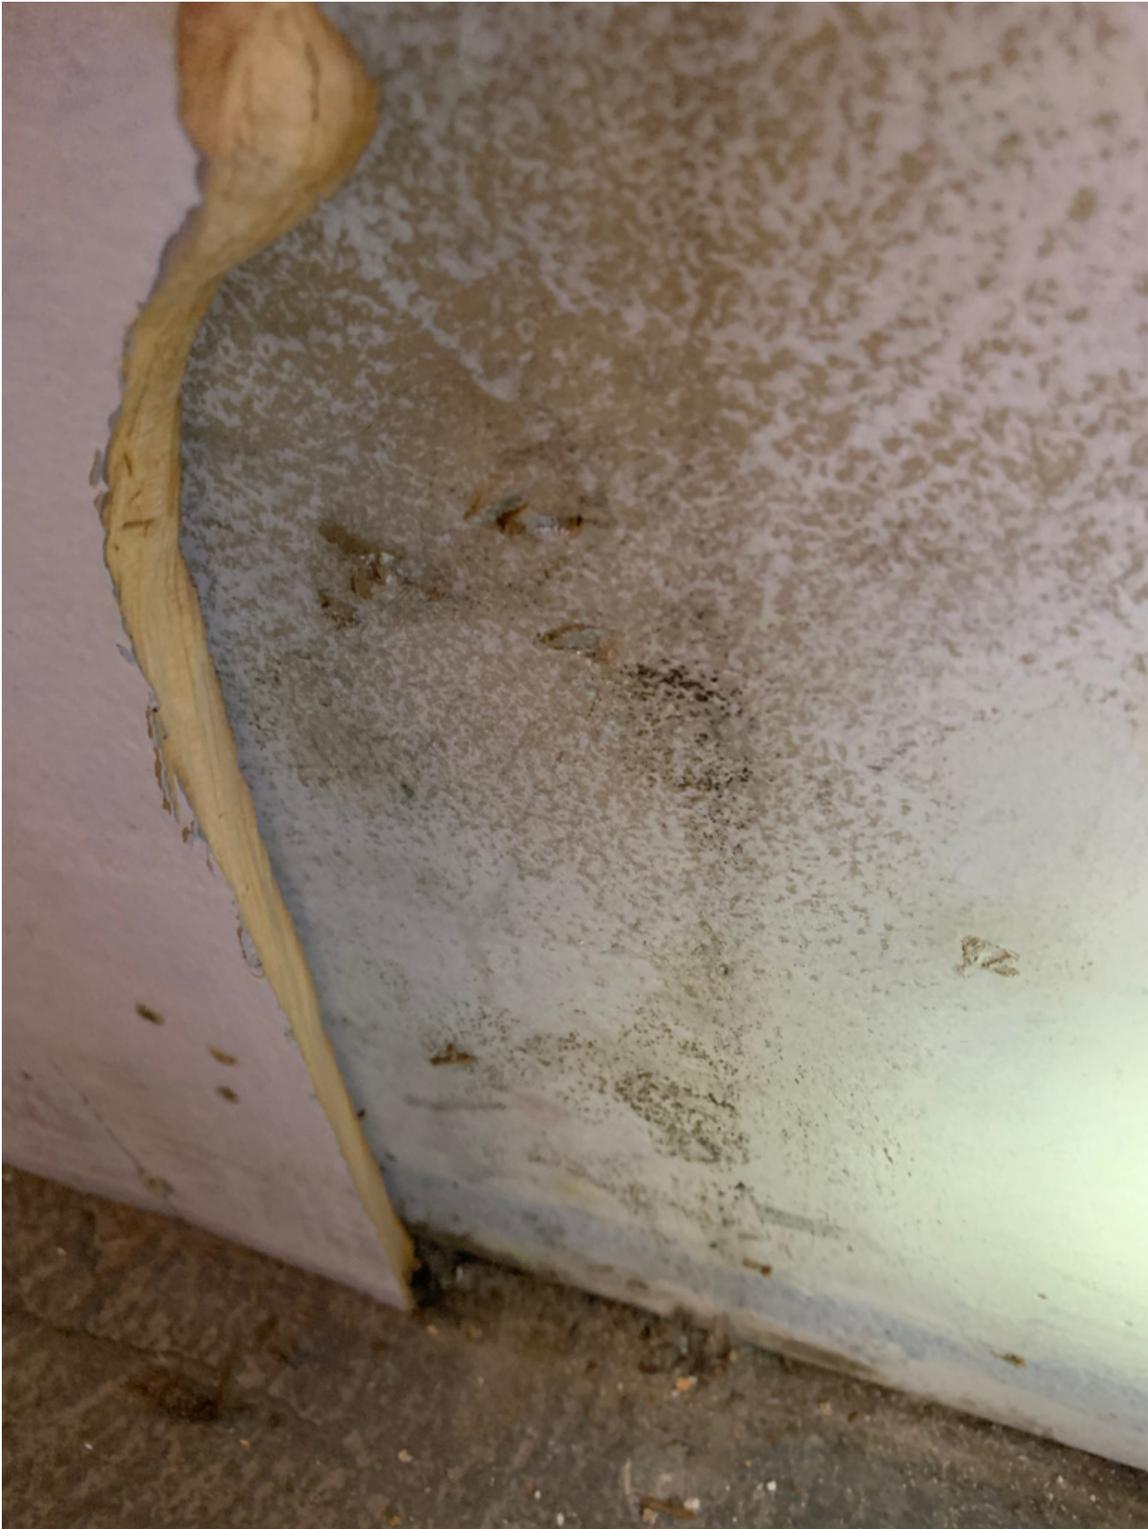
Wall outside room 2 has visible mold

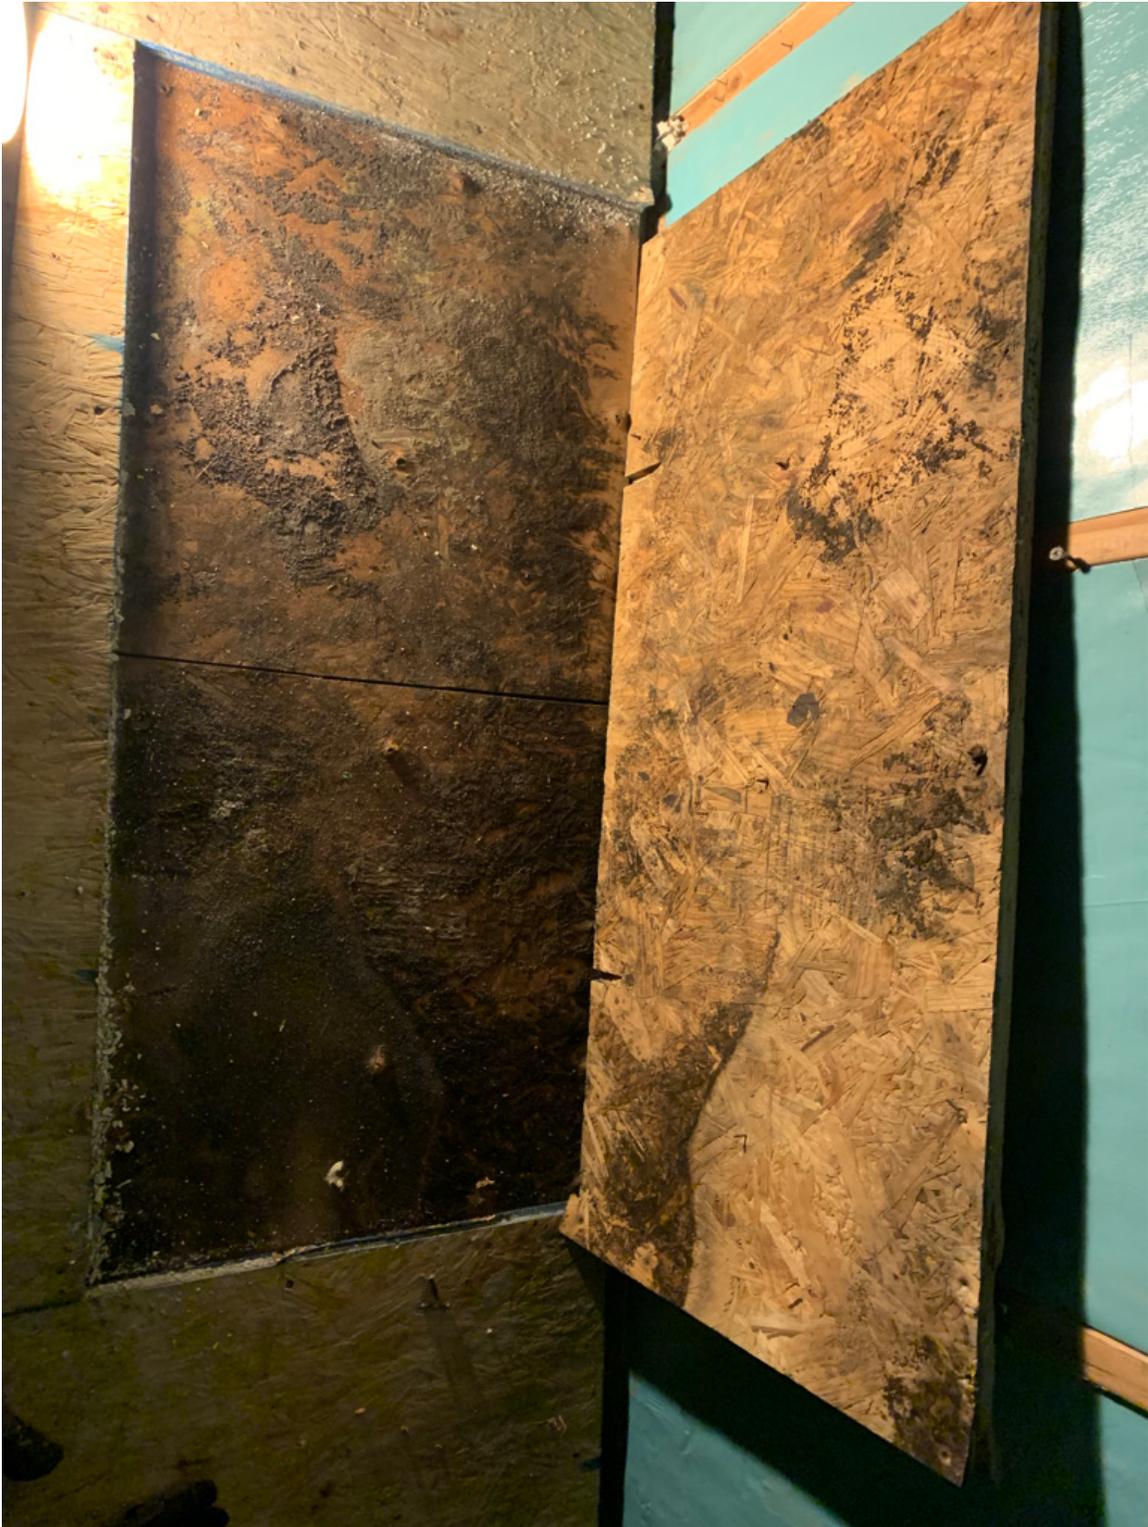
and *Trichoderma*. Another sample from the insulation, number 97G-12, had light growth of *Chaetomium*. Two layers of wood flooring were left in place. Removal of the upper layer of OSB revealed heavy mold growth on the underside of the OSB and on the fiberboard underlayment. Both layers of the wood test wet with a moisture meter and there is standing water under the wood. A sample from the underside of the floor oriented strand board (OSB), number 97G-7, had heavy growth of *Chaetomium* and *Acremonium*. The foam was removed from the ceiling revealed visible mold on the sheetrock above. A sample from the sheetrock confirmed the growth of *Chaetomium*. A sample from the insulation confirmed *Chaetomium* growth.

Underside of the OSB floor and the press wood subfloor are wet and moldy

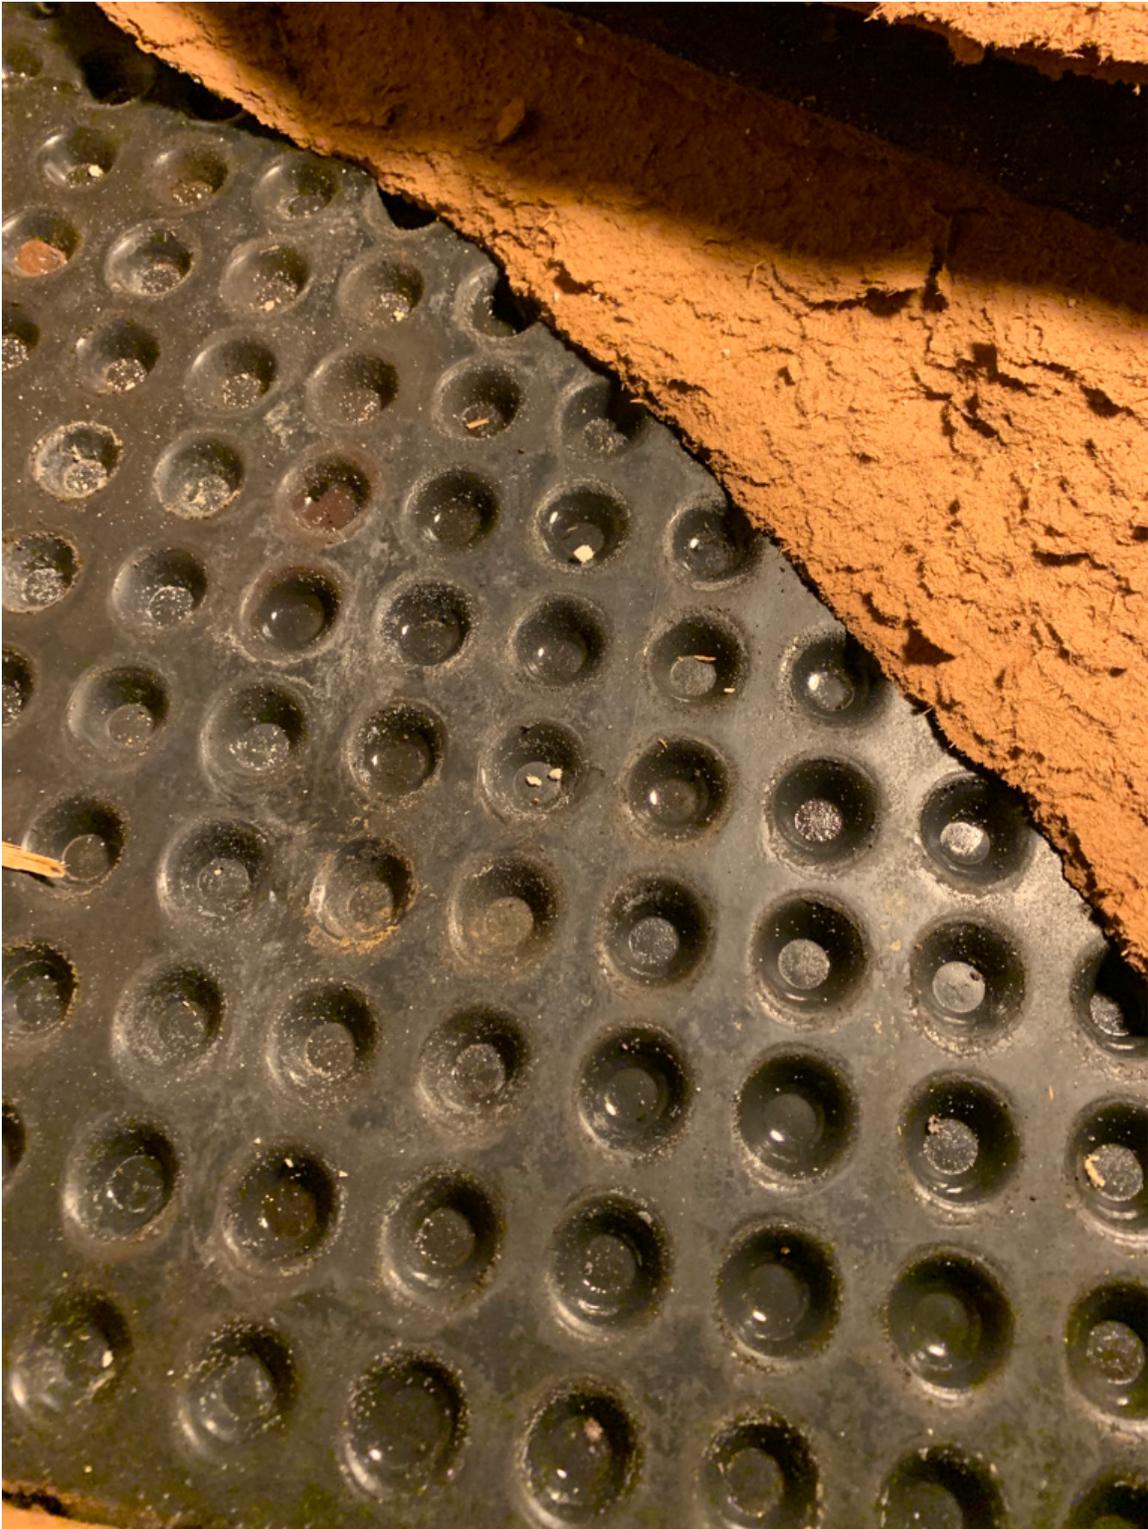
There is water under the press wood subfloor

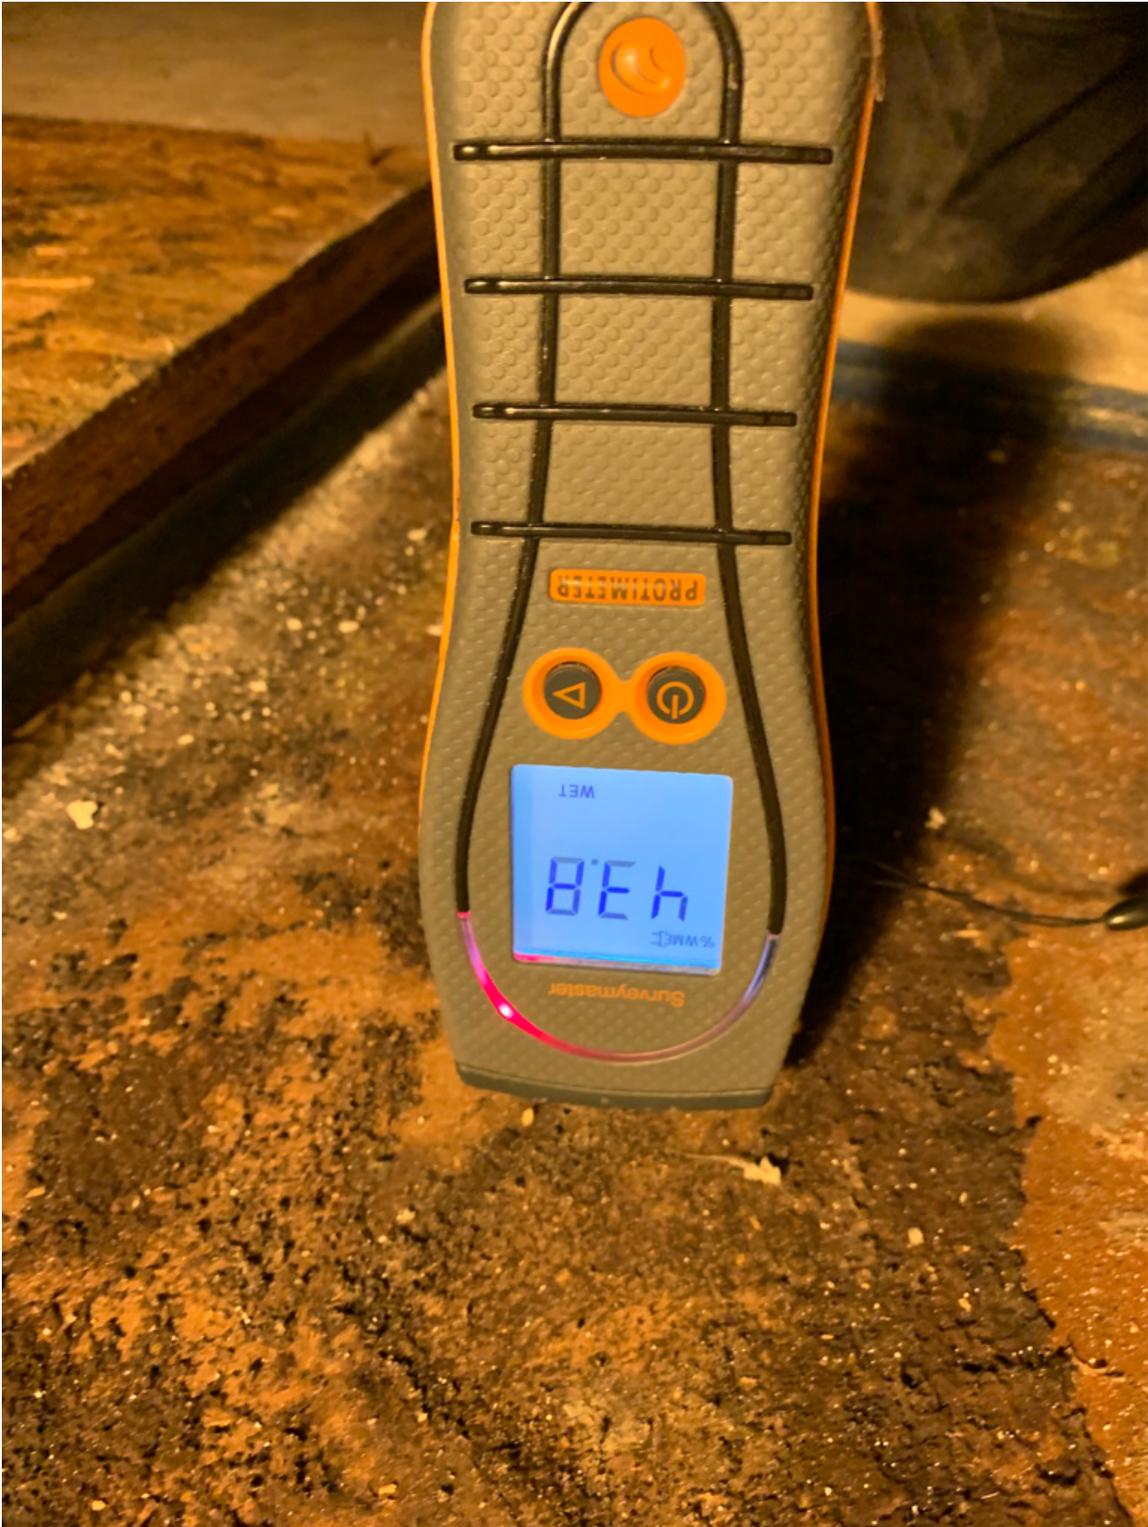
Wet and moldy subfloor
