# **OLMSTED ENVIRONMENTAL SERVICES, INC**

Date: June 28, 2020

Subject: Mold Inspection  
97 Green St. Apartment #G21 Brooklyn, NY 11222

Inspection Date: June 15, 2020

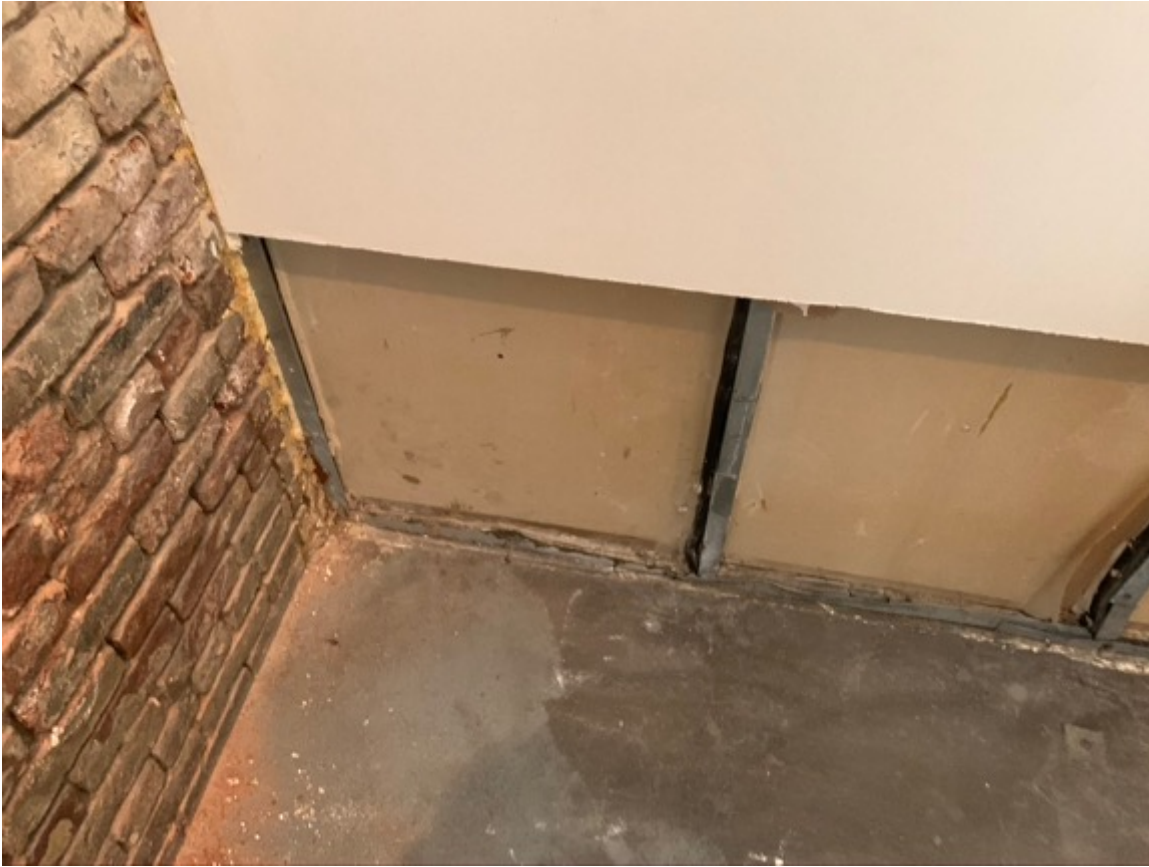
6. Living Room – A tape lift sample from inside the open wall cavity was analyzed by Ed Olmsted and tested positive for growth of mold. All of the sheetrock and insulation should be removed from this wall and the remaining sheetrock in the wall cavity should be cleaned and encapsulated. There is no visible mold growth in the living room. A wipe sample was collected from above the sheetrock around the columns to test the area above the sheetrock ceiling. The wood deck and insulation area above and were impacted by the flood. The wipe sample, number 97G-13, had massive levels of spores at over 5 million CFU per square inch. The sample was had *Aspergillus sydowii*, *Aspergillus versicolor*, *Penicillium*, and *Trichoderma longibrachiatum*. This is indicative of mold growth above the ceiling. Another wipe was collected from the top of the wall between the living room and adjacent studio. There was water damage but no visible mold. The sample had 740,000 CFU/in<sup>2</sup> dominated by *Penicillium*. This is indicative of mold growth. These results indicate there is mold growth in the wall and ceiling cavities and at the upper parts of the walls and not just the base of the walls. The walls should be demolished in the living room and studios.

Inside the living room area wall cavity – tape lifts revealed light mold growth is present

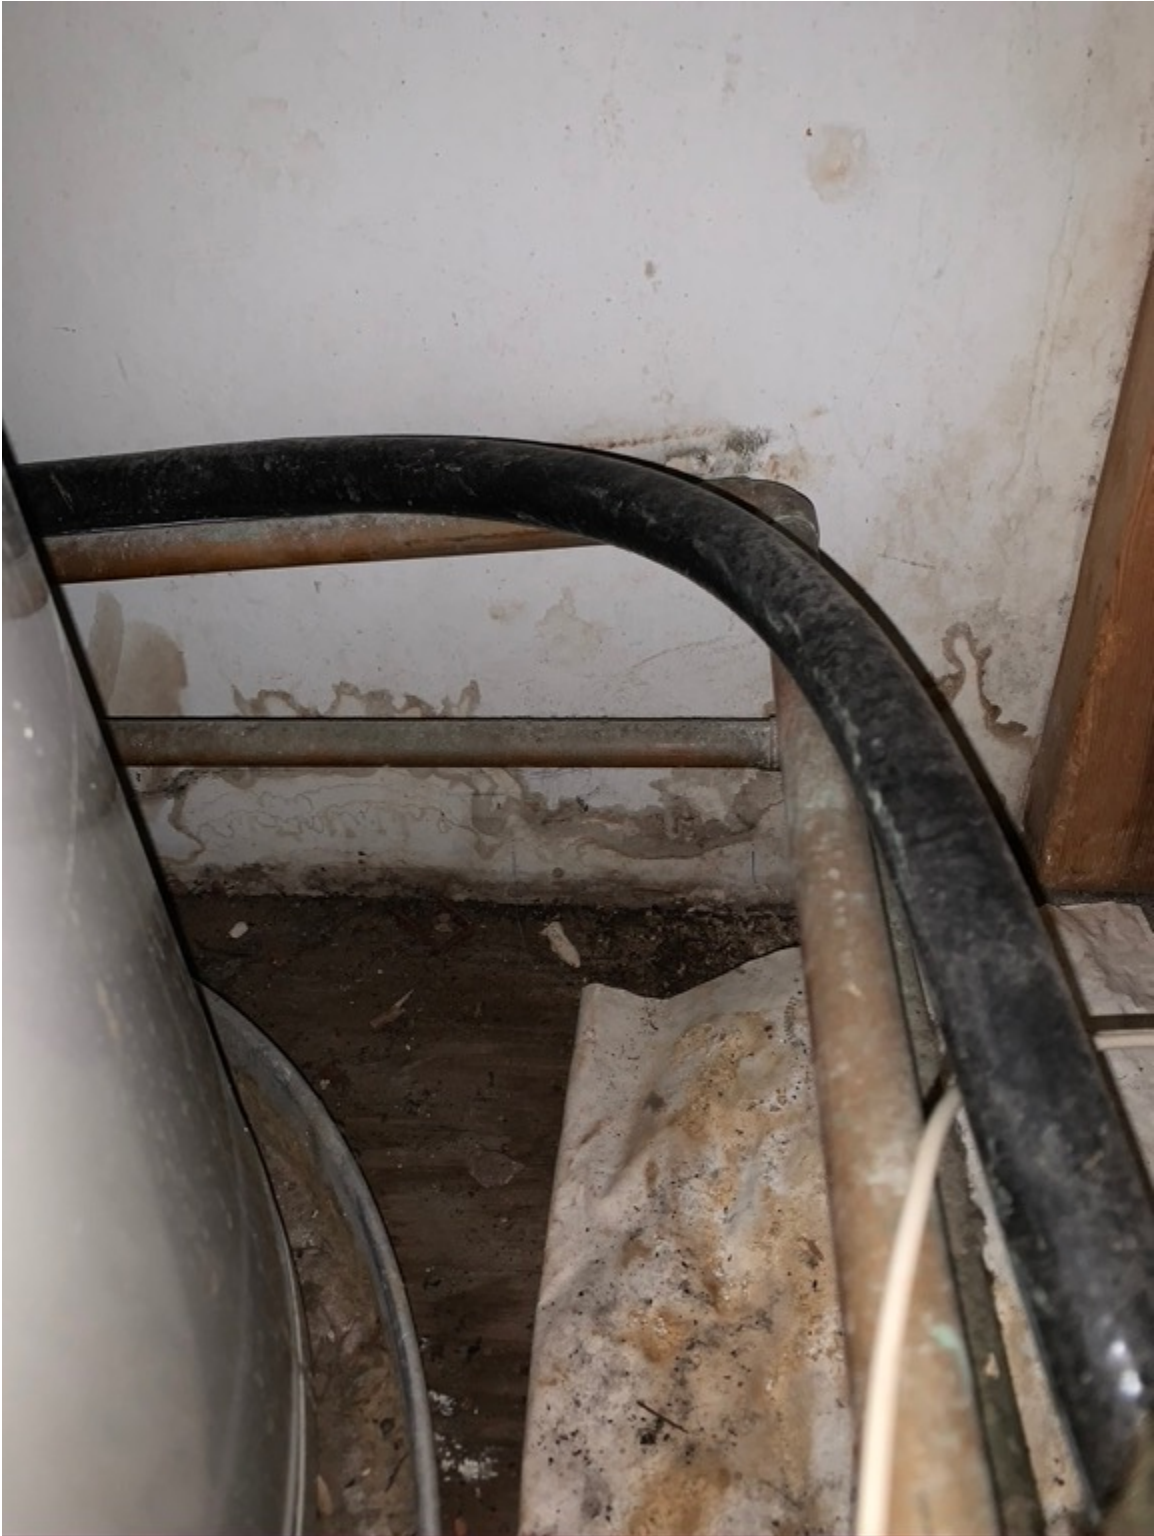
4. Bathroom - The raised wood floor in the bathroom has evidence of water damage to the wood in the hot water tank area adjacent to the bathtub. There is also mold growth on the wall between the bathroom and the kitchen. A tape lift from the raised

- wood floor in the bathroom, number 97G-6, was analyzed by Ed Olmsted and Prestige. The sample had growth of *Scopulariopsis*. There is surely greater amounts of mold growth under the raised wood floor where water was trapped. The wall cavity between the bathtub and the kitchen has visible mold growth. A bulk sample from the bathroom wall in the area by the hot water tank, number 97G-4, was analyzed by culture methods and found to have 780,000 colony forming units per gram (CFU/g). The sample was dominated by *Aspergillus calidoustus* at 690,000 CFU/g. This is indicative of mold growth. The raised floor and bathtub should be demolished in the bathroom. The wall shared with the kitchen should be opened and the back of the kitchen cabinets and wall cavity should be cleaned with HEPA vacuuming and damp wiping with a strong biocide.

The hot water tank next to the bathtub – there is mold growth on the raised wood floor and on the wall shared with the kitchen

The studios and bathroom should be completely demolished including the walls, floors and ceilings. Remove the bathroom raised floor and bath tub. Clean the back side of the kitchen cabinets from the bathroom side of the wall. The ceilings must come down in the living room area. The kitchen floor must be removed. The insulation inside the walls and above ceilings must be removed. The work essentially requires a full gutting of the studio. The scope of work involving removal of floor finishes and the lower walls in the studios outlined by the owner's expert is insufficient.

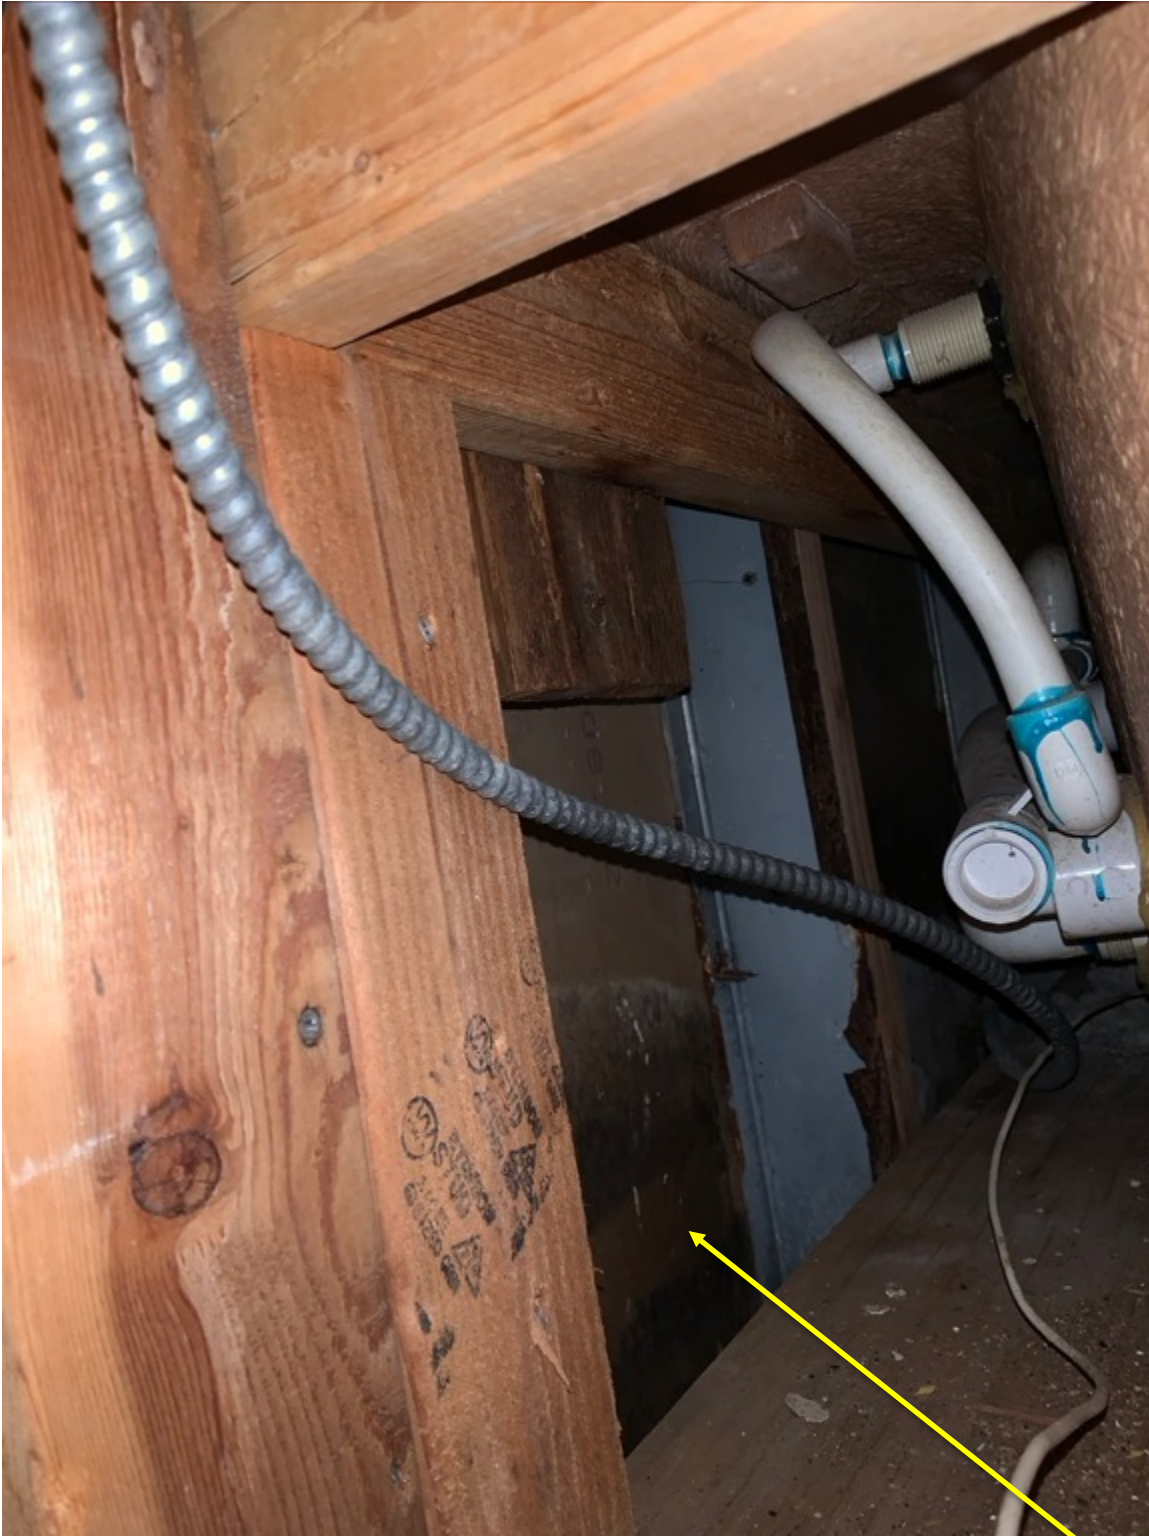
There is water staining and mold growth on the bathroom wall shared with the kitchen.

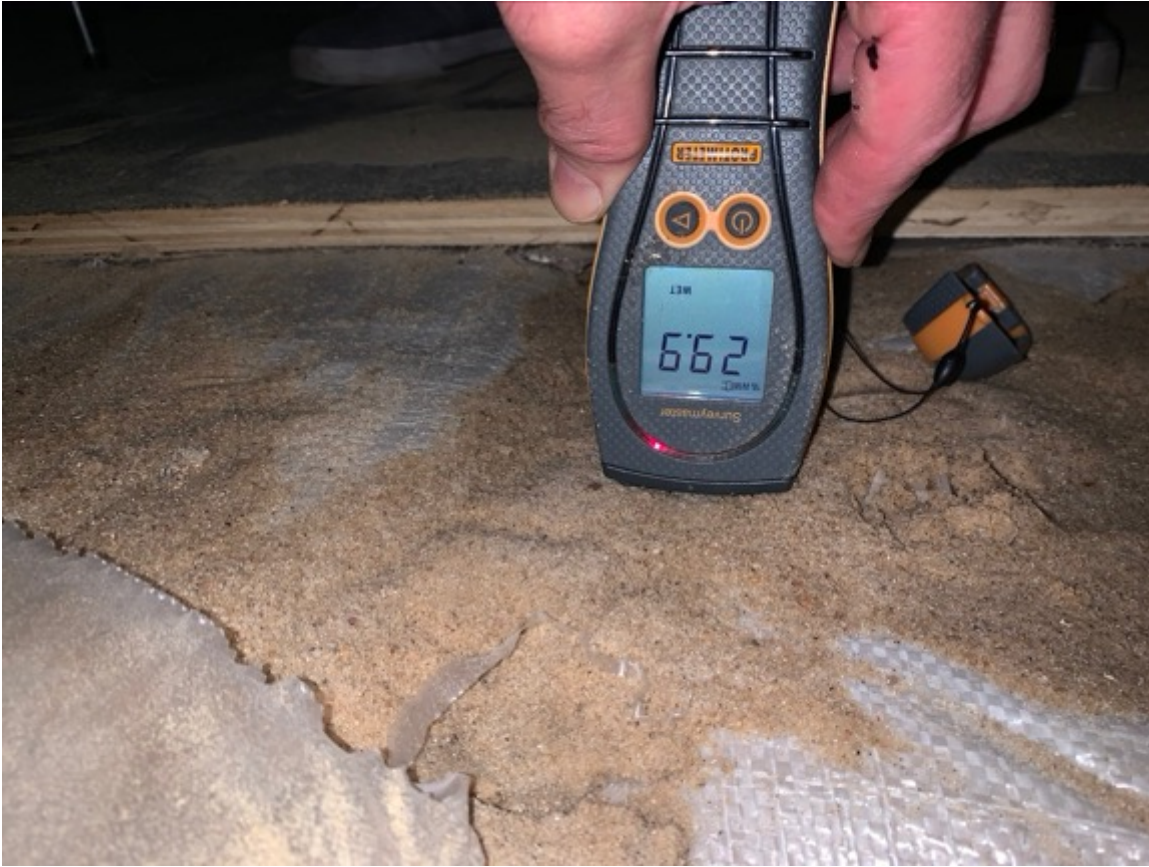
5. Studio Area Room 3 – This room has a raised wood floor with sand under the floor. The sand and wood is covered with plastic sheeting. Both the wood and sand tested wet with a moisture meter. The wood floor should be removed in this room and the sand removed as well as all plastic sheeting. The joists should be cleaned and dried.

The sand is wet under the raised floor

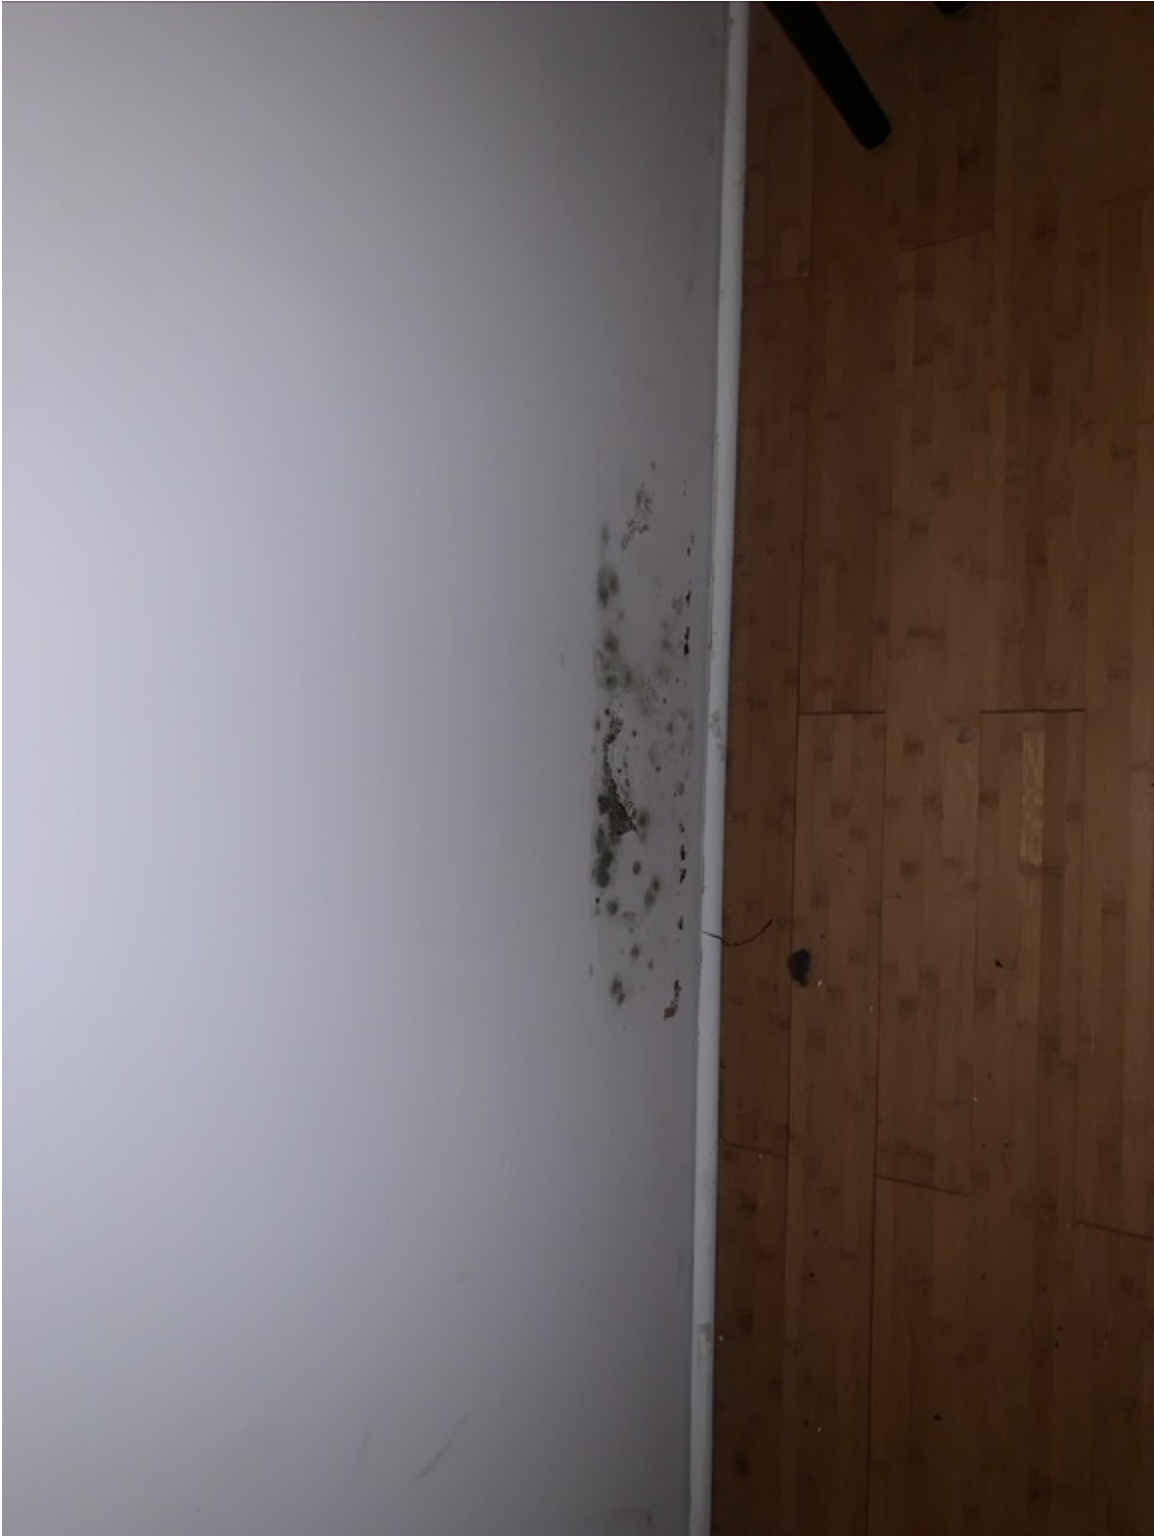
Visible mold on the base of the wall in studio area

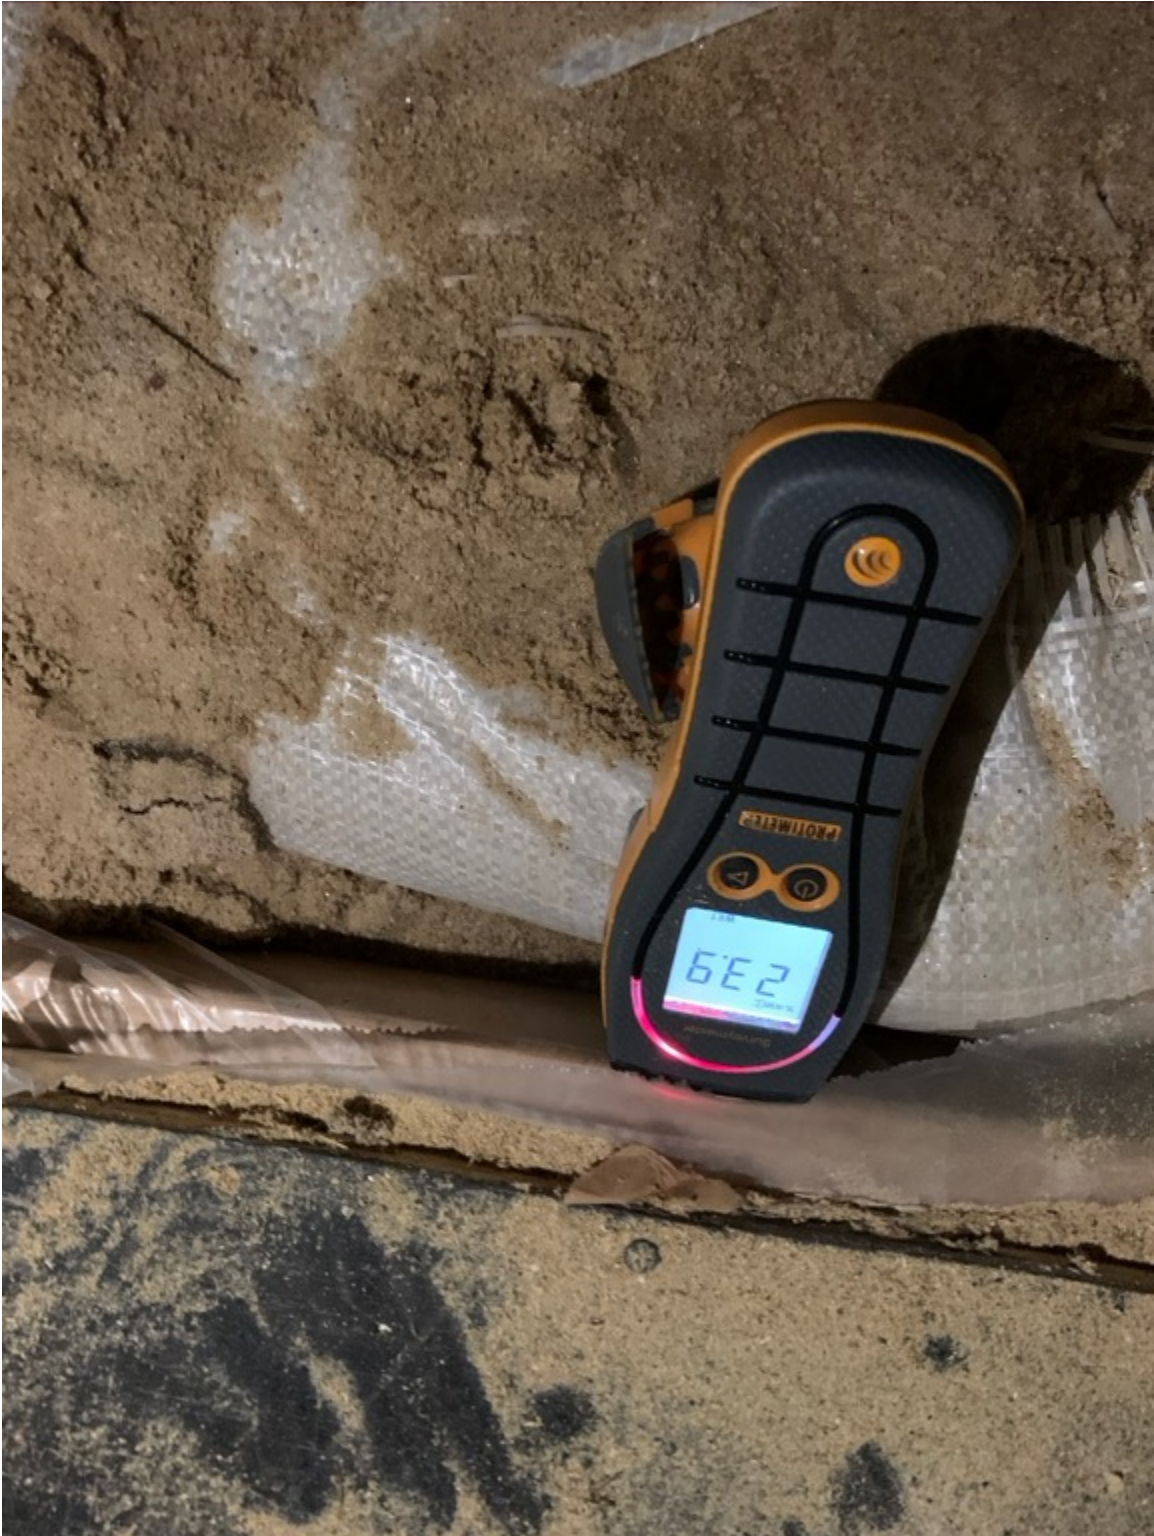
- b. The underside of the raised floor in one room of the studio area is slightly damp. The joists are damp measuring 30 to 40%. The sand also measured damp at 40%. This was due to the flood. The sand absorbed the water and the plastic lining the flooring and bags of sand trapped the water. This area has been wet for over 8 months. It should be assumed water was trapped under all of the floors including the finish floors in the other two rooms of the studio area, the raised floor in the bathroom, and the layers of wood flooring in the kitchen.

The wood joists adjacent to the sand is wet

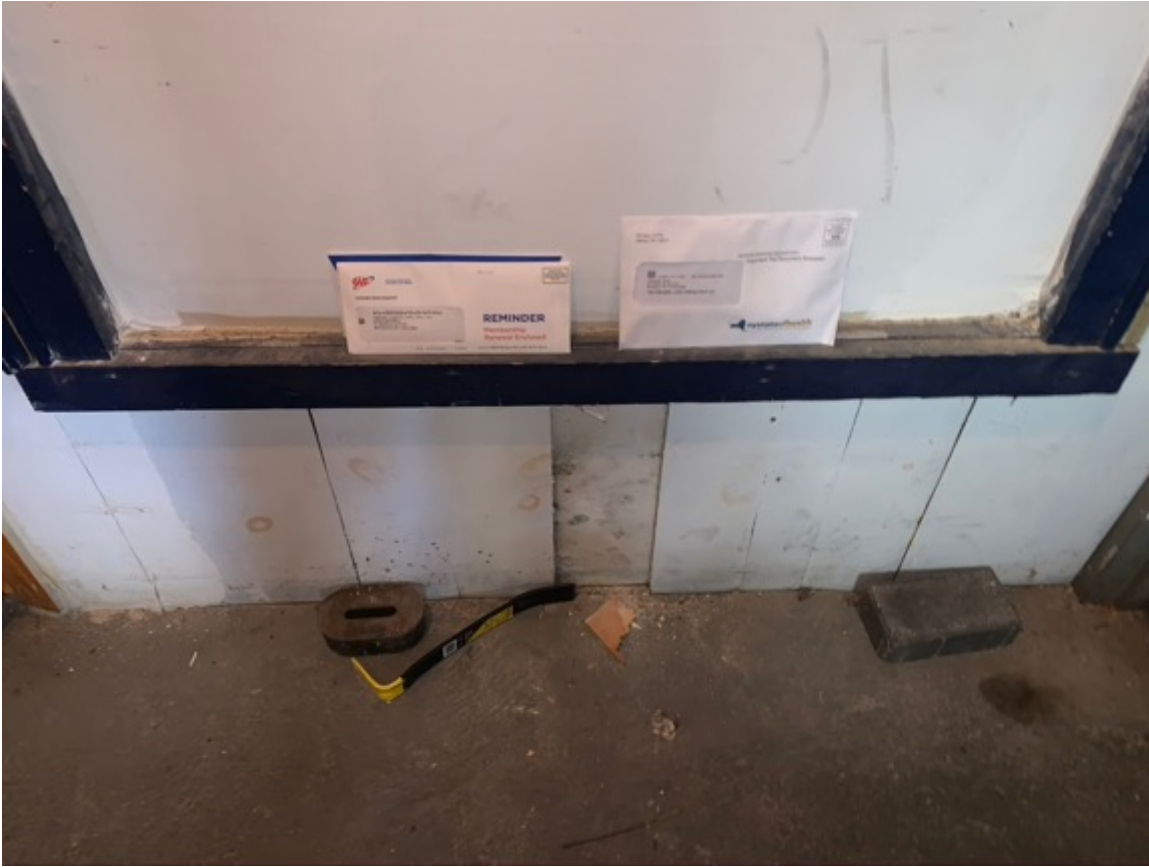
9. Studio Area Room 2. – There is visible mold growth on the base of the walls inside this room and outside in the hall adjacent to this room. The wood wainscoting was removed from the shared wall in the hallway outside this studio. There is heavy visible mold growth on the sheetrock behind wainscoting extending up the wall. This is an indication that most of the mold growth is hidden inside walls and between layers of walls and insulation.
10. Wood Deck above loft – There is visible mold on the wood deck and joists above the insulation in the loft area above the hallway. The underside of the wood floor deck and the joists above the ceiling were tested. The sample, number 97G-18, was analyzed by Olmsted and Prestige and found to have mold growth.

Visible mold behind the removed wood wainscot

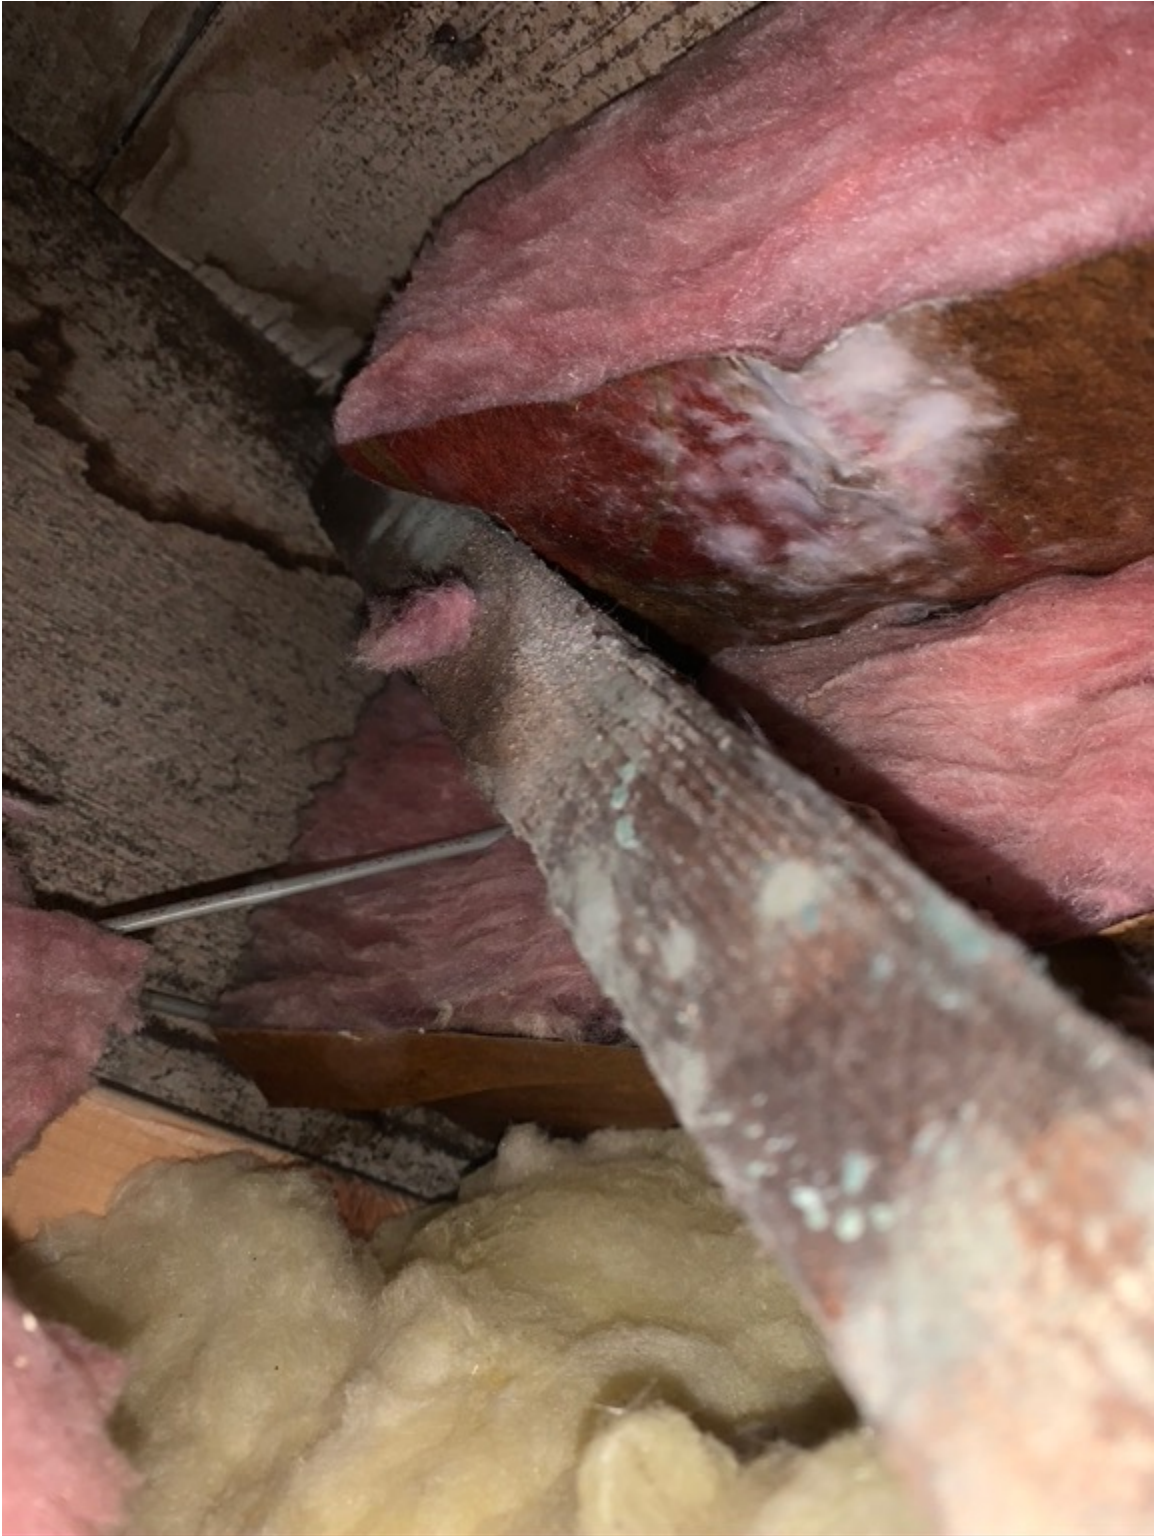
Mold growth on insulation and wood joists on the underside of the floor above
