August 03, 2021

Subject: Post Remediation Verification (PRV)

Location: 226 Franklin Street, Apartment G21, Brooklyn, NY 11222

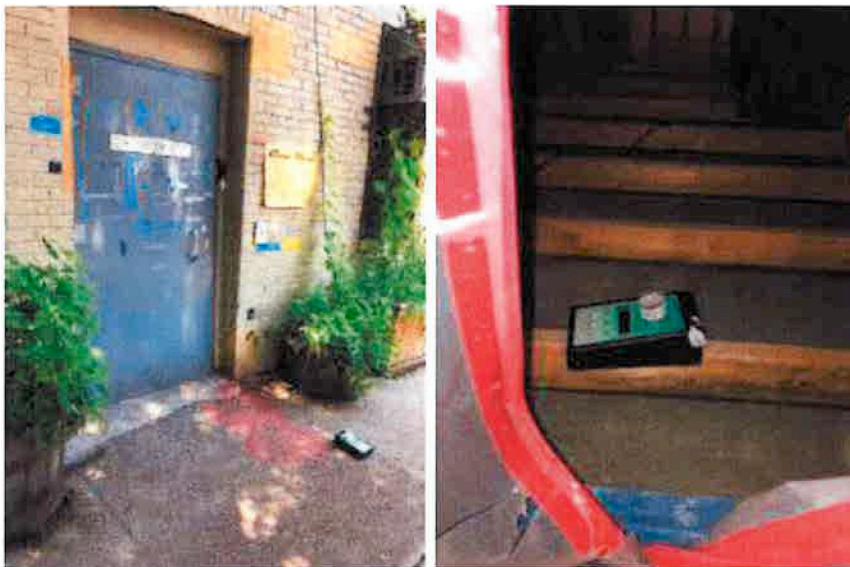
Studio 3: Up to 2ft of wall removed on wall b and wall c of hallway side; walls and ceiling removed. Studs and beams HEPA and detergent cleaned. The area is free and clean of VMG and odors.

Above Left: Entrance 97 Green Street, Outdoor Air Sample Location
Above Right: Studio 3: Air Sample Location

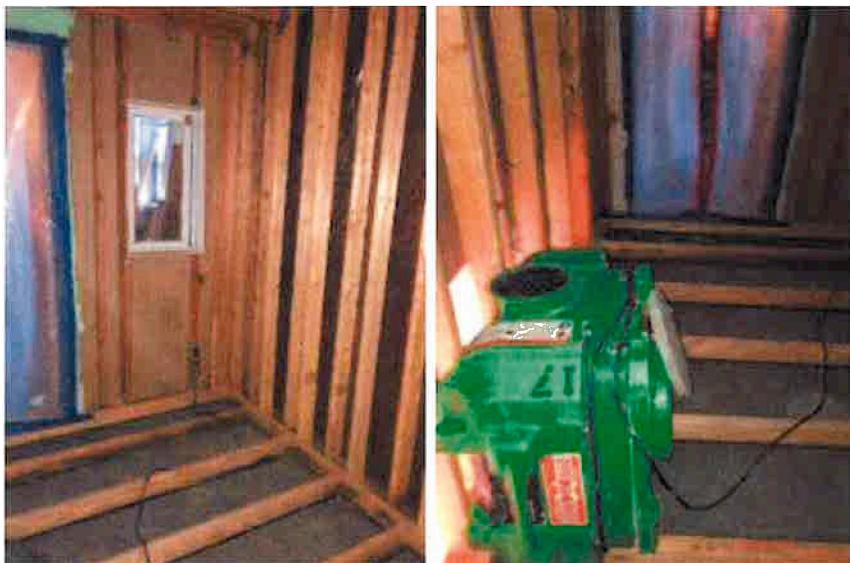
Above Left: Studio 3
Above Right: Studio 3

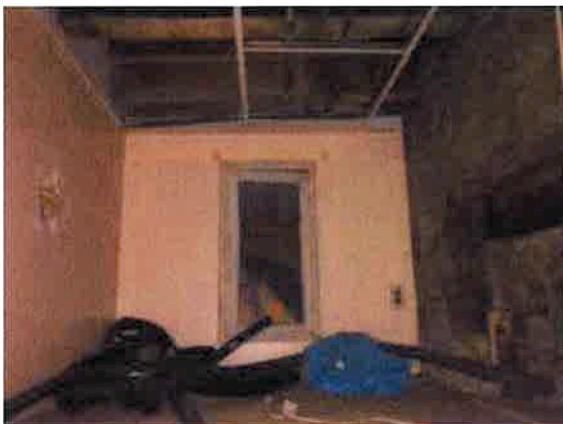
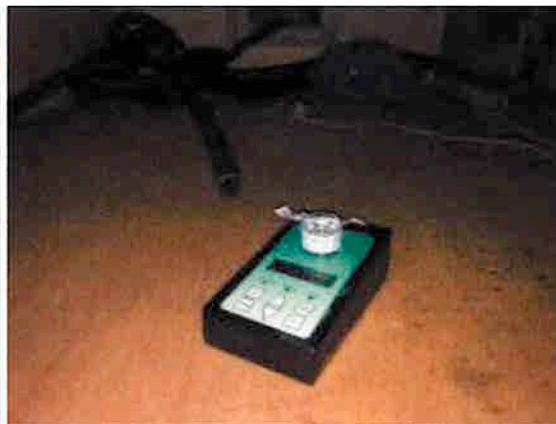
Upper Level Studio 3: The ceiling tiles were removed. The area is free and clean of VMG or odors.

Above Left: Upper Level Studio 3

Above Right: Upper Level Studio 3: Air Sample Location

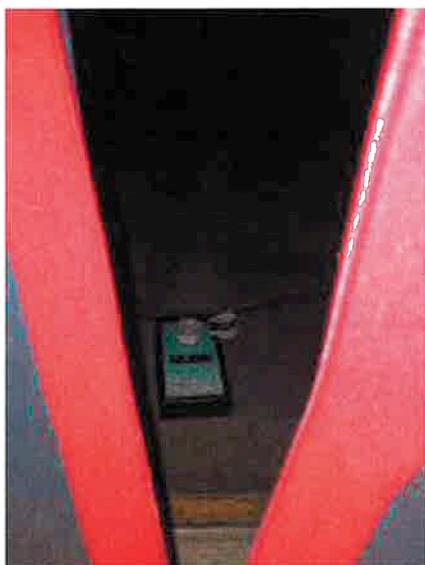
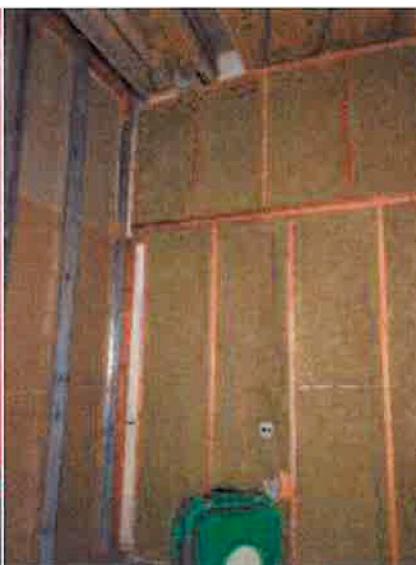
Studio 2: The carpeting, ceiling, and walls were removed. The area is free and clean of VMG or odors.

Above Left: Studio 2

Above Right: Studio 2

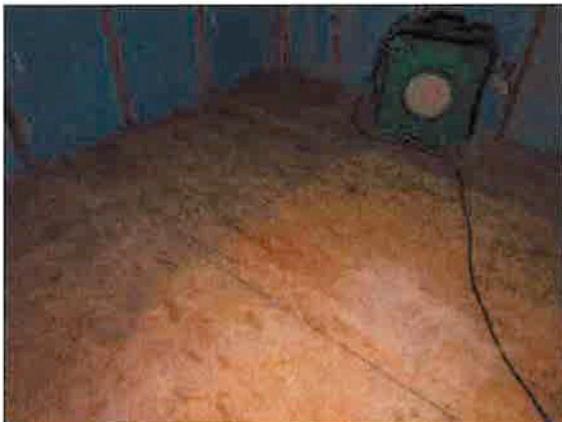
Above Left: Studio 1

Studio 1: The walls, ceiling, and floor were removed as per work scope. The area is free and clean of VMG or odors.

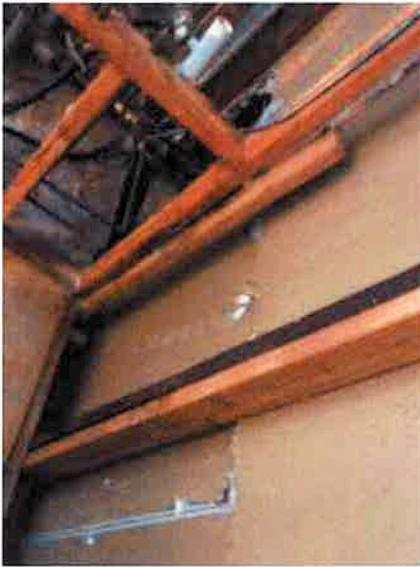
Bathroom: The shower wall was removed, gypsum wall 3 ft. from the floor was removed, the water heater, sink, bathtub, tiles, and raised floor were removed. The area is free and clean of VMG or odors.

Above Left: Bathroom (Shower wall, Water Heater and Bathtub removed)

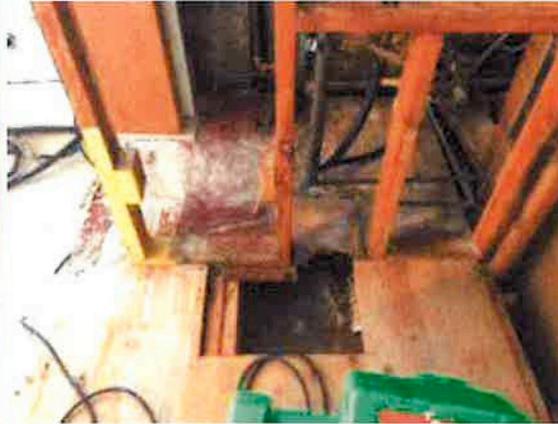
Above Right: Bathroom (Raised floor, Water Heater and Bathtub removed)

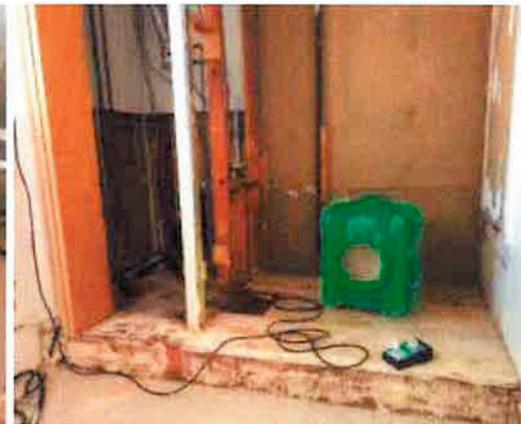
Above Right: Bathroom (Water Heater, Bathtub, Shower wall removed)

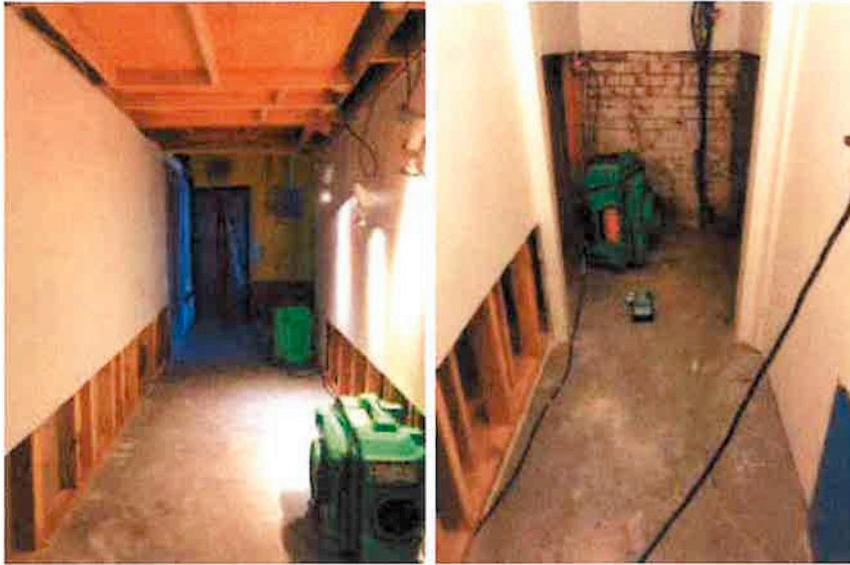
Hallway/washer dryer area: The washer and dryer were removed; ceiling and 2 ft. of wall from the floor were removed (brick exposed). The area is free and clean of VMG or odors.

Above Left: Hallway

Above Right: Hallway with Washer and Dryer Removed
