March 18, 2020 Revised

Subject: Limited Water Intrusion Inspection

Location: 226 Franklin Street, Apartment G21, Brooklyn, NY 11222

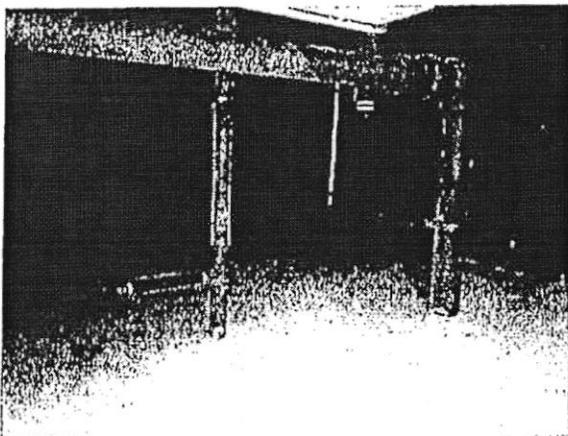
According to the Client, a flood event took place on October 13, 2019 caused by a faulty sprinkler from the fire suppression system. According to the resident, the water "gushed" from the ceiling from approximately 11:30pm until 5:30am.

Above: Sprinkler head that caused the pipe burst in October 2020 in the apartment above.

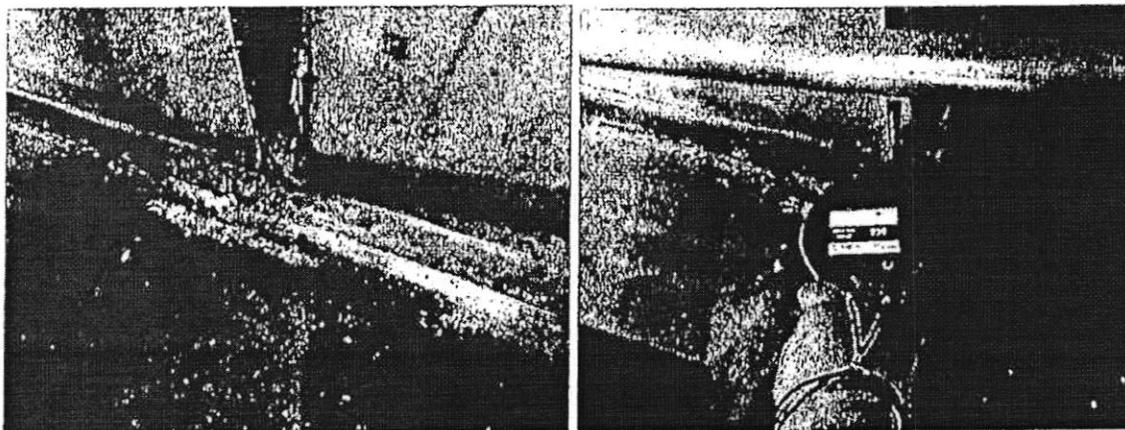
Living room and Bedroom: The west brick wall measured wet with the moisture meter (see Appendix B: Pictures for further details). The concrete floor in the living room measured wet with the moisture meter (pinless 287-999).

Above Left: visible microbial growth in living room north wall

Above Right: Moisture meter measured the concrete floor as wet near north wall in living room

The concrete floor in the living room, and tile floor in the bathroom should be monitored during the remediation process. The floor measured wet and is painted. If the foundation beneath the concrete floor is soil, this may contribute to this finding. Use professional discretion; however no corrective action is required.

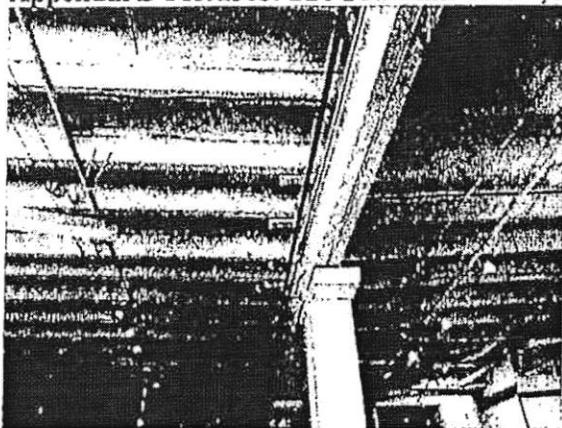
Living Room and Bedroom: Visible microbial growth on the drywall north wall was observed (approximately 13 square feet). Ceiling joists were sagging. The main support beam shows signs of cracking and splitting. Above the ceiling joists is drywall, inaccessible to measure for moisture.

**Above left: Living room ceiling with sagging ceiling joists and support beam cracking
Above right: Visible mold in studio room 2 west drywall wall**

Inspect integrity of the sagging ceiling joists in the living room by a building engineer or qualified professional. The main support beam showed signs of cracks and splitting.

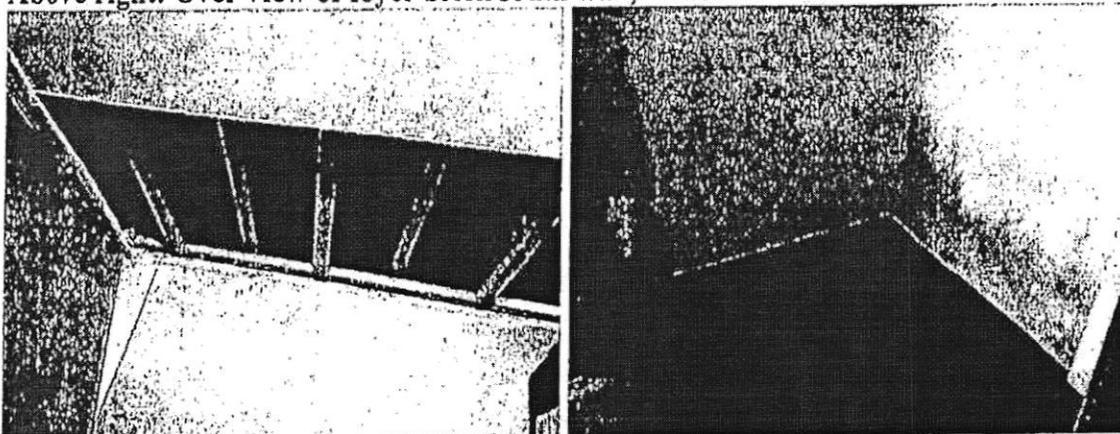
Above left: Water damage and visible microbial growth in hallway south wall

Above right: Visible microbial growth on east and south wall in studio room 3
