OLMSTED ENVIRONMENTAL SERVICES, INC

Report for: Christian Gray
97 Green St.
Apartment. G21
Brooklyn, NY 11222

Subject: Mold Inspection
97 Green St. Apartment #G21 Brooklyn, NY 11222

Inspection Date: June 15, 2020

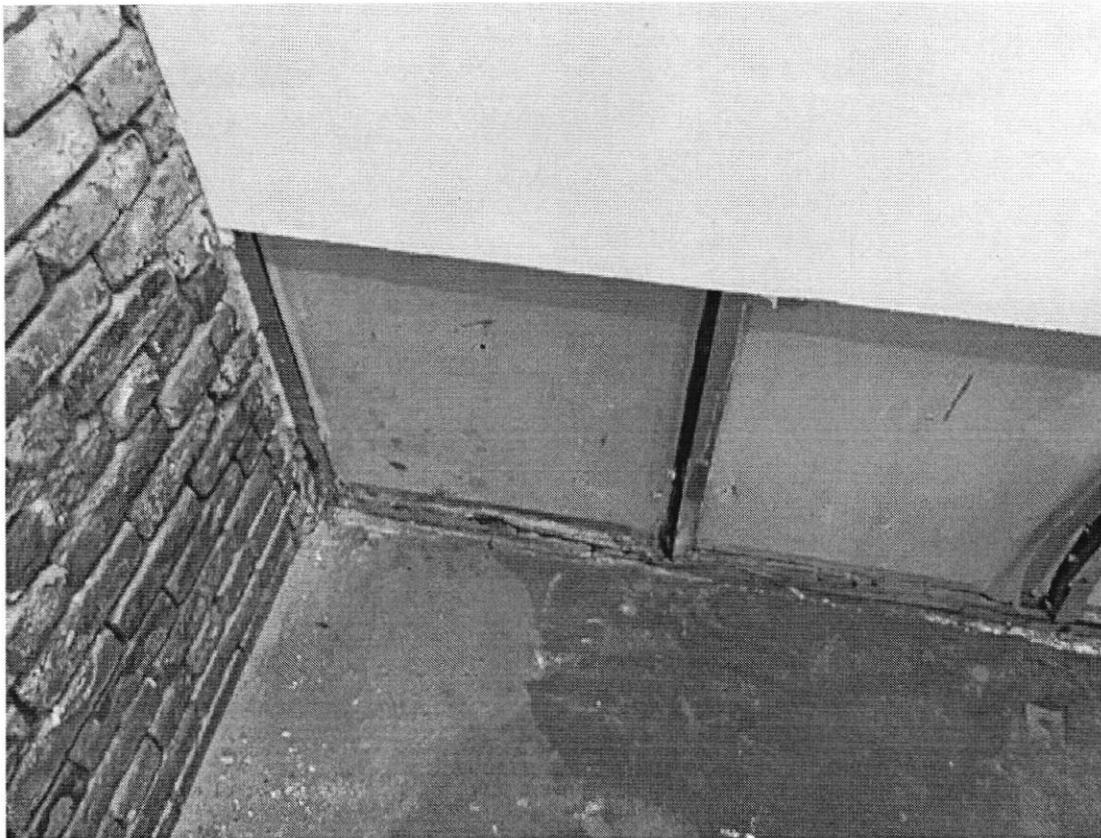
6. Living Room – A tape lift sample from inside the open wall cavity was analyzed by Ed Olmsted and tested positive for growth of mold. All of the sheetrock and insulation should be removed from this wall and the remaining sheetrock in the wall cavity should be cleaned and encapsulated. There is no visible mold growth in the living room. A wipe sample was collected from above the sheetrock around the columns to test the area above the sheetrock ceiling. The wood deck and insulation area above and were impacted by the flood. The wipe sample, number 97G-13, had massive levels of spores at over 5 million CFU per square inch. The sample was had *Aspergillus sydowii*, *Aspergillus versicolor*, *Penicillium*, and *Trichoderma longibrachiatum*. This is indicative of mold growth above the ceiling. Another wipe was collected from the top of the wall between the living room and adjacent studio. There was water damage but no visible mold. The sample had 740,000 CFU/in² dominated by *Penicillium*. This is indicative of mold growth. These results indicate there is mold growth in the wall and ceiling cavities and at the upper parts of the walls and not just the base of the walls. The walls should be demolished in the living room and studios.

Inside the living room area wall cavity – tape lifts revealed light mold growth is present

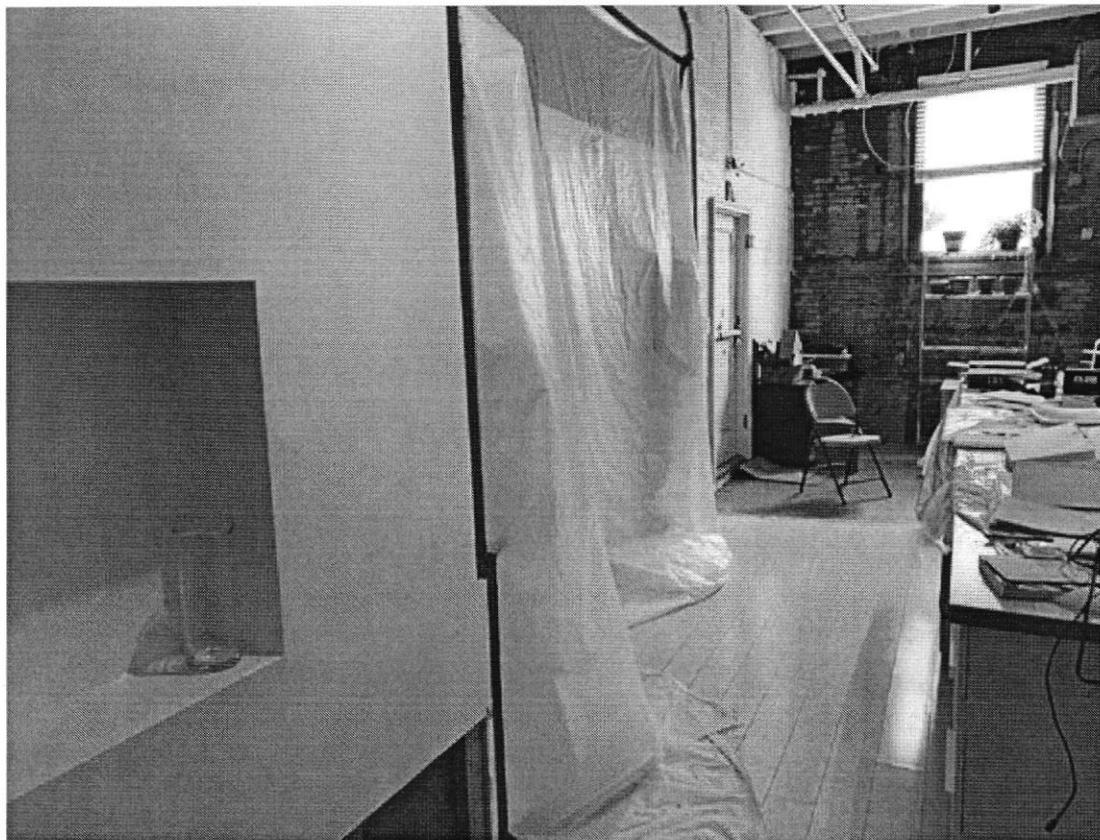
- g. The underside of the wood floor deck and the joists above the ceiling.
3. Kitchen - The kitchen wood floor is a layer of plywood subfloor with engineered wood finish floor. This area was reported by Christian Gray to have been under water and had warped. A swab was collected under the finish floor from the bottom side of the finish floor and the top side of the plywood. The sample had 190,000 colony forming units per square inch (CFU/in²) and was dominated by *Penicillium* and *Trichoderma*. Toxin producing species include *Trichoderma harzianum* and *Trichoderma longibrachiatum*. These results indicate there is mold growth present in the kitchen wood flooring.

Kitchen area – there is mold growth under the wood flooring

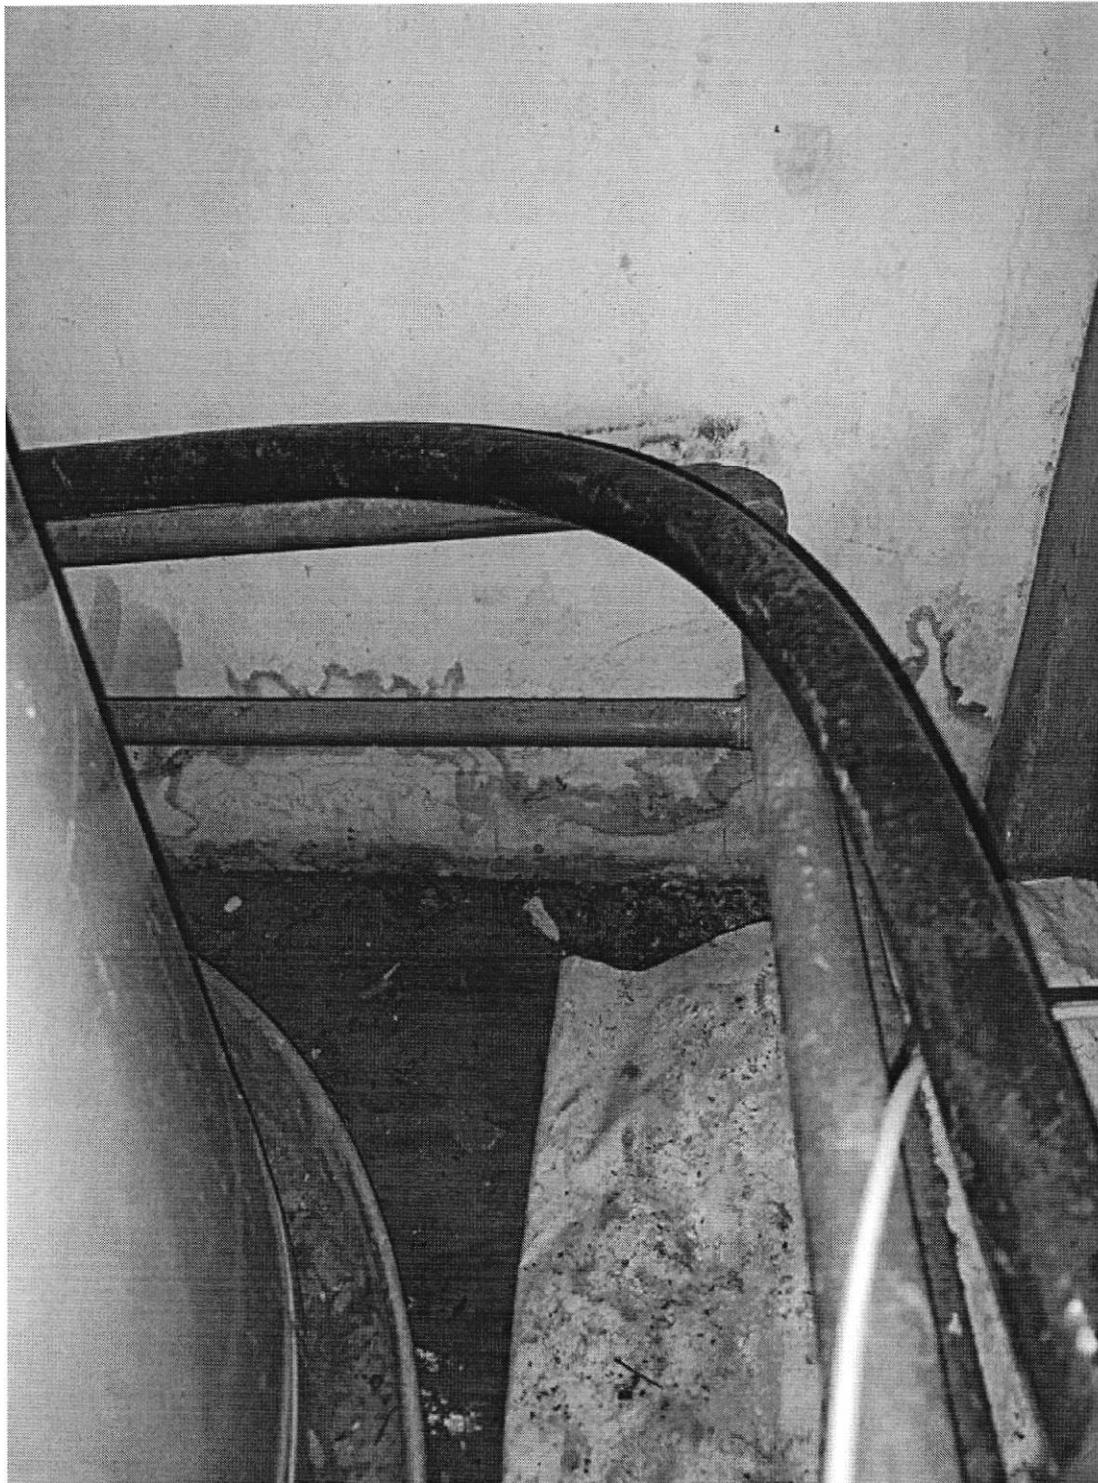
4. Bathroom - The raised wood floor in the bathroom has evidence of water damage to the wood in the hot water tank area adjacent to the bathtub. There is also mold growth on the wall between the bathroom and the kitchen. A tape lift from the raised

wood floor in the bathroom, number 97G-6, was analyzed by Ed Olmsted and Prestige. The sample had growth of *Scopulariopsis*. There is surely greater amounts of mold growth under the raised wood floor where water was trapped. The wall cavity between the bathtub and the kitchen has visible mold growth. A bulk sample from the bathroom wall in the area by the hot water tank, number 97G-4, was analyzed by culture methods and found to have 780,000 colony forming units per gram (CFU/g). The sample was dominated by *Aspergillus calidoustus* at 690,000 CFU/g. This is indicative of mold growth. The raised floor and bathtub should be demolished in the bathroom. The wall shared with the kitchen should be opened and the back of the kitchen cabinets and wall cavity should be cleaned with HEPA vacuuming and damp wiping with a strong biocide.

The hot water tank next to the bathtub – there is mold growth on the raised wood floor and on the wall shared with the kitchen

The studios and bathroom should be completely demolished including the walls, floors and ceilings. Remove the bathroom raised floor and bath tub. Clean the back side of the kitchen cabinets from the bathroom side of the wall. The ceilings must come down in the living room area. The kitchen floor must be removed. The insulation inside the walls and above ceilings must be removed. The work essentially requires a full gutting of the studio. The scope of work involving removal of floor finishes and the lower walls in the studios outlined by the owner's expert is insufficient.

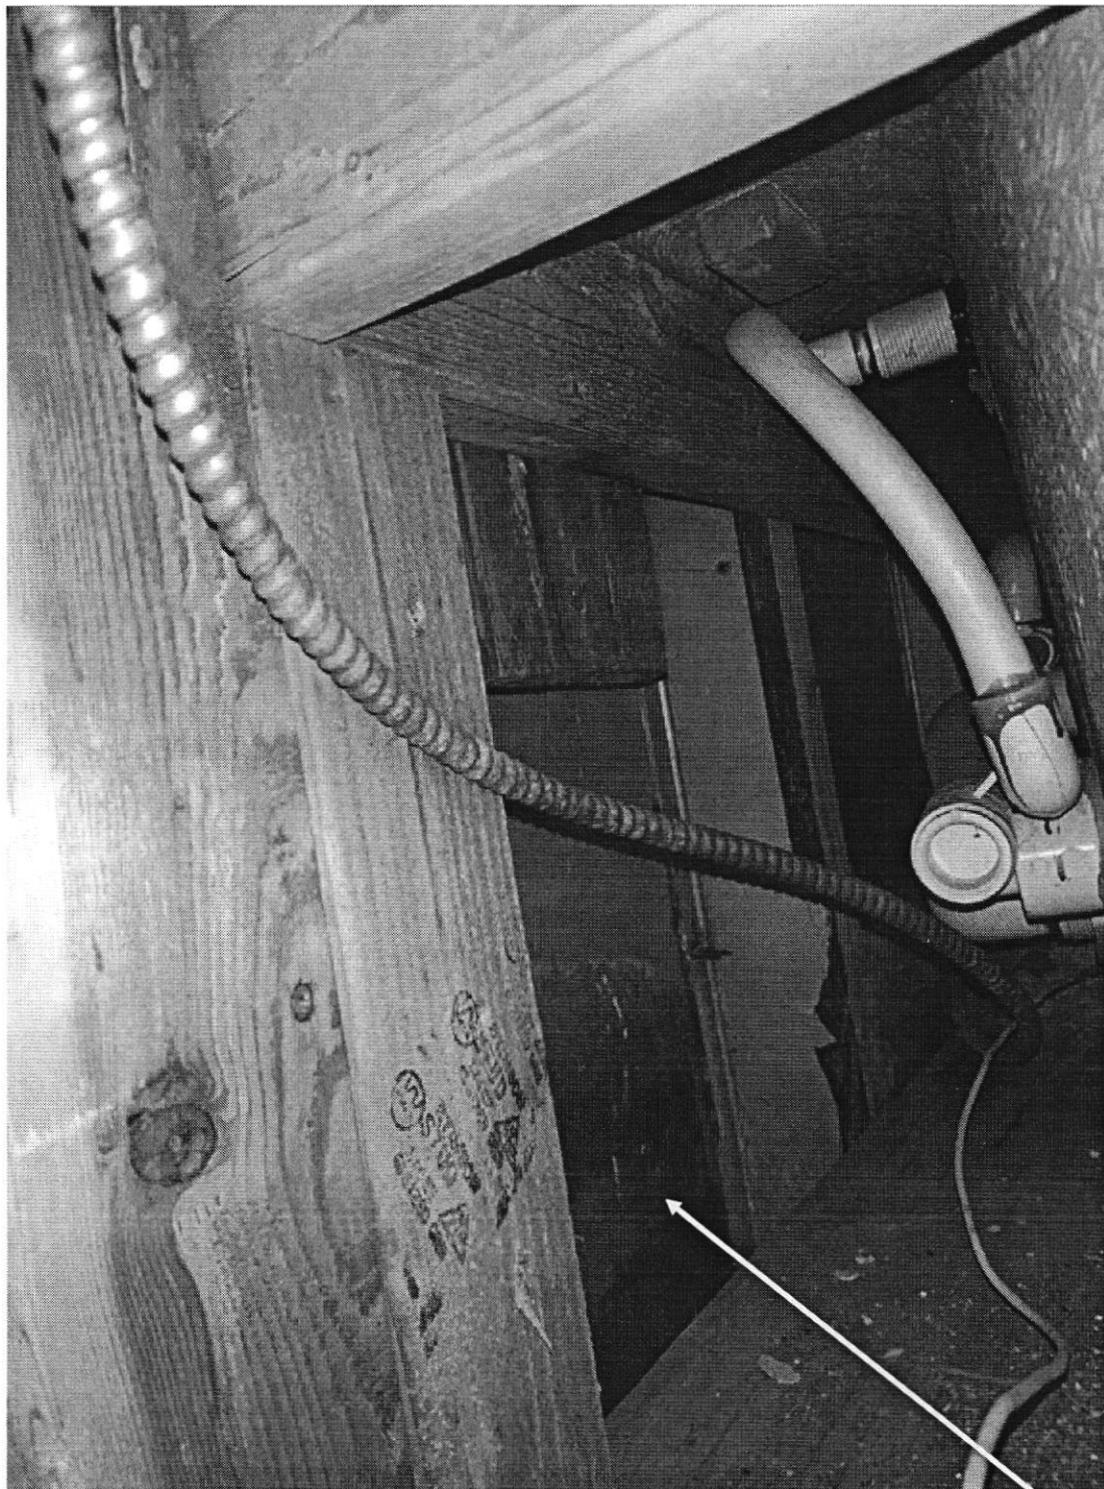
There is water staining and mold growth on the bathroom wall shared with the kitchen.

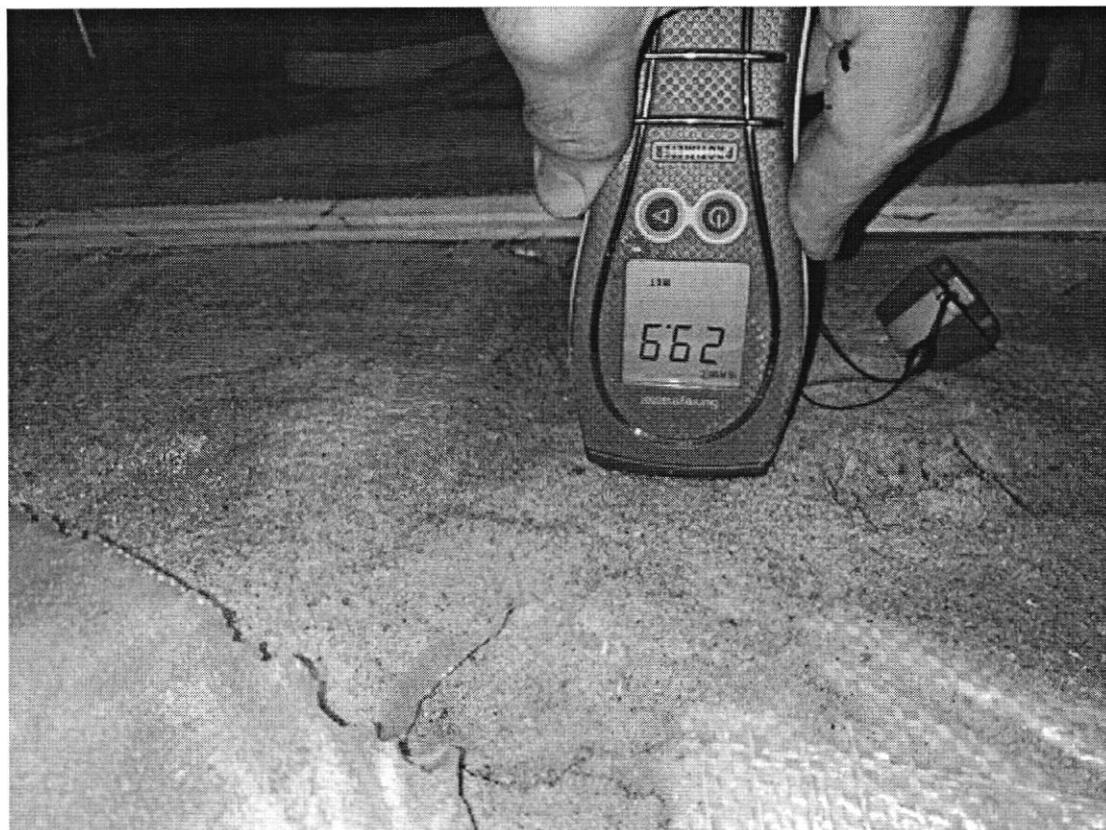
5. Studio Area Room 3 – This room has a raised wood floor with sand under the floor. The sand and wood is covered with plastic sheeting. Both the wood and sand tested wet with a moisture meter. The wood floor should be removed in this room and the sand removed as well as all plastic sheeting. The joists should be cleaned and dried.

The sand is wet under the raised floor

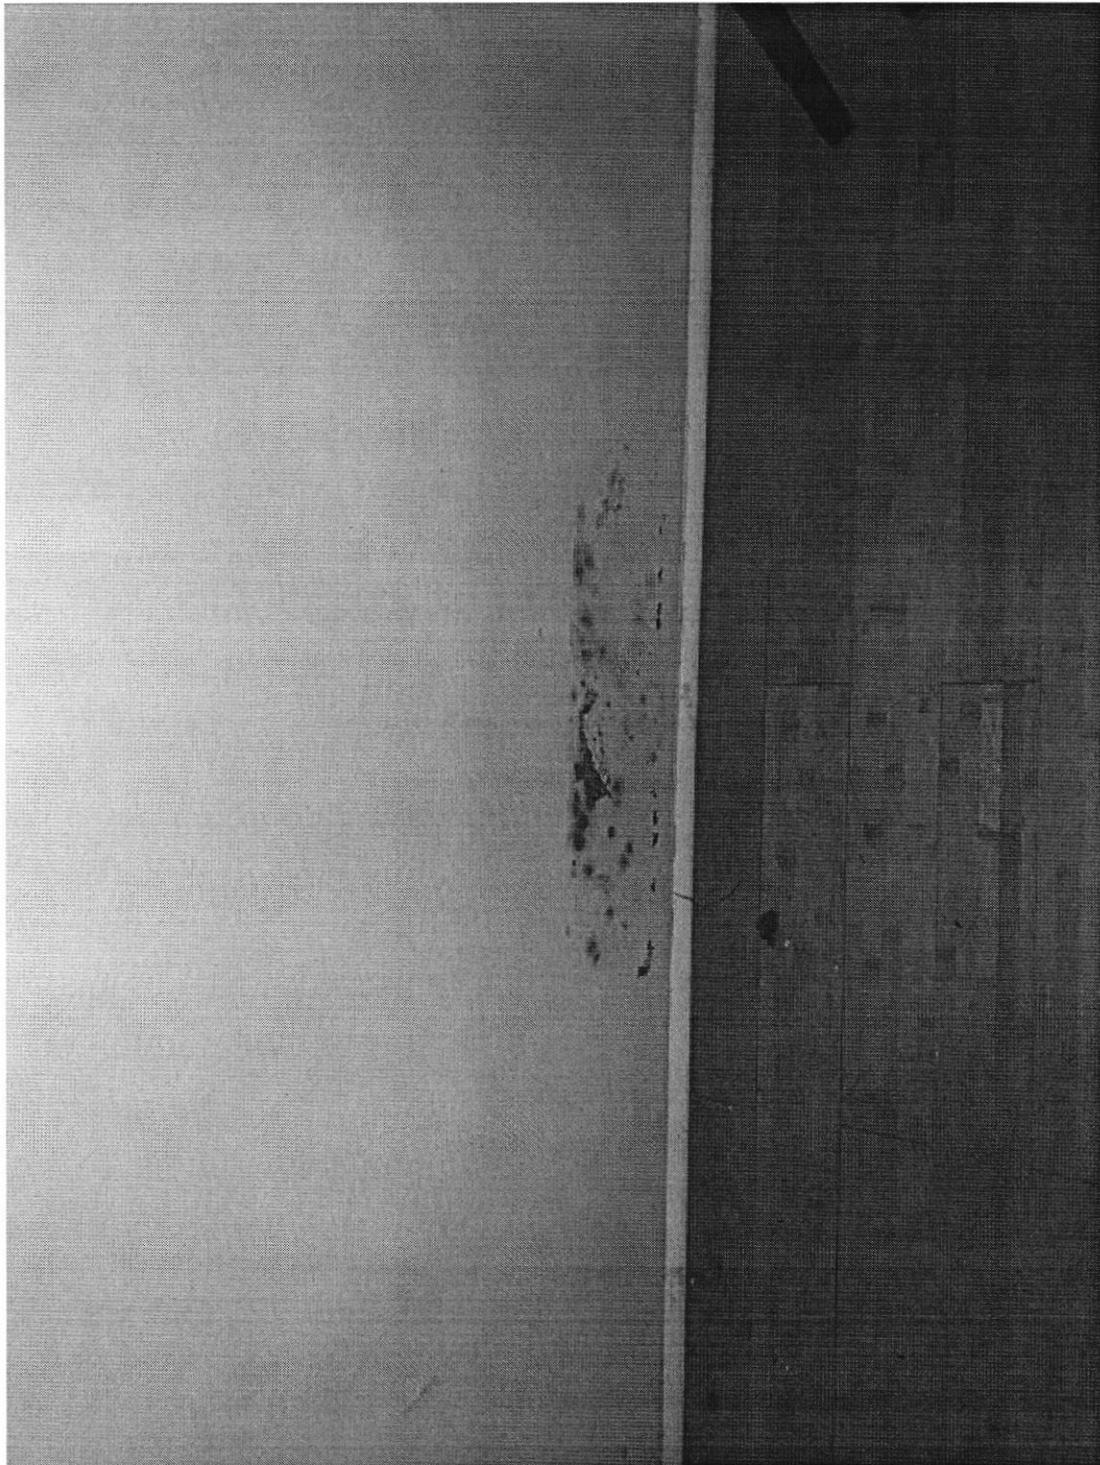
Visible mold on the base of the wall in studio area

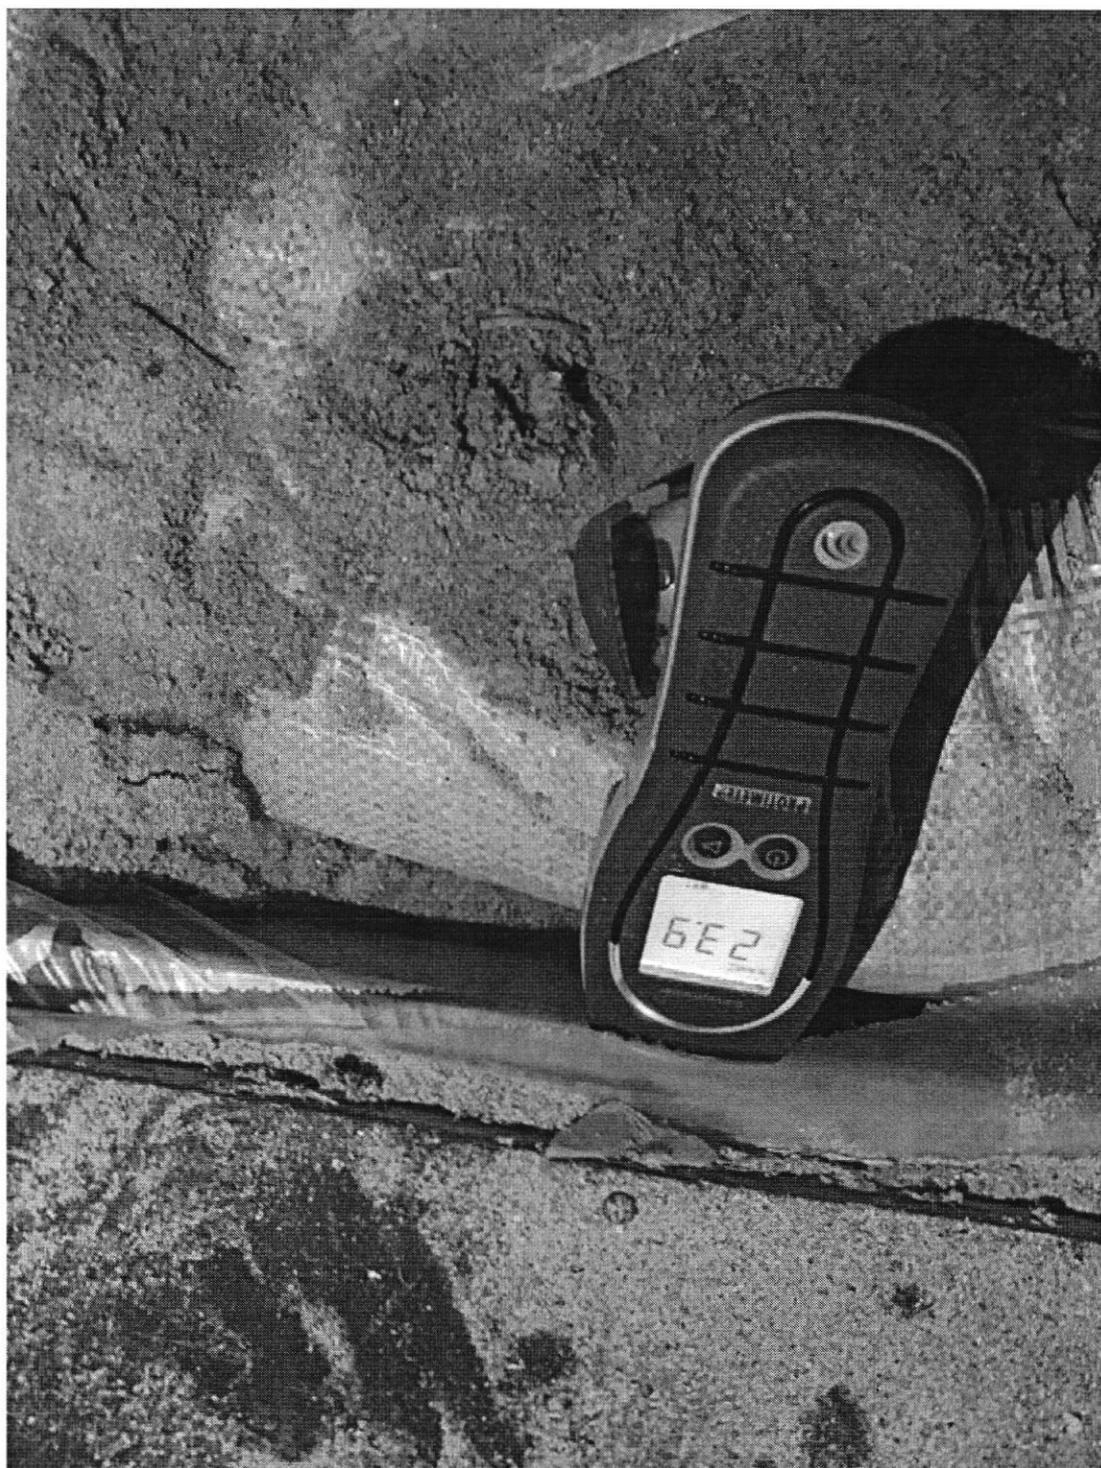
- b. The underside of the raised floor in one room of the studio area is slightly damp. The joists are damp measuring 30 to 40%. The sand also measured damp at 40%. This was due to the flood. The sand absorbed the water and the plastic lining the flooring and bags of sand trapped the water. This area has been wet for over 8 months. It should be assumed water was trapped under all of the floors including the finish floors in the other two rooms of the studio area, the raised floor in the bathroom, and the layers of wood flooring in the kitchen.

The wood joists adjacent to the sand is wet

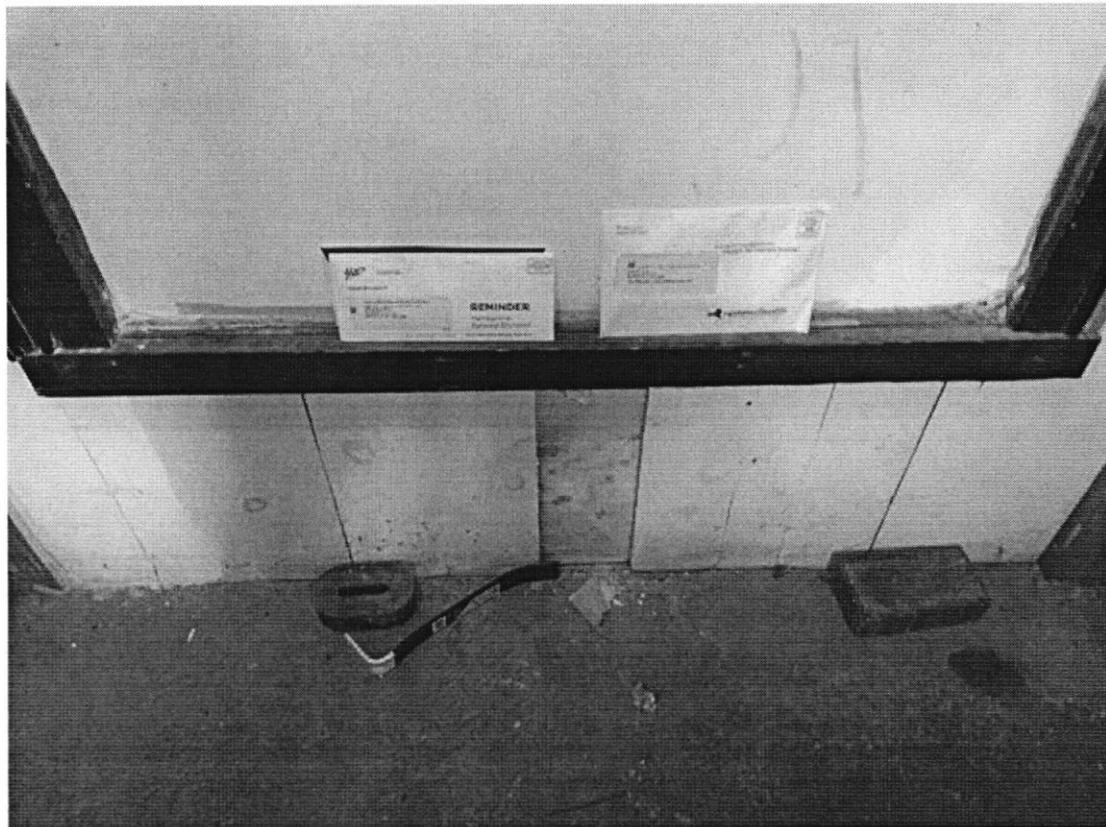
9. Studio Area Room 2. – There is visible mold growth on the base of the walls inside this room and outside in the hall adjacent to this room. The wood wainscoting was removed from the shared wall in the hallway outside this studio. There is heavy visible mold growth on the sheetrock behind wainscoting extending up the wall. This is an indication that most of the mold growth is hidden inside walls and between layers of walls and insulation.
10. Wood Deck above loft – There is visible mold on the wood deck and joists above the insulation in the loft area above the hallway. The underside of the wood floor deck and the joists above the ceiling were tested. The sample, number 97G-18, was analyzed by Olmsted and Prestige and found to have mold growth.

Visible mold behind the removed wood wainscot

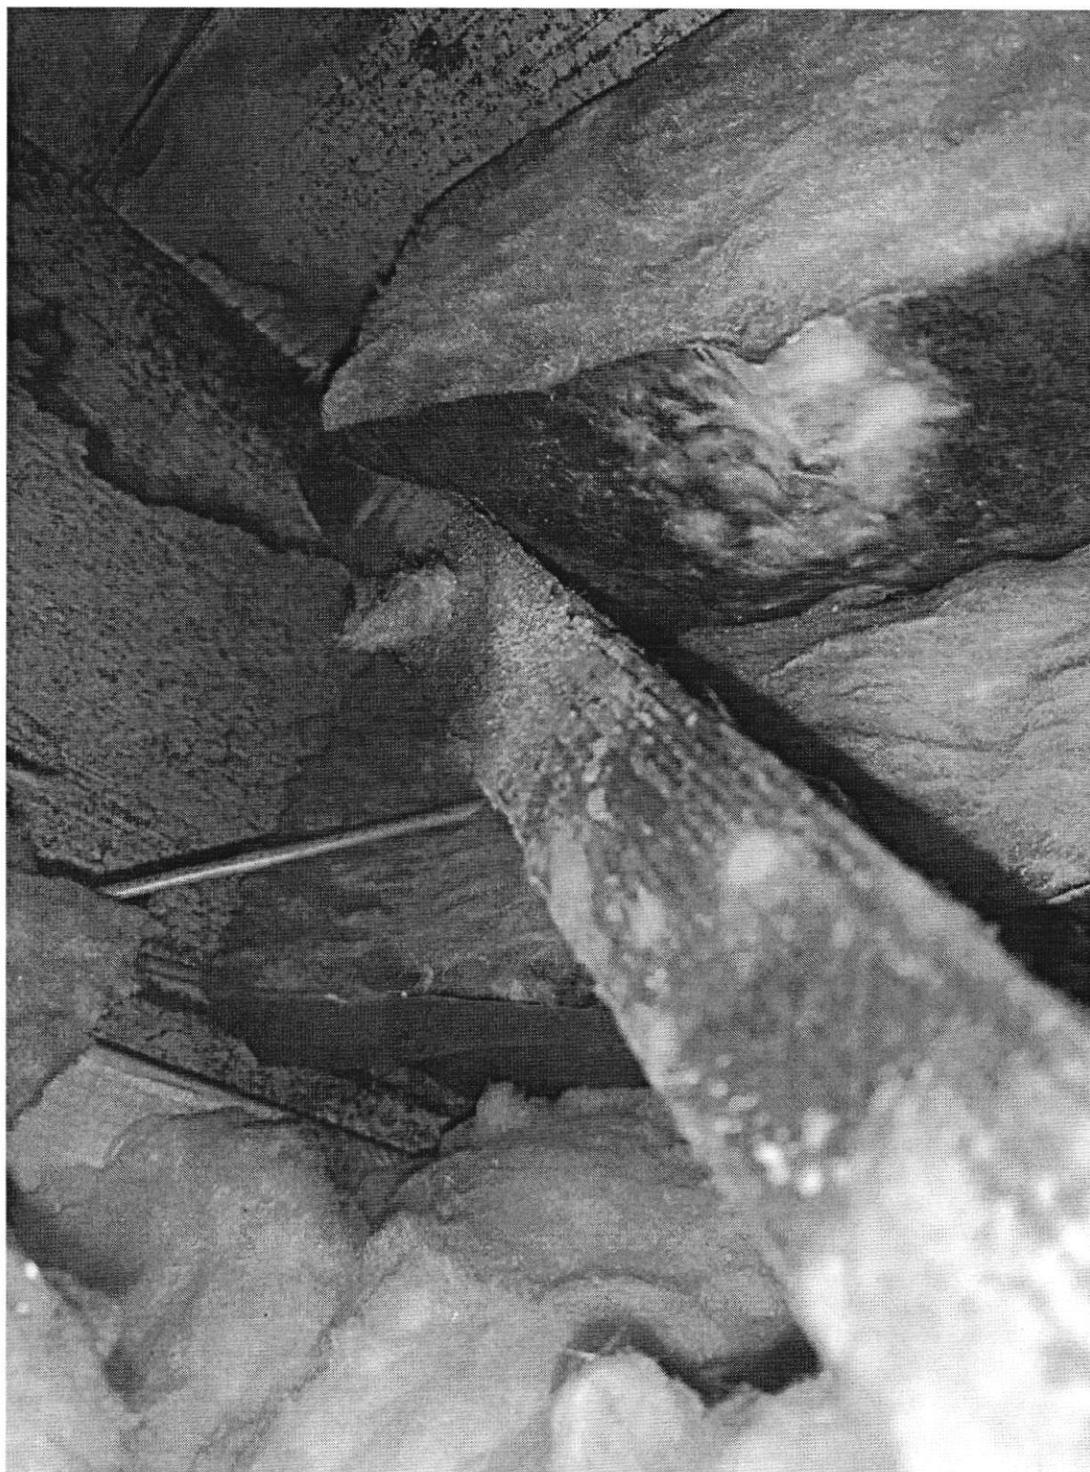
Mold growth on insulation and wood joists on the underside of the floor above
