OLMSTED ENVIRONMENTAL SERVICES, INC**1992 Route 9 Garrison NY 10524**phone 845 424 4077 • fax 845 424 3482 • email Olmsted.mac@me.com

Report for: Christian Gray
97 Green St.
Apartment. G21
Brooklyn, NY 11222

Subject: Mold Inspection
97 Green St. Apartment #G21 Brooklyn, NY 11222

Inspection Date: June 15, 2020

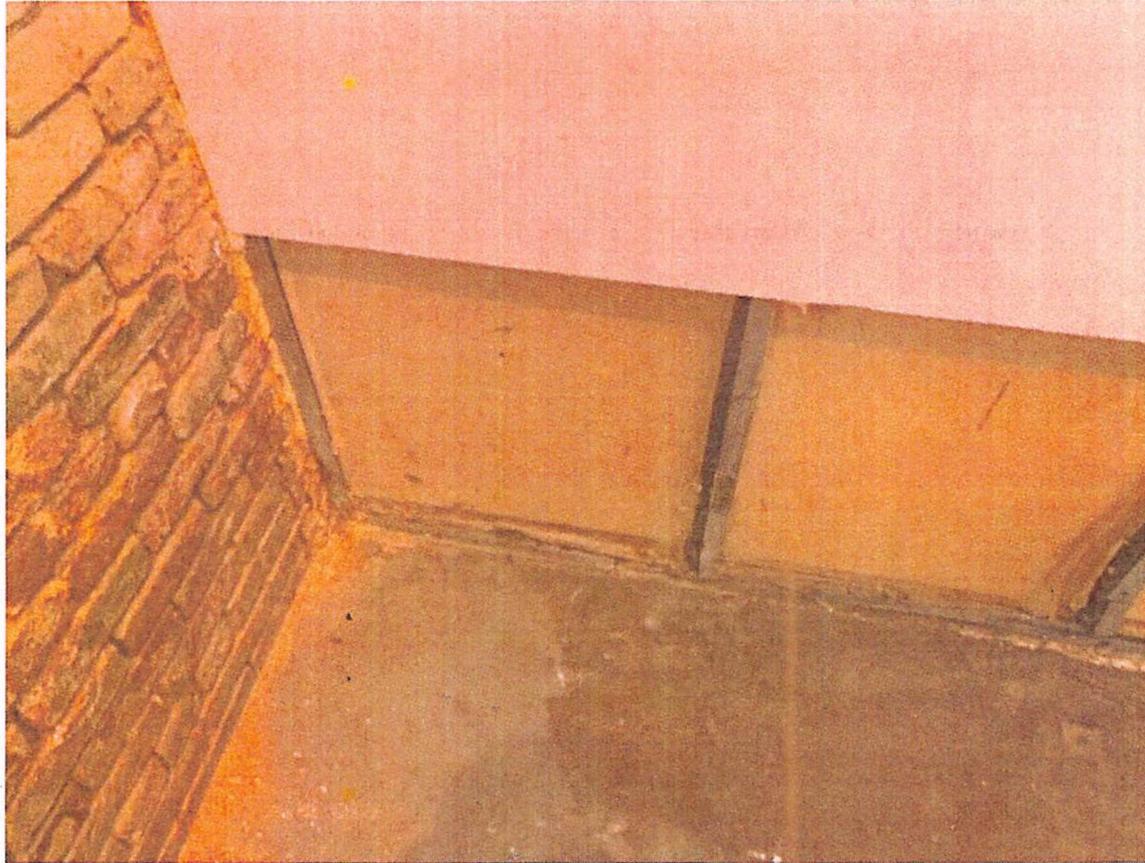
6. Living Room – A tape lift sample from inside the open wall cavity was analyzed by Ed Olmsted and tested positive for growth of mold. All of the sheetrock and insulation should be removed from this wall and the remaining sheetrock in the wall cavity should be cleaned and encapsulated. There is no visible mold growth in the living room. A wipe sample was collected from above the sheetrock around the columns to test the area above the sheetrock ceiling. The wood deck and insulation area above and were impacted by the flood. The wipe sample, number 97G-13, had massive levels of spores at over 5 million CFU per square inch. The sample was had *Aspergillus sydowii*, *Aspergillus versicolor*, *Penicillium*, and *Trichoderma longibrachiatum*. This is indicative of mold growth above the ceiling. Another wipe was collected from the top of the wall between the living room and adjacent studio. There was water damage but no visible mold. The sample had 740,000 CFU/in² dominated by *Penicillium*. This is indicative of mold growth. These results indicate there is mold growth in the wall and ceiling cavities and at the upper parts of the walls and not just the base of the walls. The walls should be demolished in the living room and studios.

Inside the living room area wall cavity – tape lifts revealed light mold growth is present

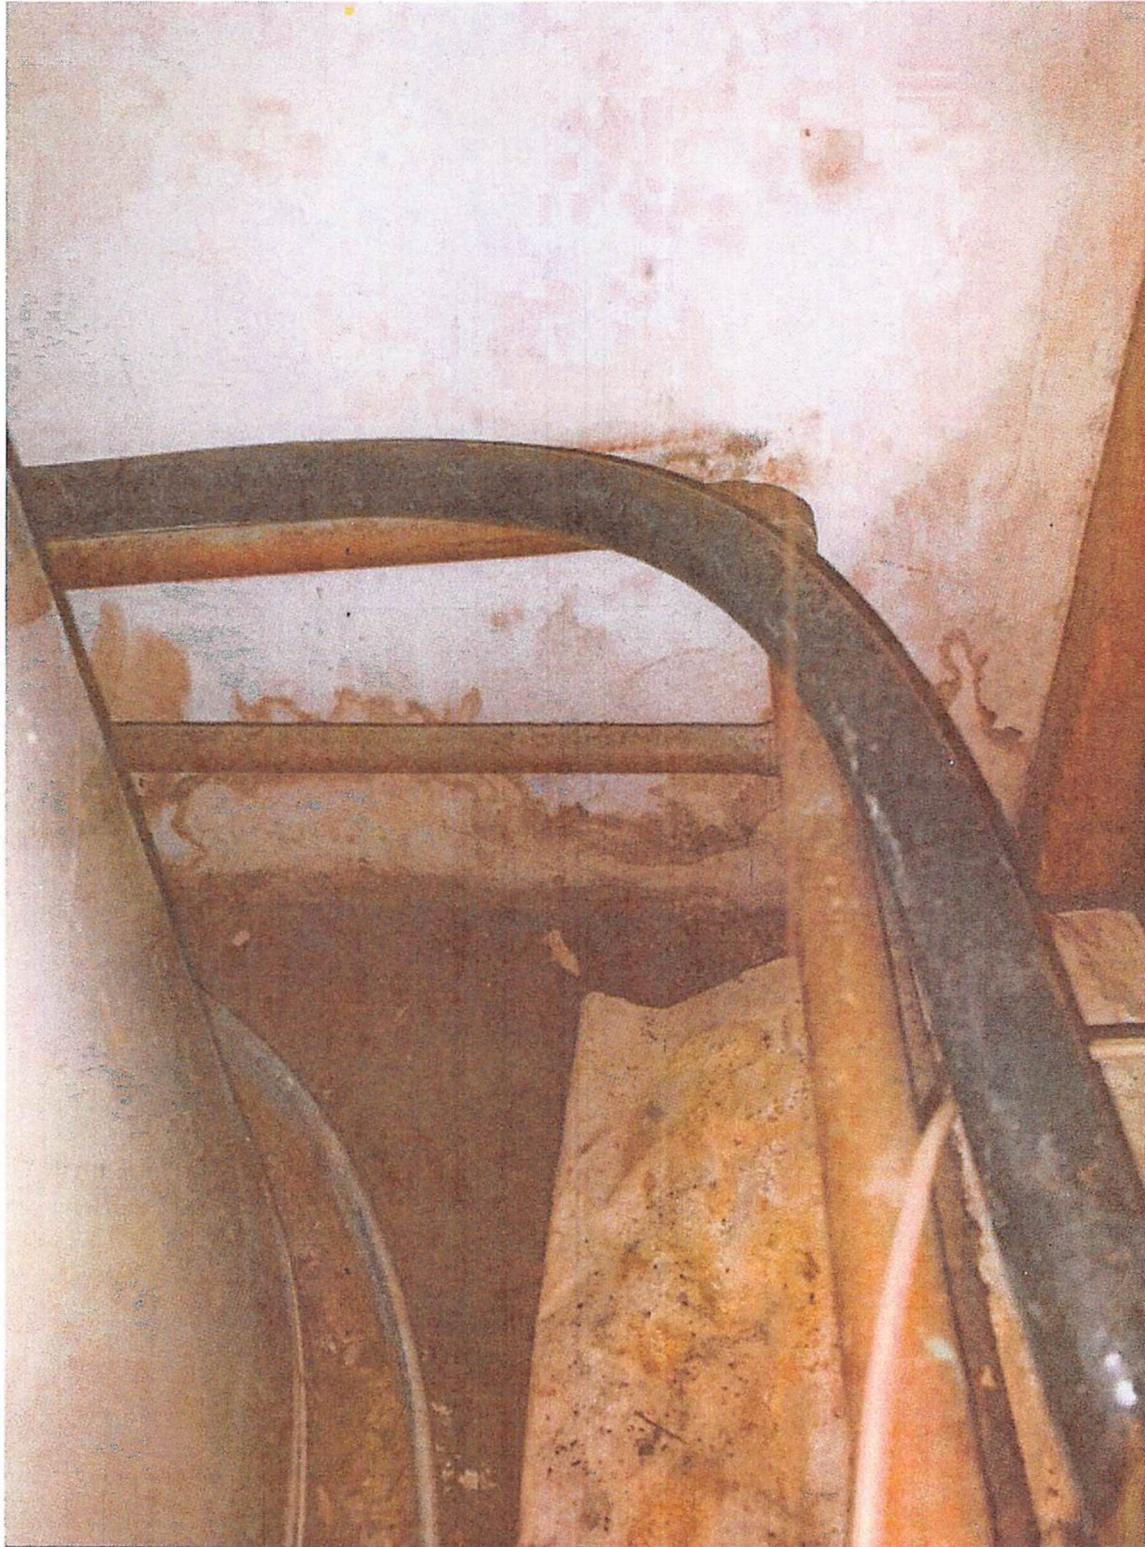
4. Bathroom - The raised wood floor in the bathroom has evidence of water damage to the wood in the hot water tank area adjacent to the bathtub. There is also mold growth on the wall between the bathroom and the kitchen. A tape lift from the raised

wood floor in the bathroom, number 97G-6, was analyzed by Ed Olmsted and Prestige. The sample had growth of *Scopulariopsis*. There is surely greater amounts of mold growth under the raised wood floor where water was trapped. The wall cavity between the bathtub and the kitchen has visible mold growth. A bulk sample from the bathroom wall in the area by the hot water tank, number 97G-4, was analyzed by culture methods and found to have 780,000 colony forming units per gram (CFU/g). The sample was dominated by *Aspergillus calidoustus* at 690,000 CFU/g. This is indicative of mold growth. The raised floor and bathtub should be demolished in the bathroom. The wall shared with the kitchen should be opened and the back of the kitchen cabinets and wall cavity should be cleaned with HEPA vacuuming and damp wiping with a strong biocide.

The hot water tank next to the bathtub – there is mold growth on the raised wood floor and on the wall shared with the kitchen

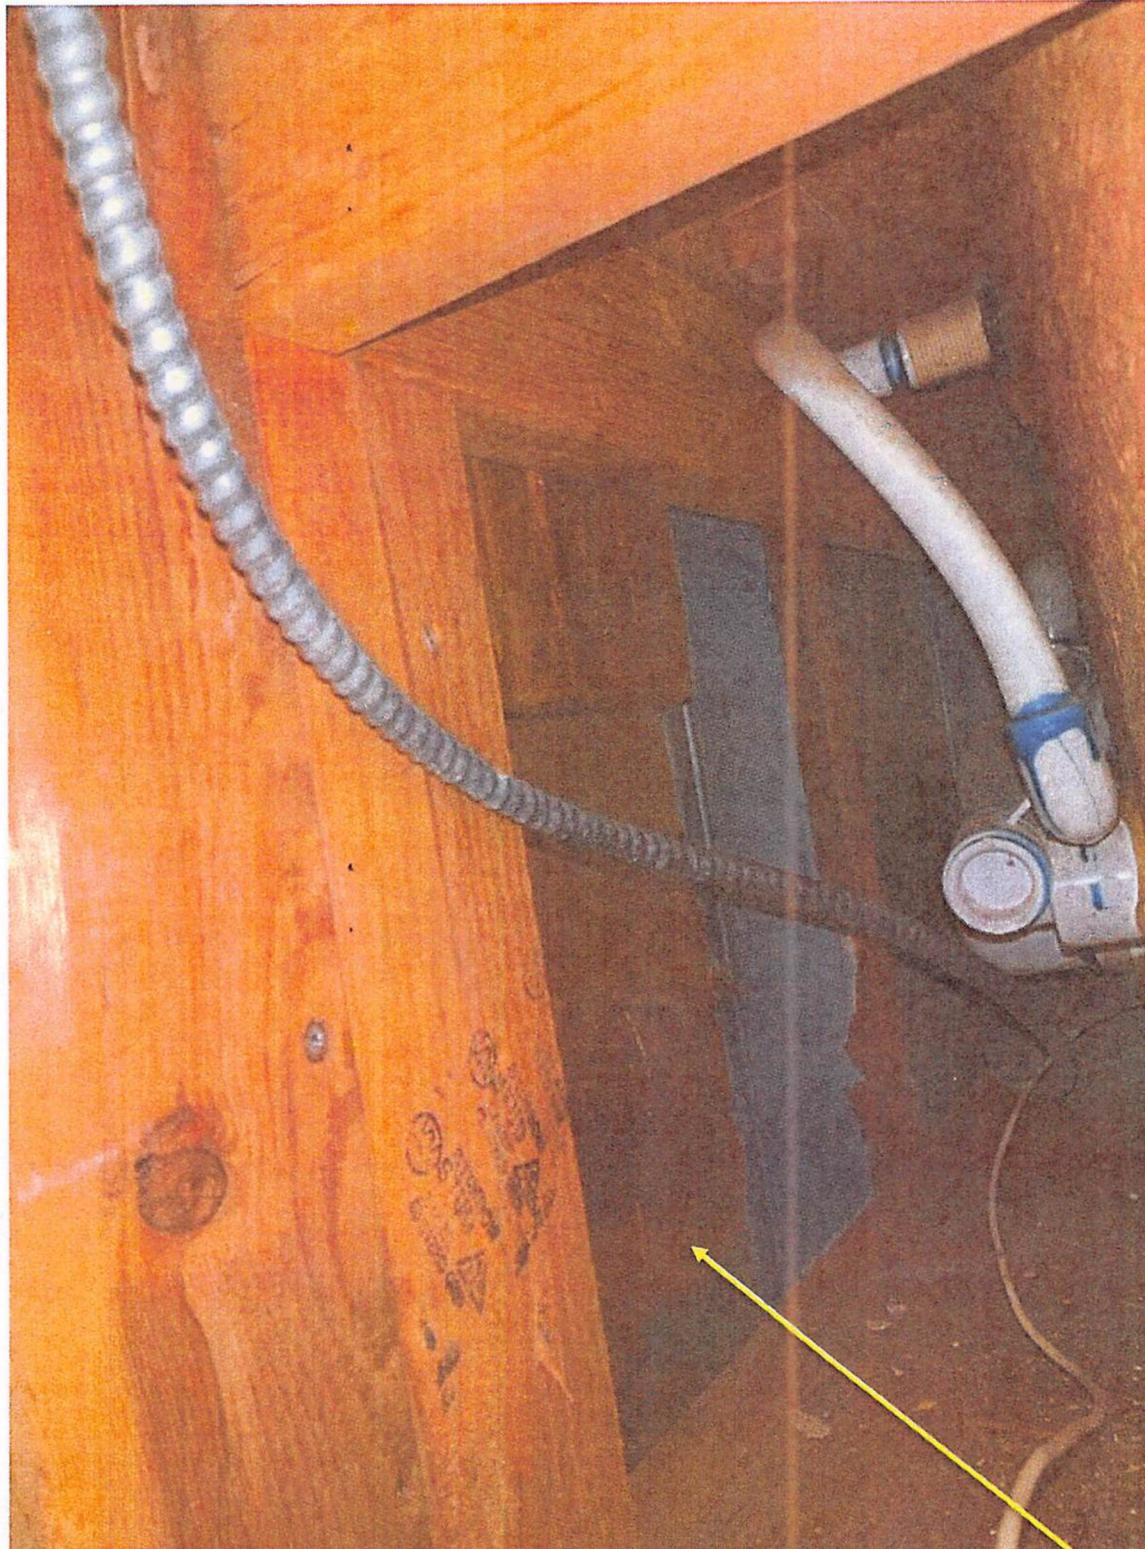
There is water staining and mold growth on the bathroom wall shared with the kitchen.

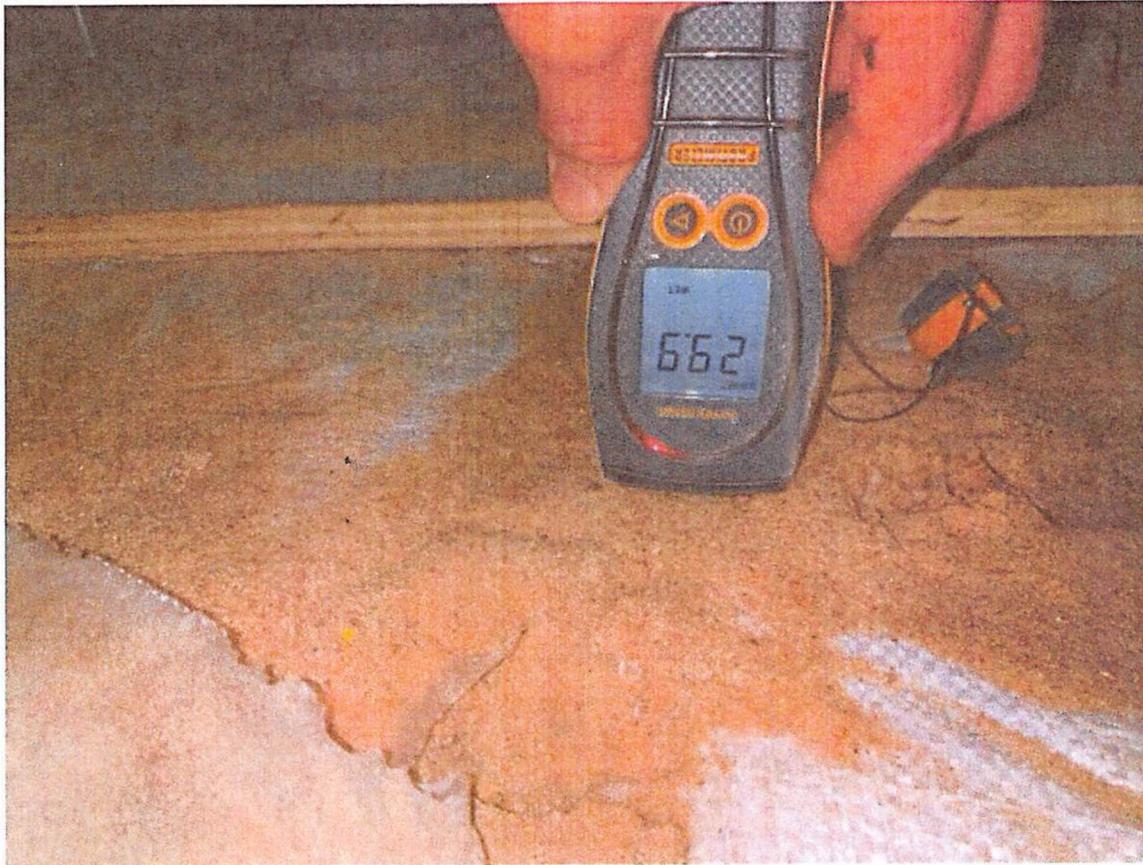
- b. The underside of the raised floor in one room of the studio area is slightly damp. The joists are damp measuring 30 to 40%. The sand also measured damp at 40%. This was due to the flood. The sand absorbed the water and the plastic lining the flooring and bags of sand trapped the water. This area has been wet for over 8 months. It should be assumed water was trapped under all of the floors including the finish floors in the other two rooms of the studio area, the raised floor in the bathroom, and the layers of wood flooring in the kitchen.

5. Studio Area Room 3 – This room has a raised wood floor with sand under the floor. The sand and wood is covered with plastic sheeting. Both the wood and sand tested wet with a moisture meter. The wood floor should be removed in this room and the sand removed as well as all plastic sheeting. The joists should be cleaned and dried.

The sand is wet under the raised floor

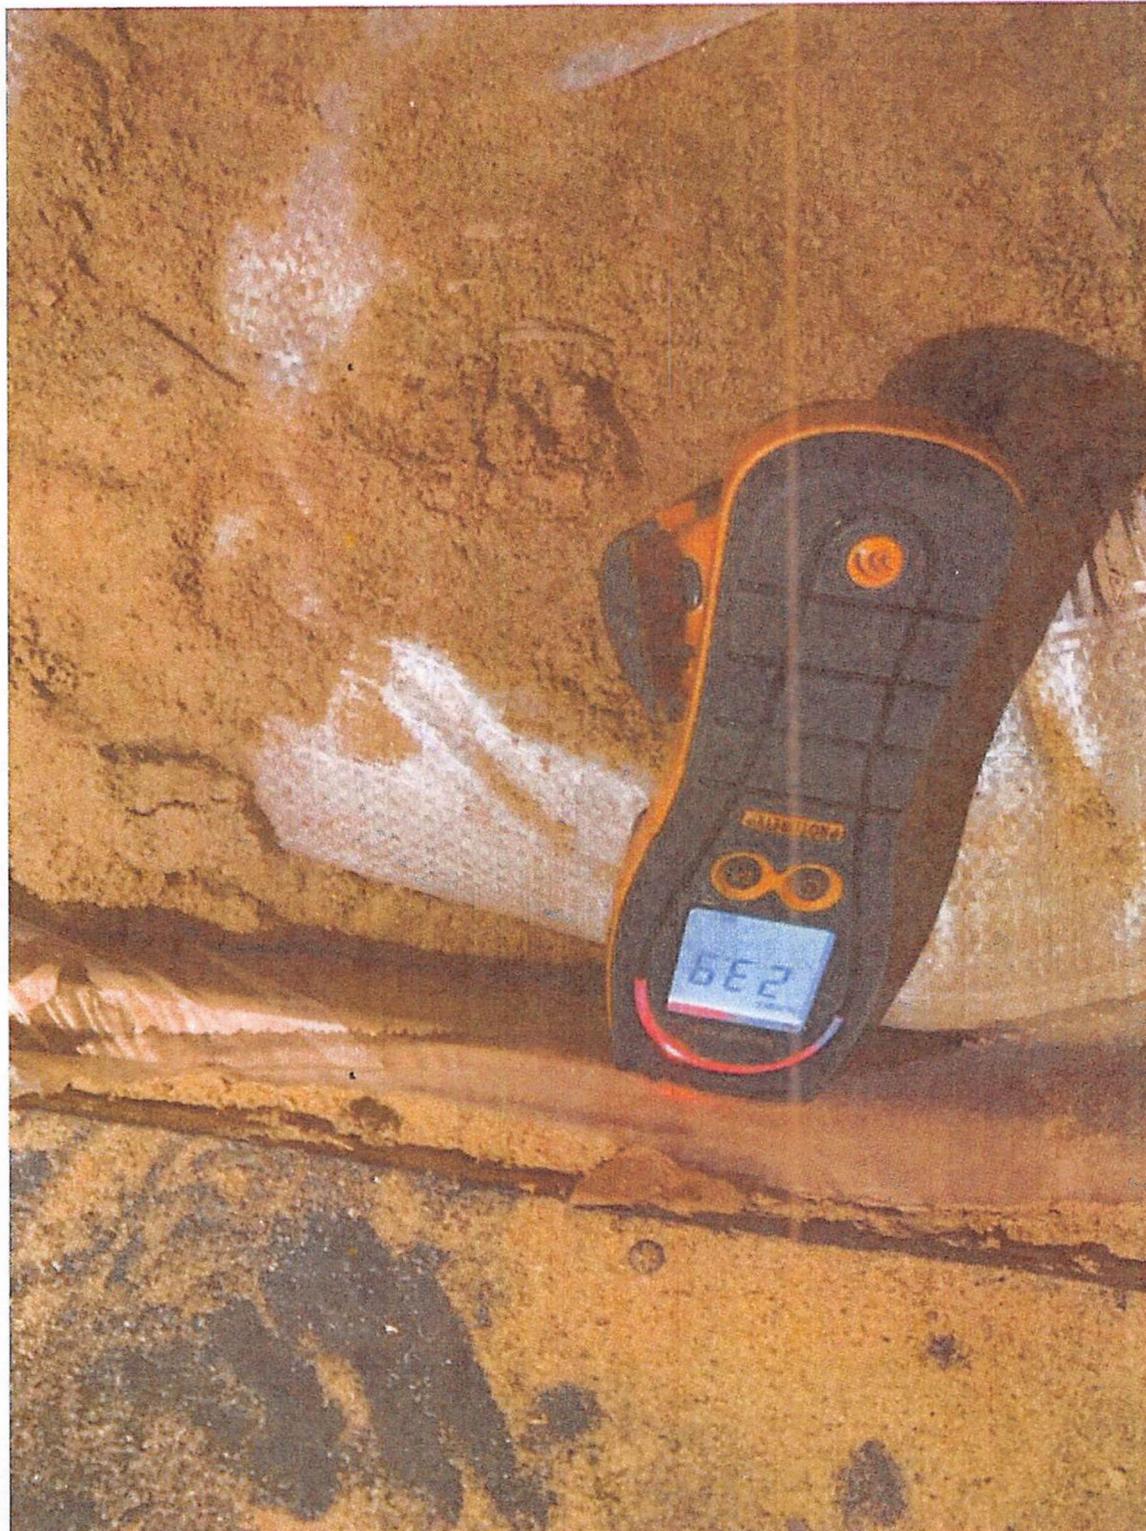
The wood joists adjacent to the sand is wet

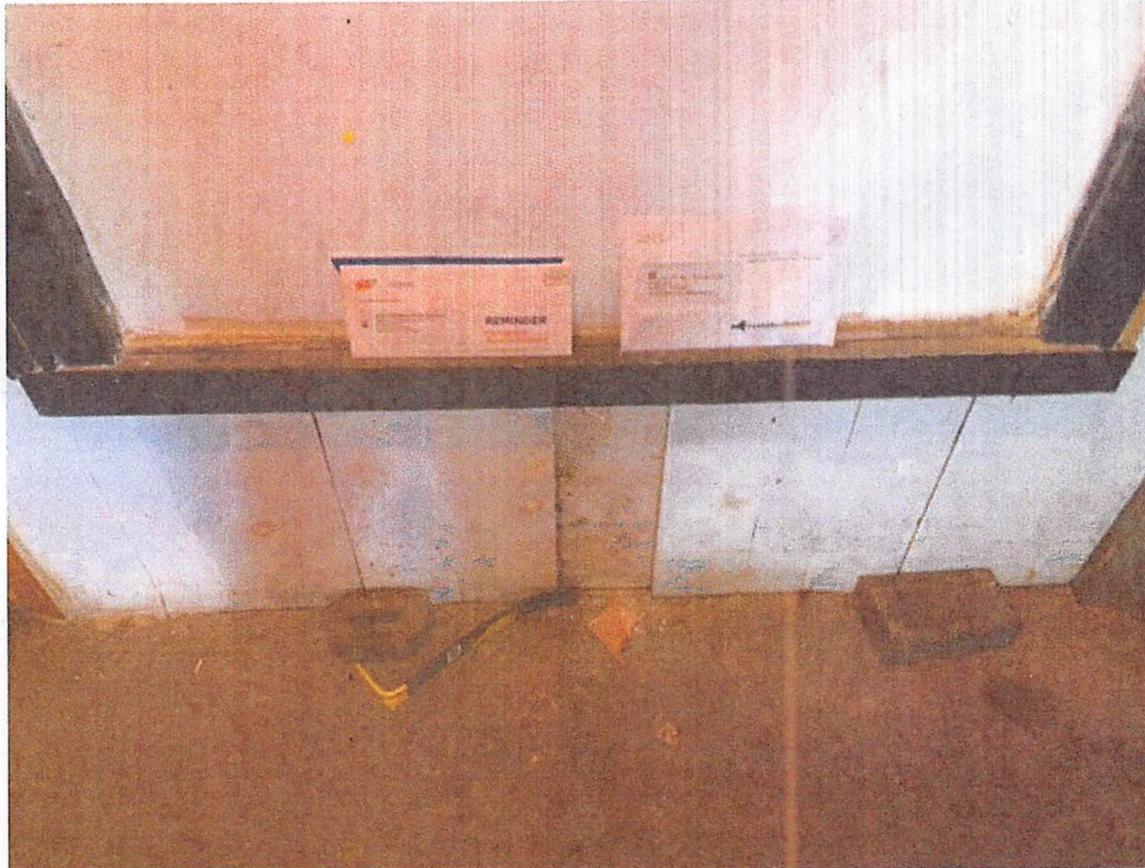
9. Studio Area Room 2. – There is visible mold growth on the base of the walls inside this room and outside in the hall adjacent to this room. The wood wainscoting was removed from the shared wall in the hallway outside this studio. There is heavy visible mold growth on the sheetrock behind wainscoting extending up the wall. This is an indication that most of the mold growth is hidden inside walls and between layers of walls and insulation.
10. Wood Deck above loft – There is visible mold on the wood deck and joists above the insulation in the loft area above the hallway. The underside of the wood floor deck and the joists above the ceiling were tested. The sample, number 97G-18, was analyzed by Olmsted and Prestige and found to have mold growth.

Visible mold behind the removed wood wainscot

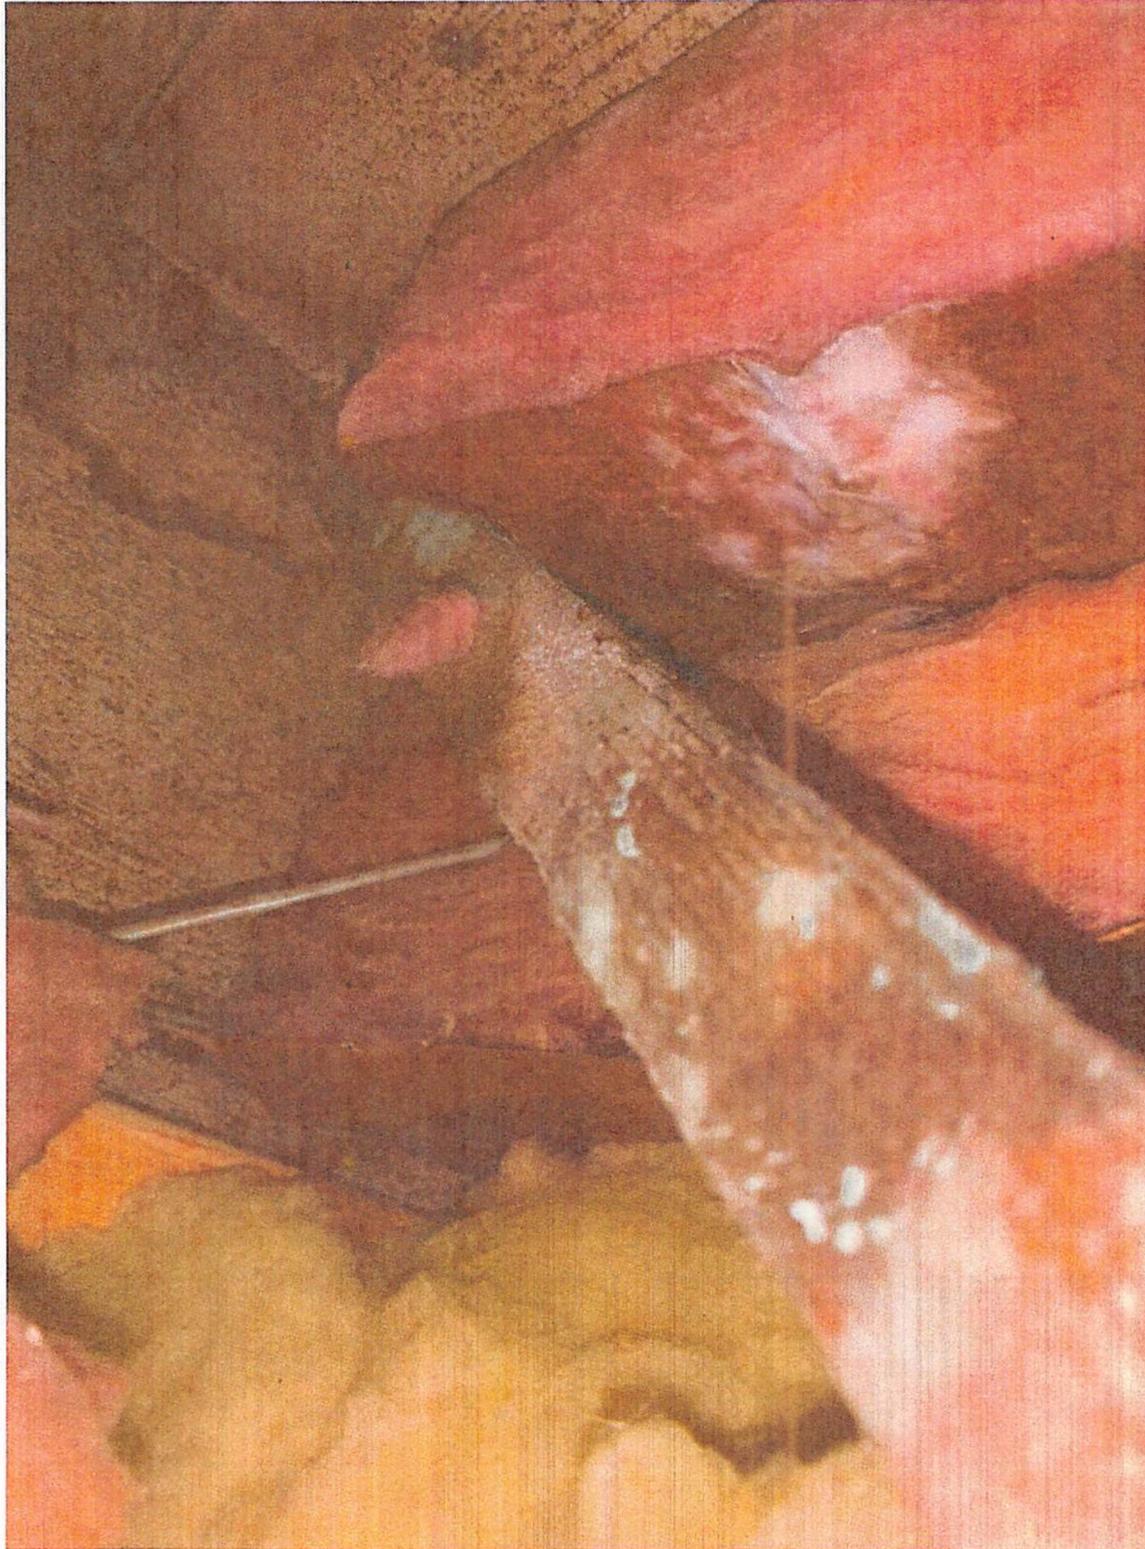
Mold growth on insulation and wood joists on the underside of the floor above
