OLMSTED ENVIRONMENTAL SERVICES, INC**1992 Route 9 Garrison NY 10524**phone 845 424 4077 • fax 845 424 3482 • email Olmsted.mac@me.com**Scope of work****Follow-up abatement****97 Green Street Apt #G21 Brooklyn, NY 11222****INTRODUCTION**

Post Abatement Microbial Survey

Report for: Margaret Sandercock
Law Offices
Goodfarb & Sandercock, LLPEmail: mbs@goodfarblaw.comPrepared by: Edward Olmsted, CIH, CSP
New York State Mold Assessor 00026Subject: **Mold Inspection and Testing After Abatement**
97 Green Street Apt #G21 Brooklyn, NY 11222

Inspection Dates: August 16 and 17, 2021

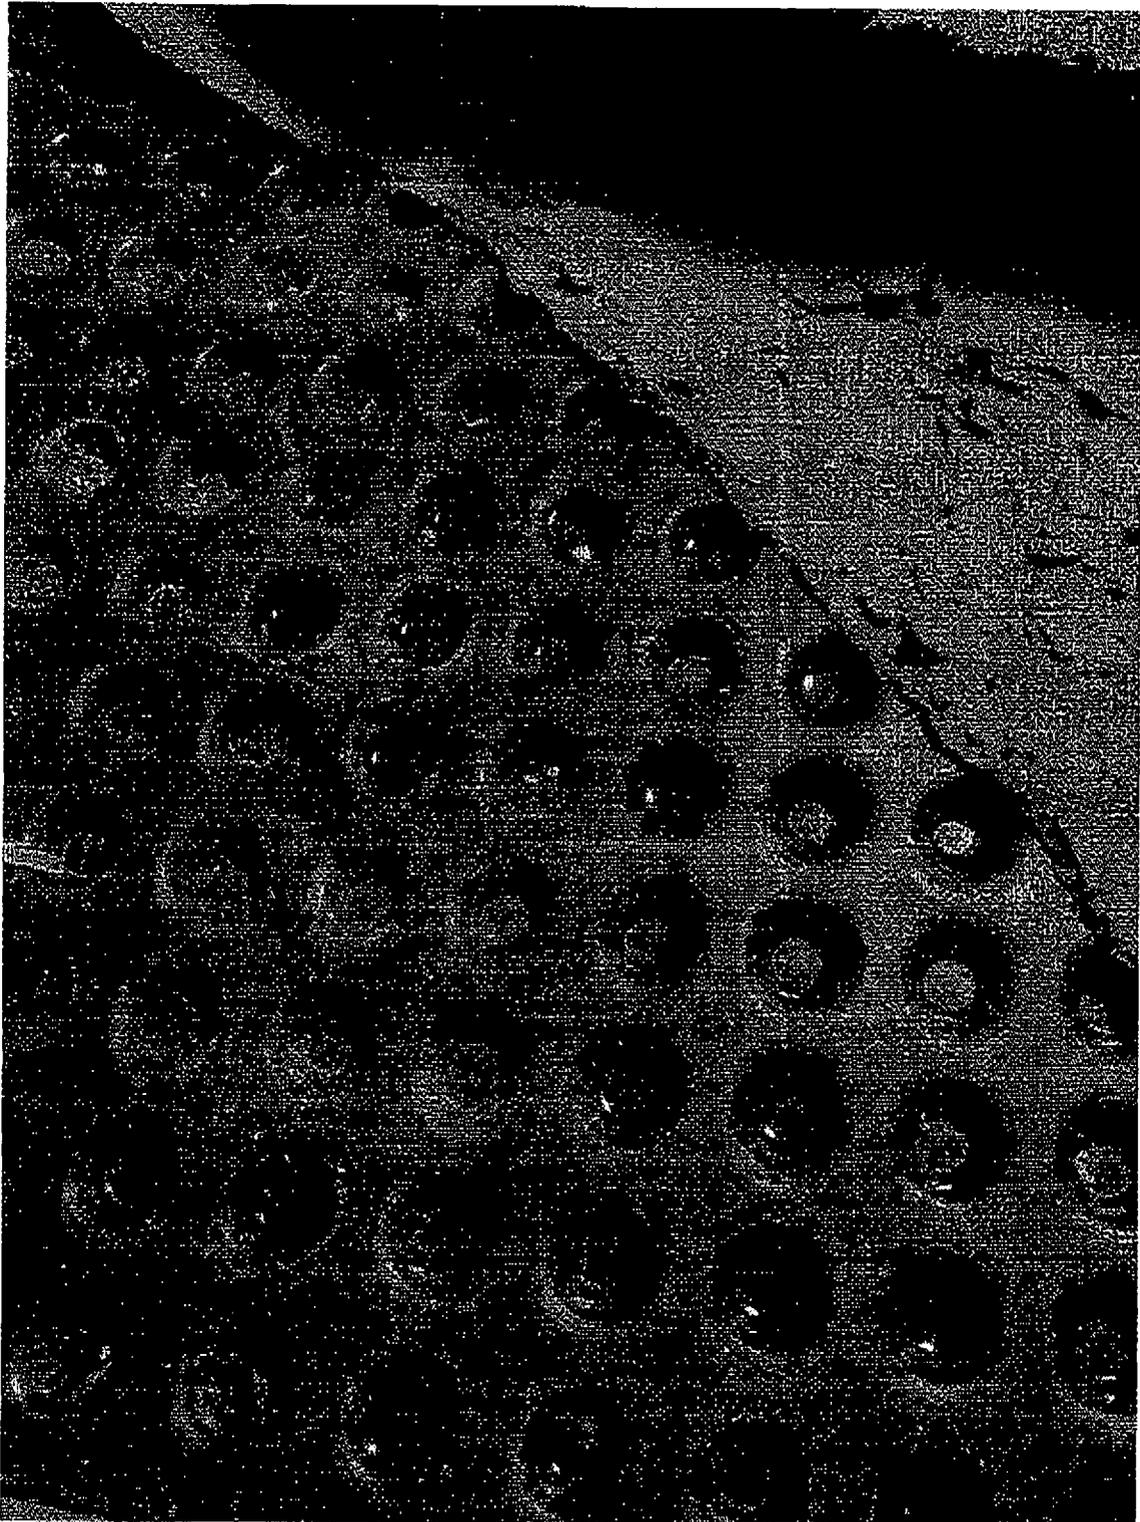
There is water under the press wood subfloor

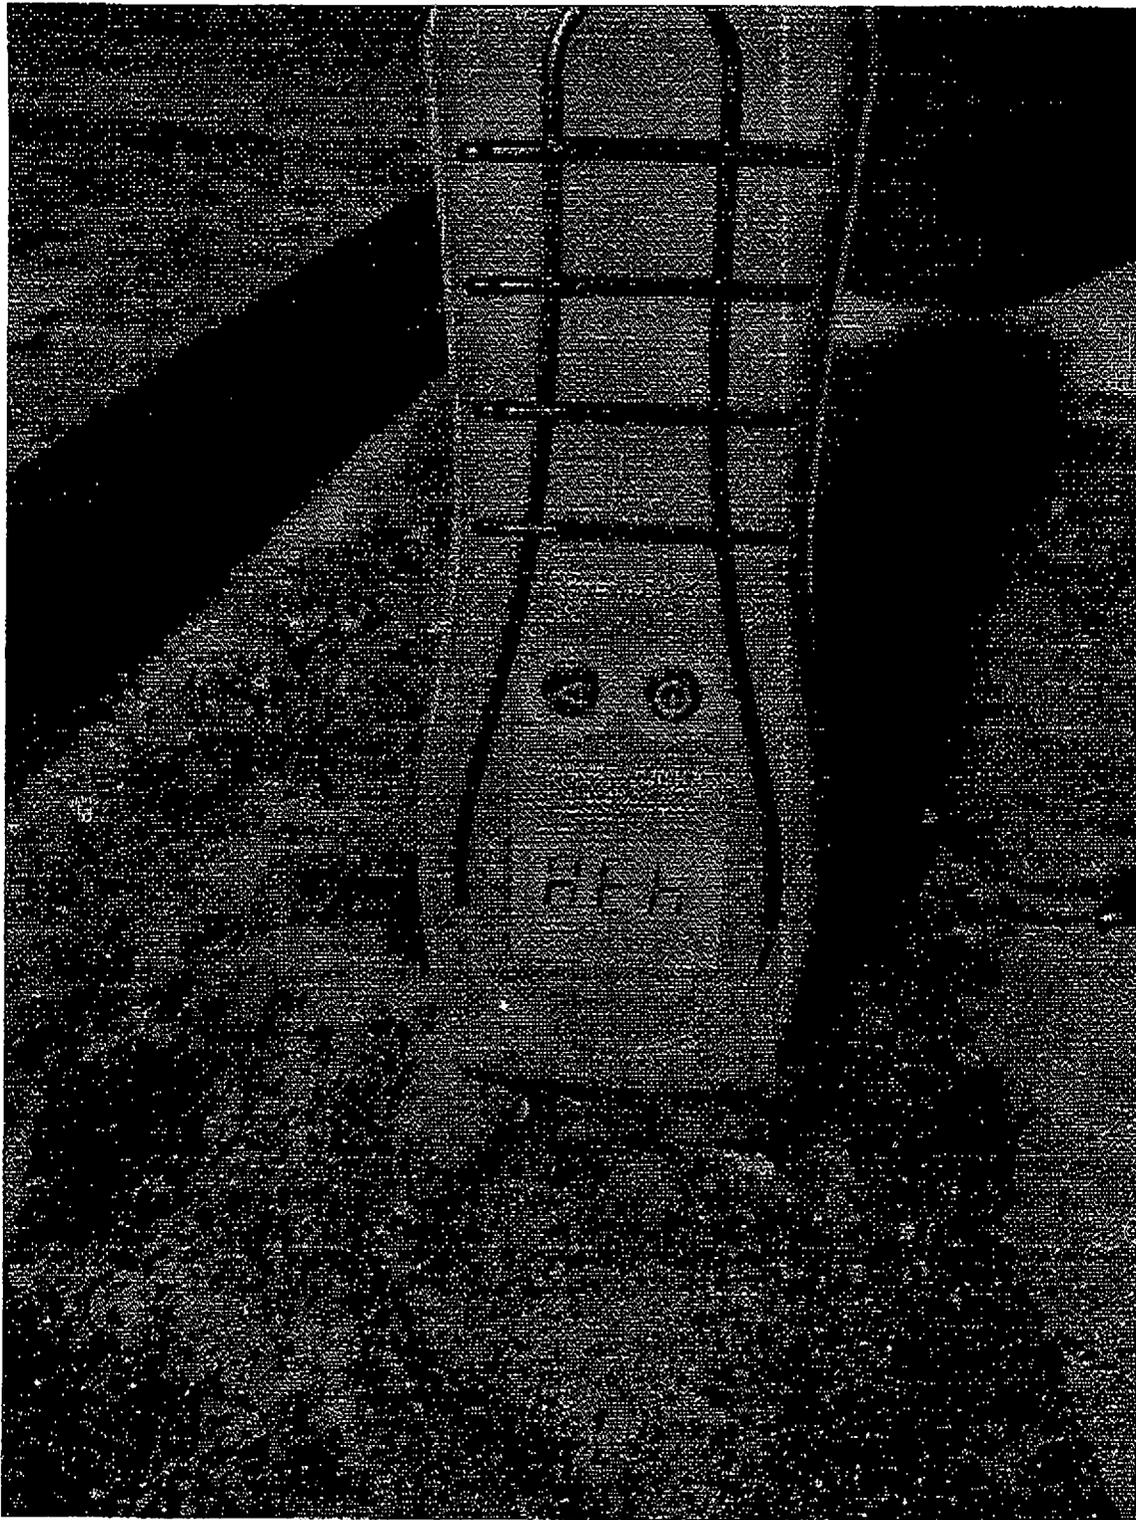
Wet and moldy subfloor
