Subject: Post Remediation Verification (PRV)

Location: 226 Franklin Street, Apartment G21, Brooklyn, NY 11222

Inspection Date:

July 28, 2021

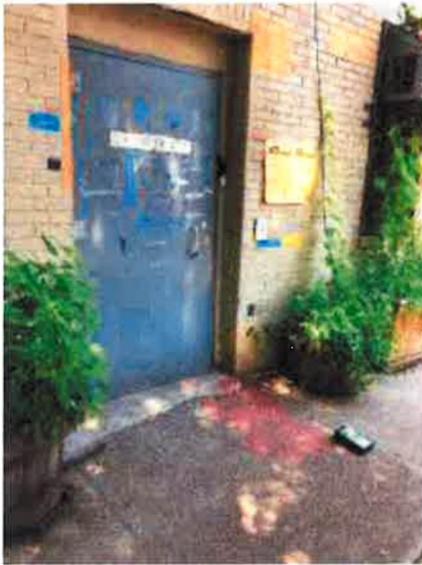
Above Left: Entrance 97 Green Street, Outdoor Air Sample Location

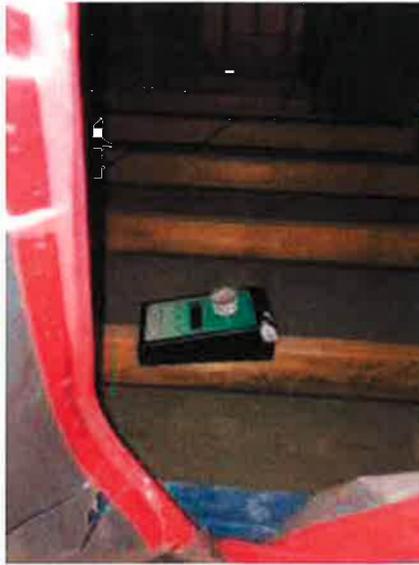
Above Right: Studio 3: Air Sample Location

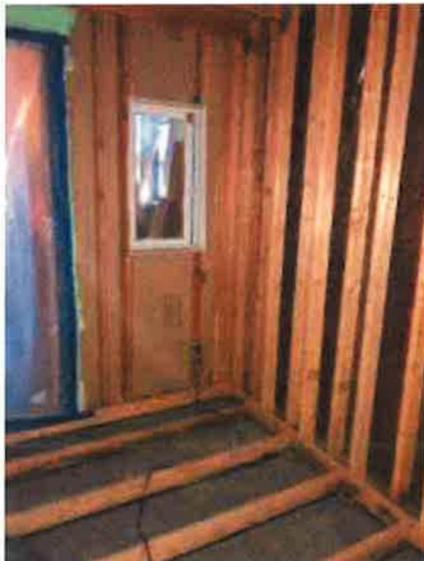
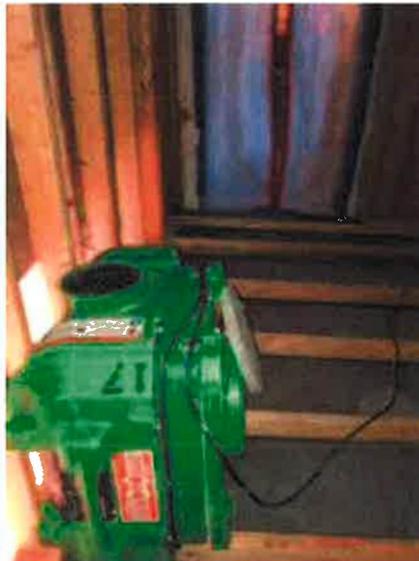
Studio 3: Up to 2ft of wall removed on wall b and wall c of hallway side; walls and ceiling removed. Studs and beams HEPA and detergent cleaned. The area is free and clean of VMG and odors.

Above Left: Studio 3

Above Right: Studio 3

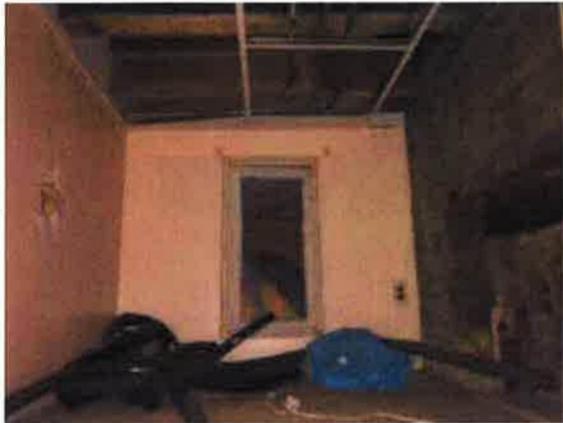
Upper Level Studio 3: The ceiling tiles were removed. The area is free and clean of VMG or odors.

Above Left: Upper Level Studio 3

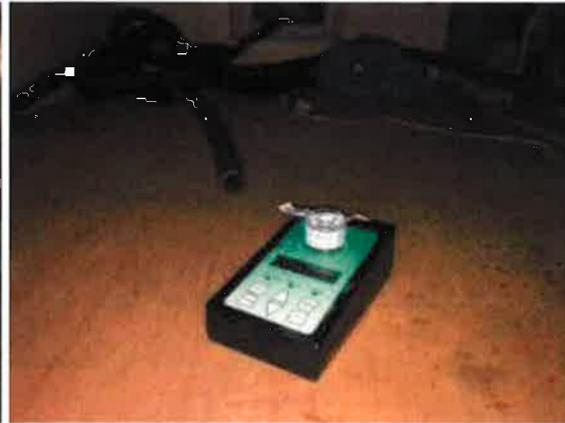
Above Right: Upper Level Studio 3: Air Sample Location

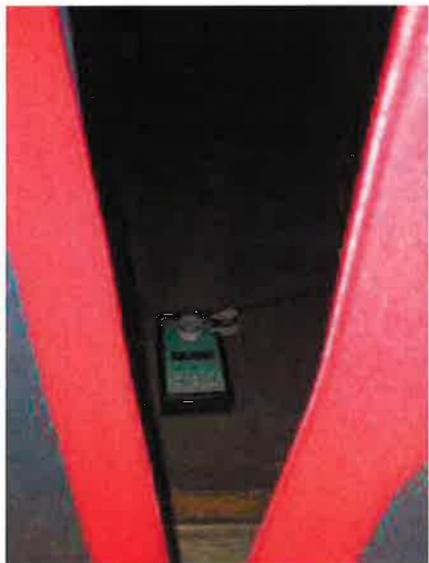
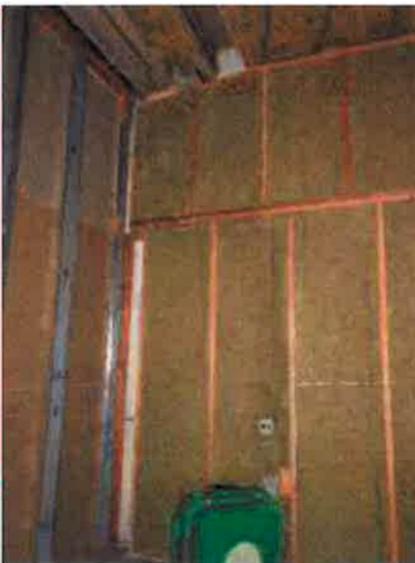
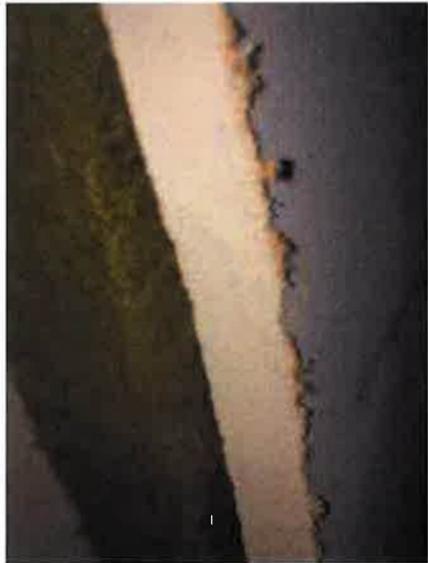
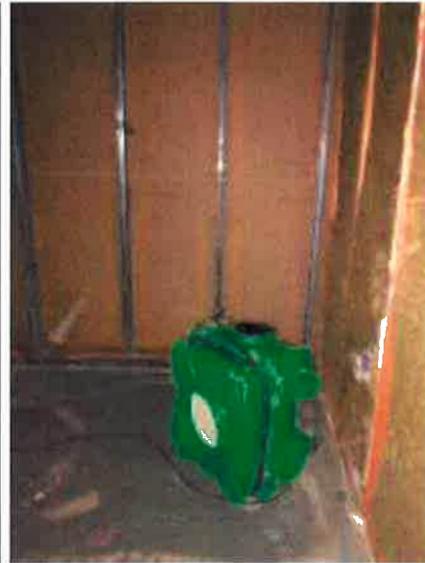
Studio 2: The carpeting, ceiling, and walls were removed. The area is free and clean of VMG or odors.

Above Left: Studio 2

Above Right: Studio 2

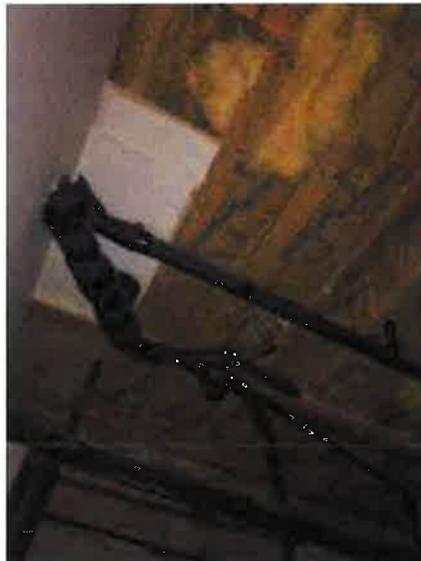
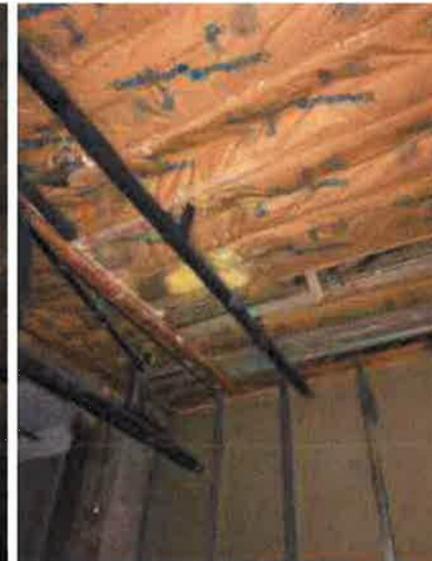
Above Left: Studio 2 Ceiling

Above Right: Studio 2 Ceiling

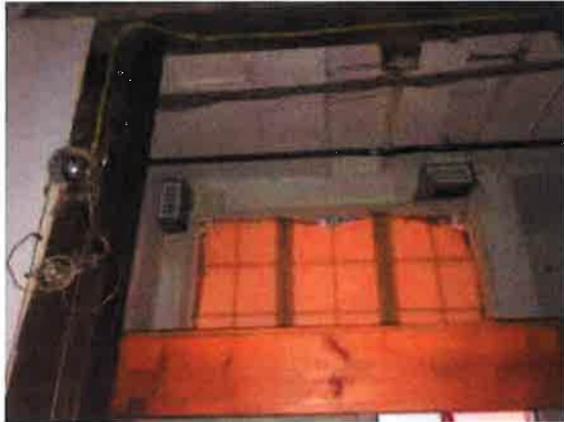
Above Left: Studio 2 Upper Level

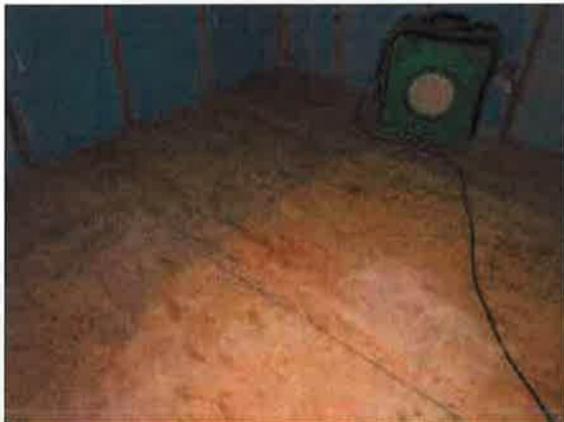
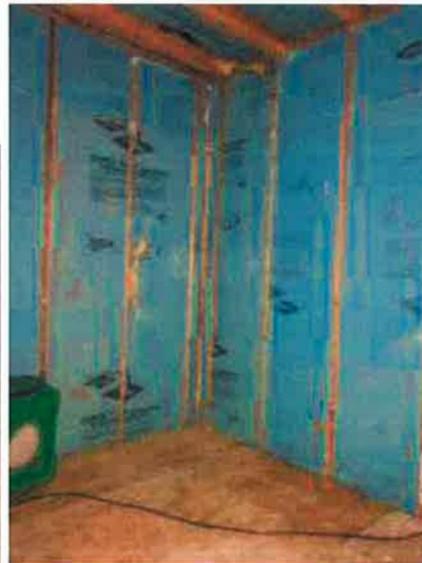
Studio 1: The walls, ceiling, and floor were removed as per work scope. The area is free and clean of VMG or odors.

Above Left: Studio 1

Above Right: Studio 1

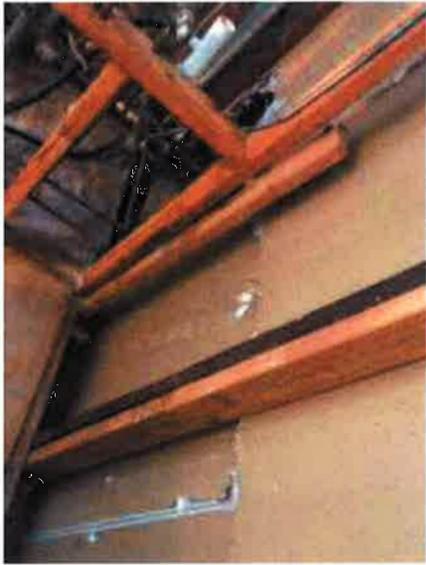
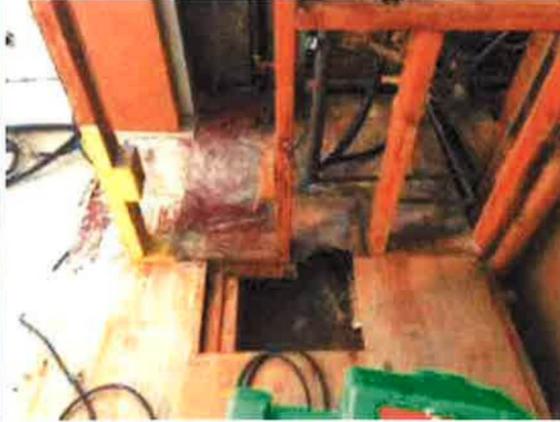
Bathroom: The shower wall was removed, gypsum wall 3 ft. from the floor was removed, the water heater, sink, bathtub, tiles, and raised floor were removed. The area is free and clean of VMG or odors.

**Above Left: Bathroom (Shower wall, Water Heater and Bathtub removed)
Above Right: Bathroom (Raised floor, Water Heater and Bathtub removed)**

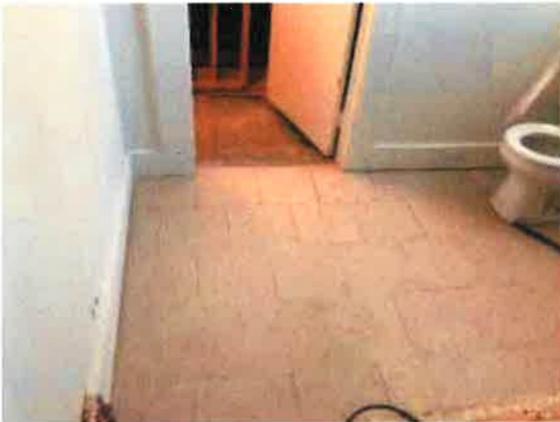
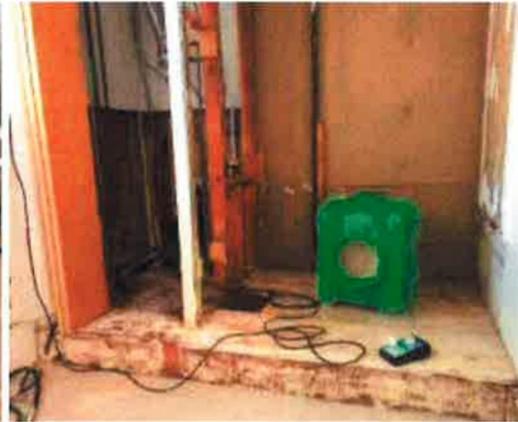
**Above Left: Bathroom
Above Right: Bathroom (Water Heater, Bathtub, Shower wall removed)**

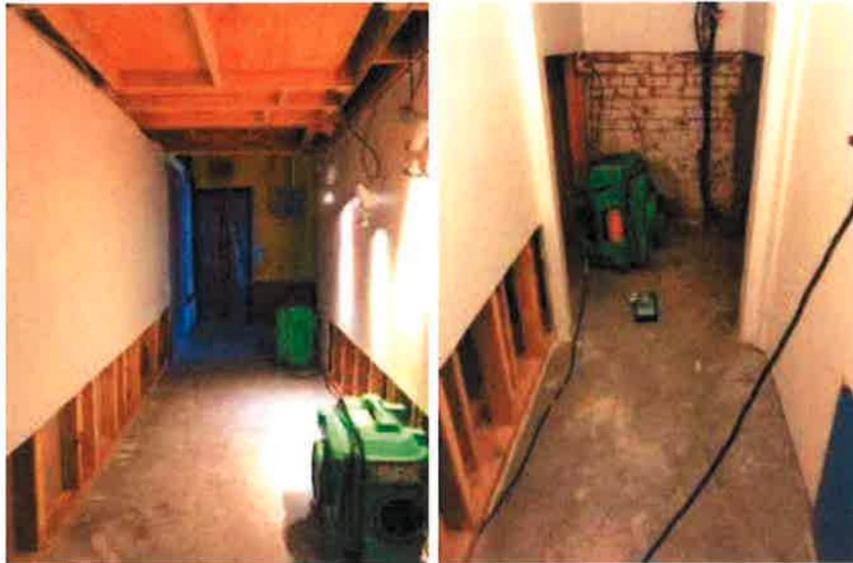
Hallway/washer dryer area: The washer and dryer were removed; ceiling and 2 ft. of wall from the floor were removed (brick exposed). The area is free and clean of VMG or odors.

Above Left: Hallway

Above Right: Hallway with Washer and Dryer Removed

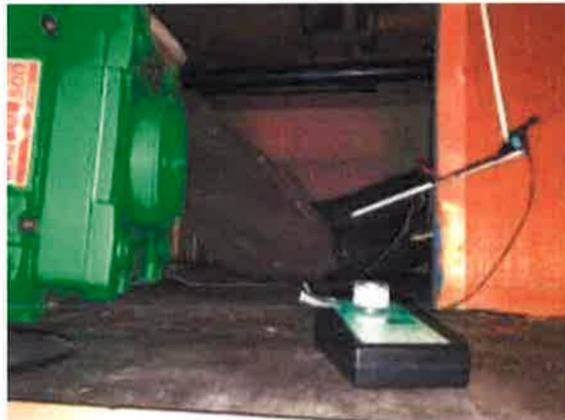
Above Left: Upper level Hallway: Air Sampling Location

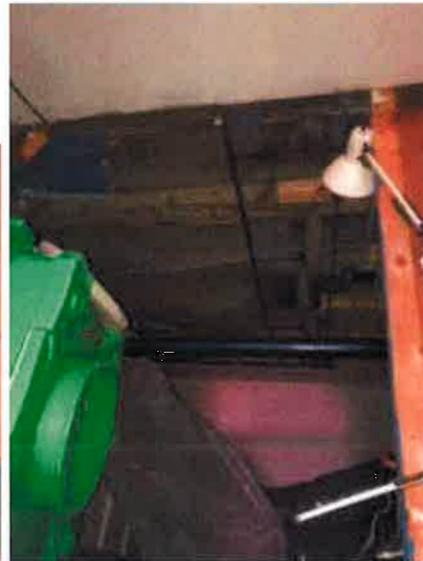
Above Right: Upper level Hallway
