CIVIL COURT OF THE CITY OF NEW YORK  
COUNTY OF KINGS

Index No.  
006086/20

NOTICE OF MOTION

Edward Olmsted, CIH, CSP conducted a mold inspection in unit # G21 at 97 Green Street in Brooklyn, NY. The survey was done on June 15<sup>th</sup> to evaluate the apartment for the presence of mold growth due to a catastrophic flood caused by a sprinkler head bursting on the floor above. The flood occurred on October 23<sup>rd</sup>, 2019 and the space sat for many days with standing water on the floor and soaked walls and ceilings. The survey included the following:

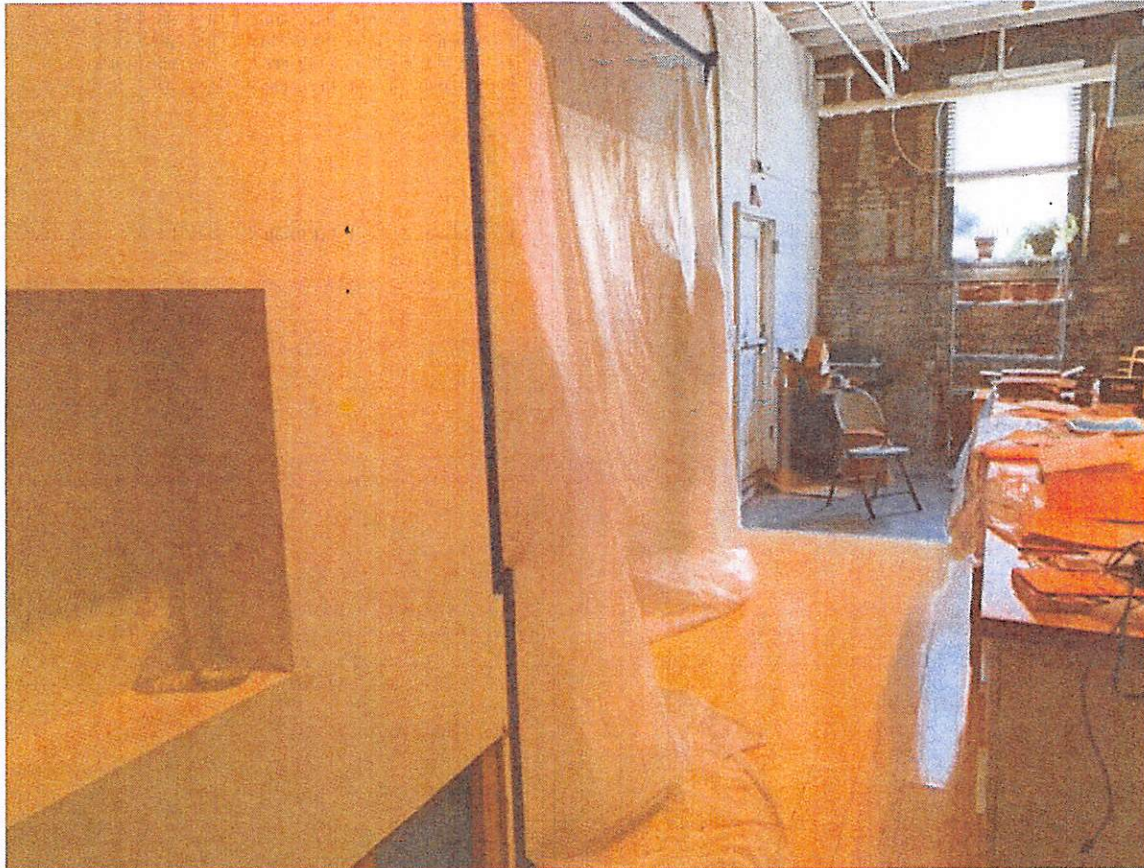
Kitchen area – there is mold growth under the wood flooring

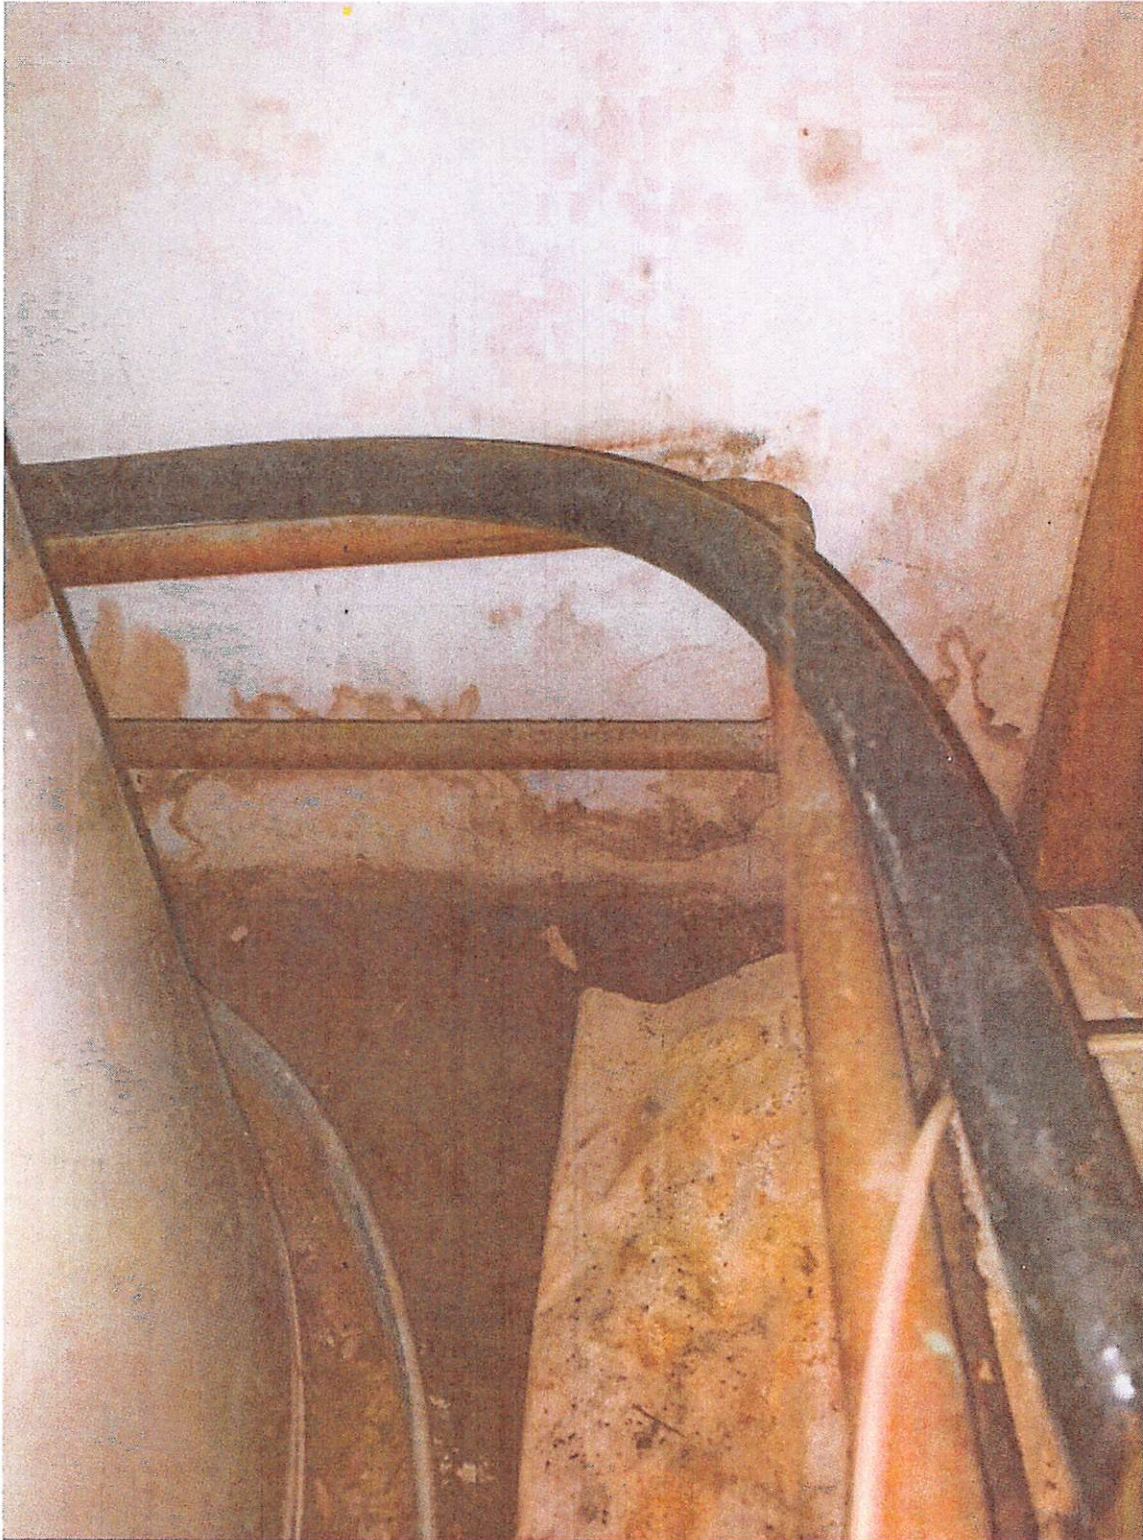
4. Bathroom - The raised wood floor in the bathroom has evidence of water damage to the wood in the hot water tank area adjacent to the bathtub. There is also mold growth on the wall between the bathroom and the kitchen. A tape lift from the raised

wood floor in the bathroom, number 97G-6, was analyzed by Ed Olmsted and Prestige. The sample had growth of *Scopulariopsis*. There is surely greater amounts of mold growth under the raised wood floor where water was trapped. The wall cavity between the bathtub and the kitchen has visible mold growth. A bulk sample from the bathroom wall in the area by the hot water tank, number 97G-4, was analyzed by culture methods and found to have 780,000 colony forming units per gram (CFU/g). The sample was dominated by *Aspergillus calidoustus* at 690,000 CFU/g. This is indicative of mold growth. The raised floor and bathtub should be demolished in the bathroom. The wall shared with the kitchen should be opened and the back of the kitchen cabinets and wall cavity should be cleaned with HEPA vacuuming and damp wiping with a strong biocide.

The hot water tank next to the bathtub – there is mold growth on the raised wood floor and on the wall shared with the kitchen

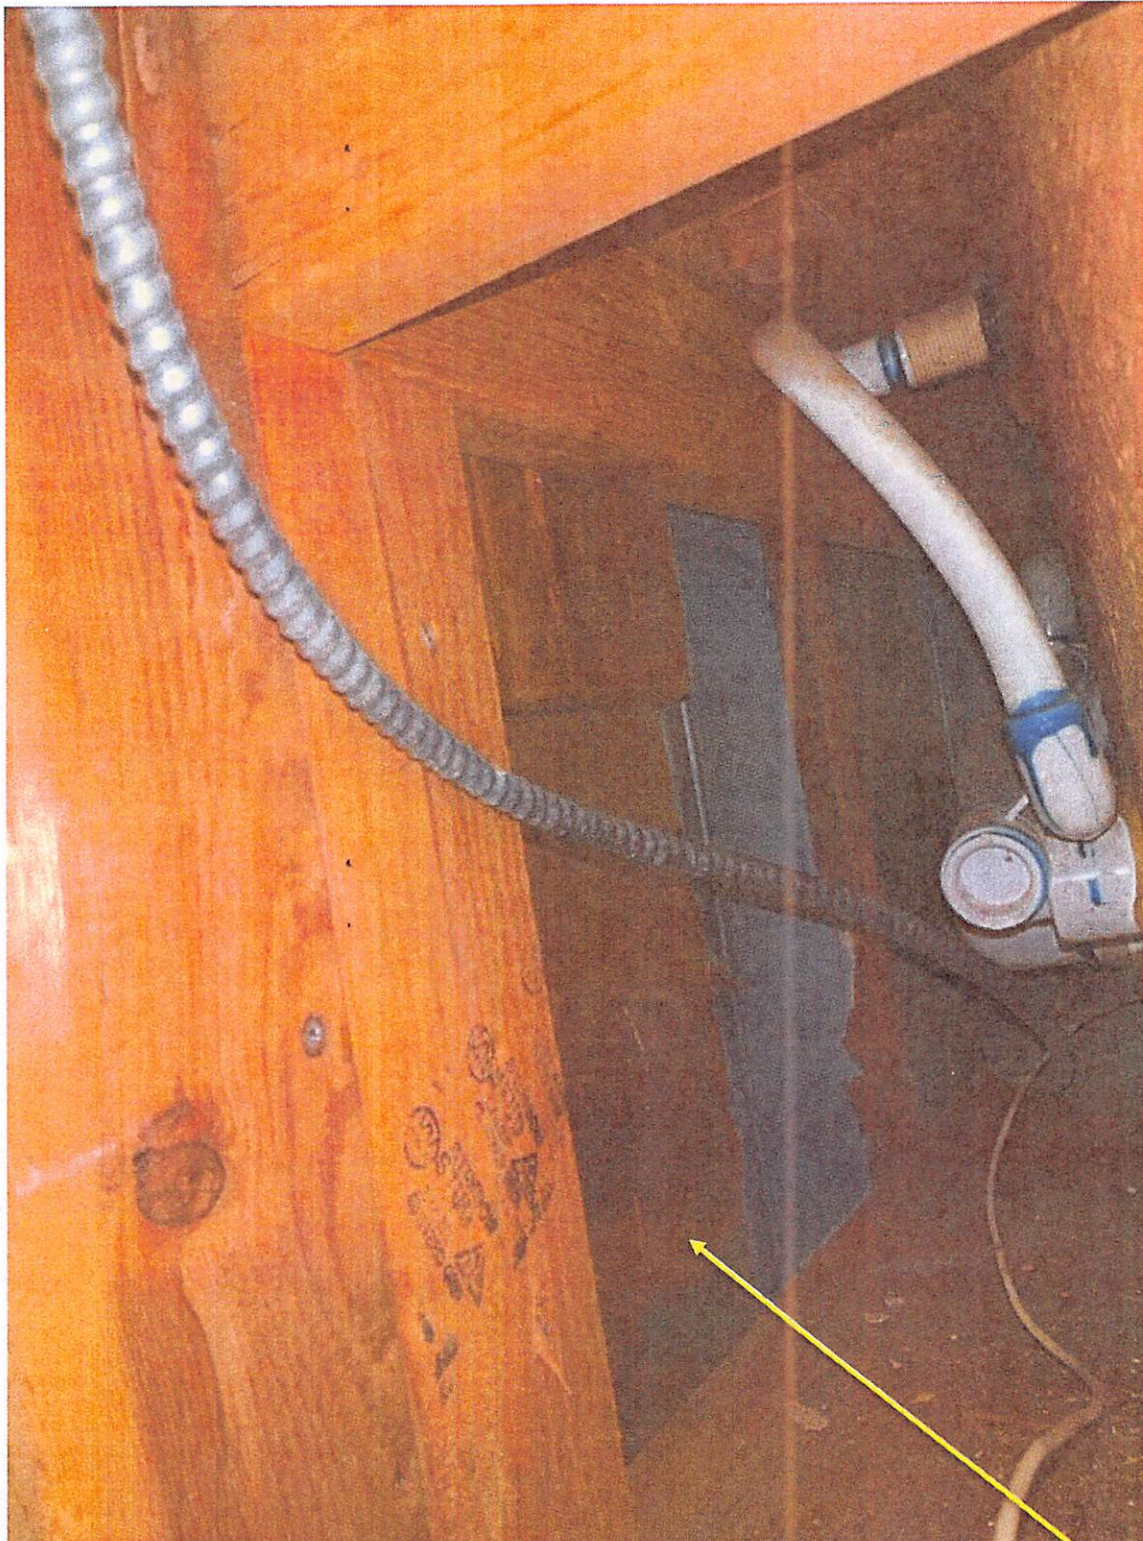
There is water staining and mold growth on the bathroom wall shared with the kitchen.

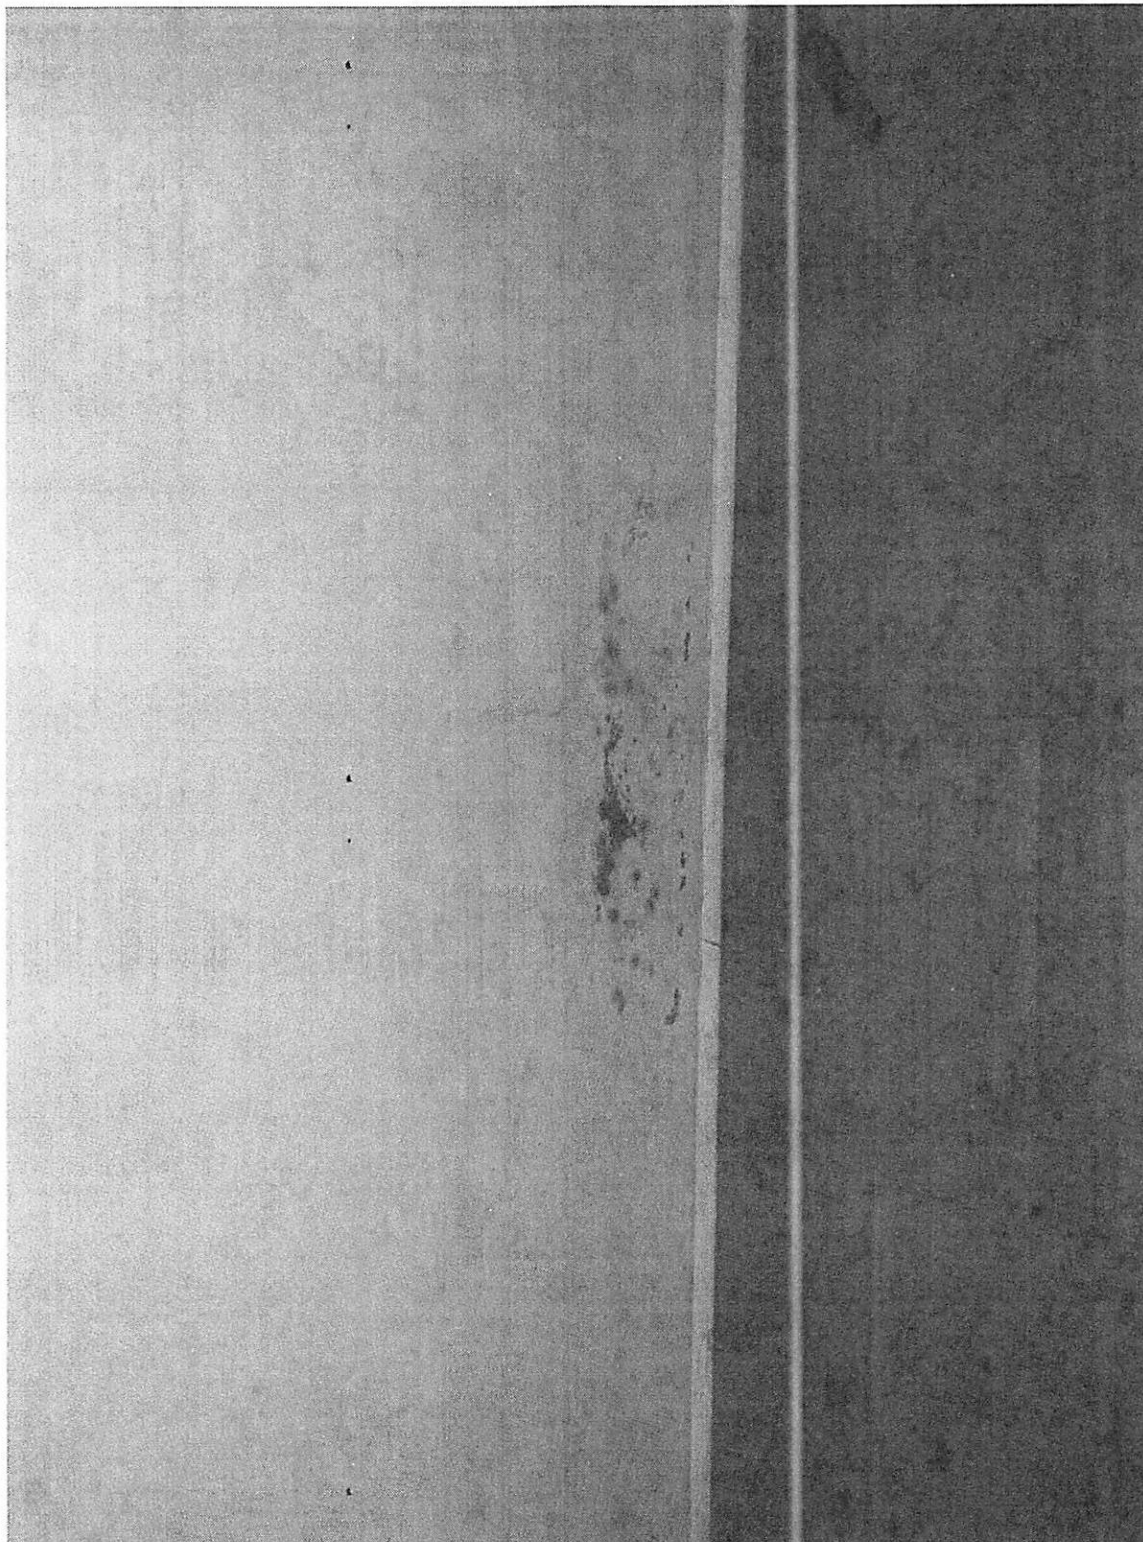
Visible mold on the base of the wall in studio area

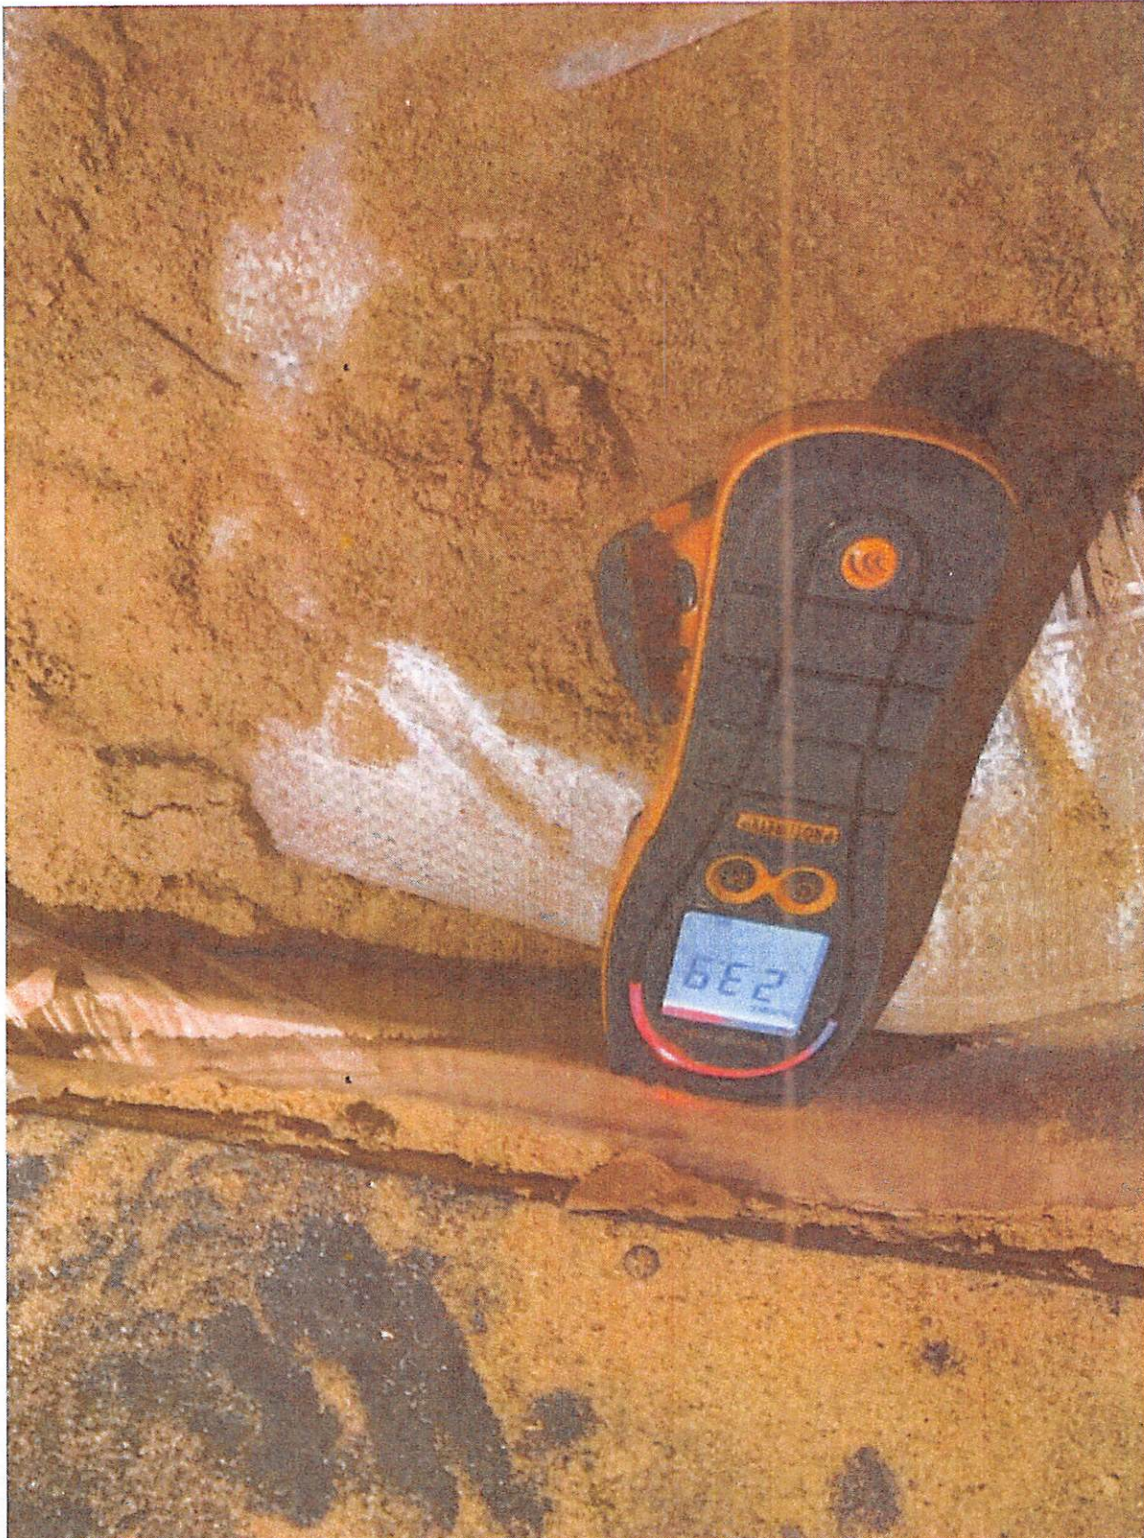
The wood joists adjacent to the sand is wet

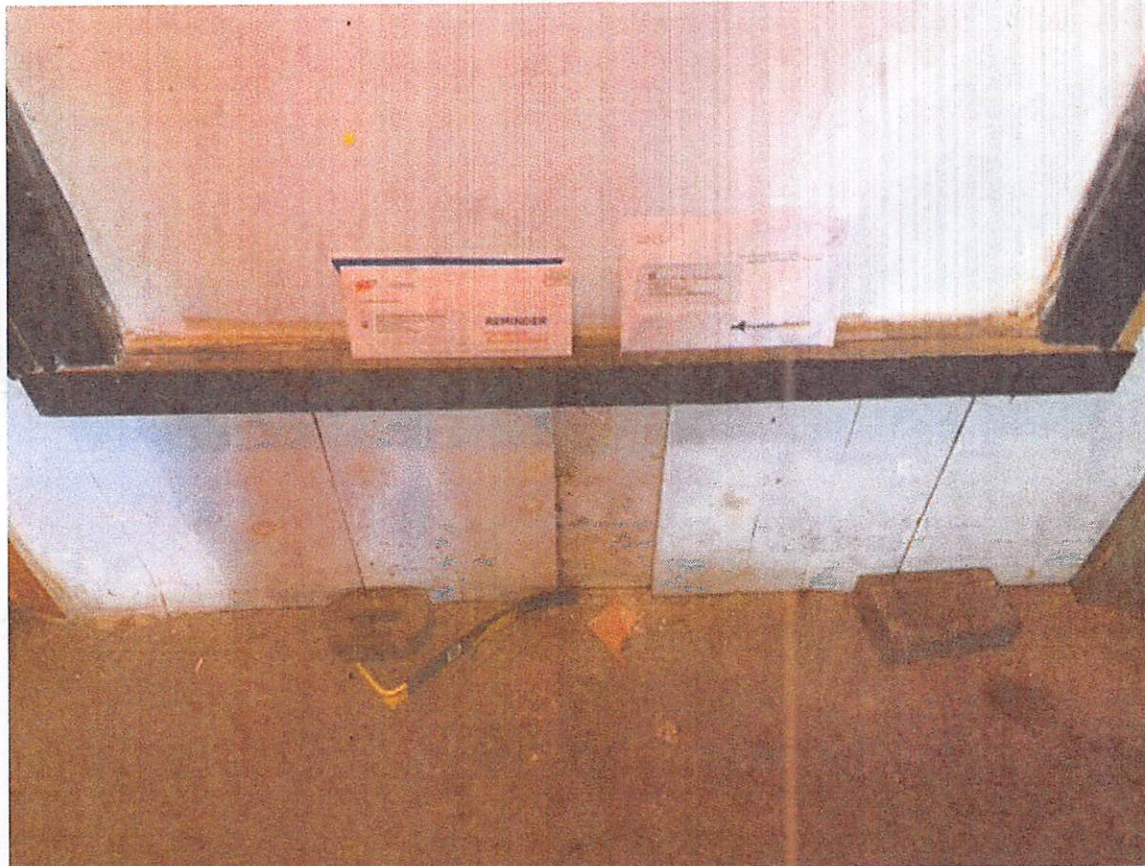
Visible mold behind the removed wood wainscot

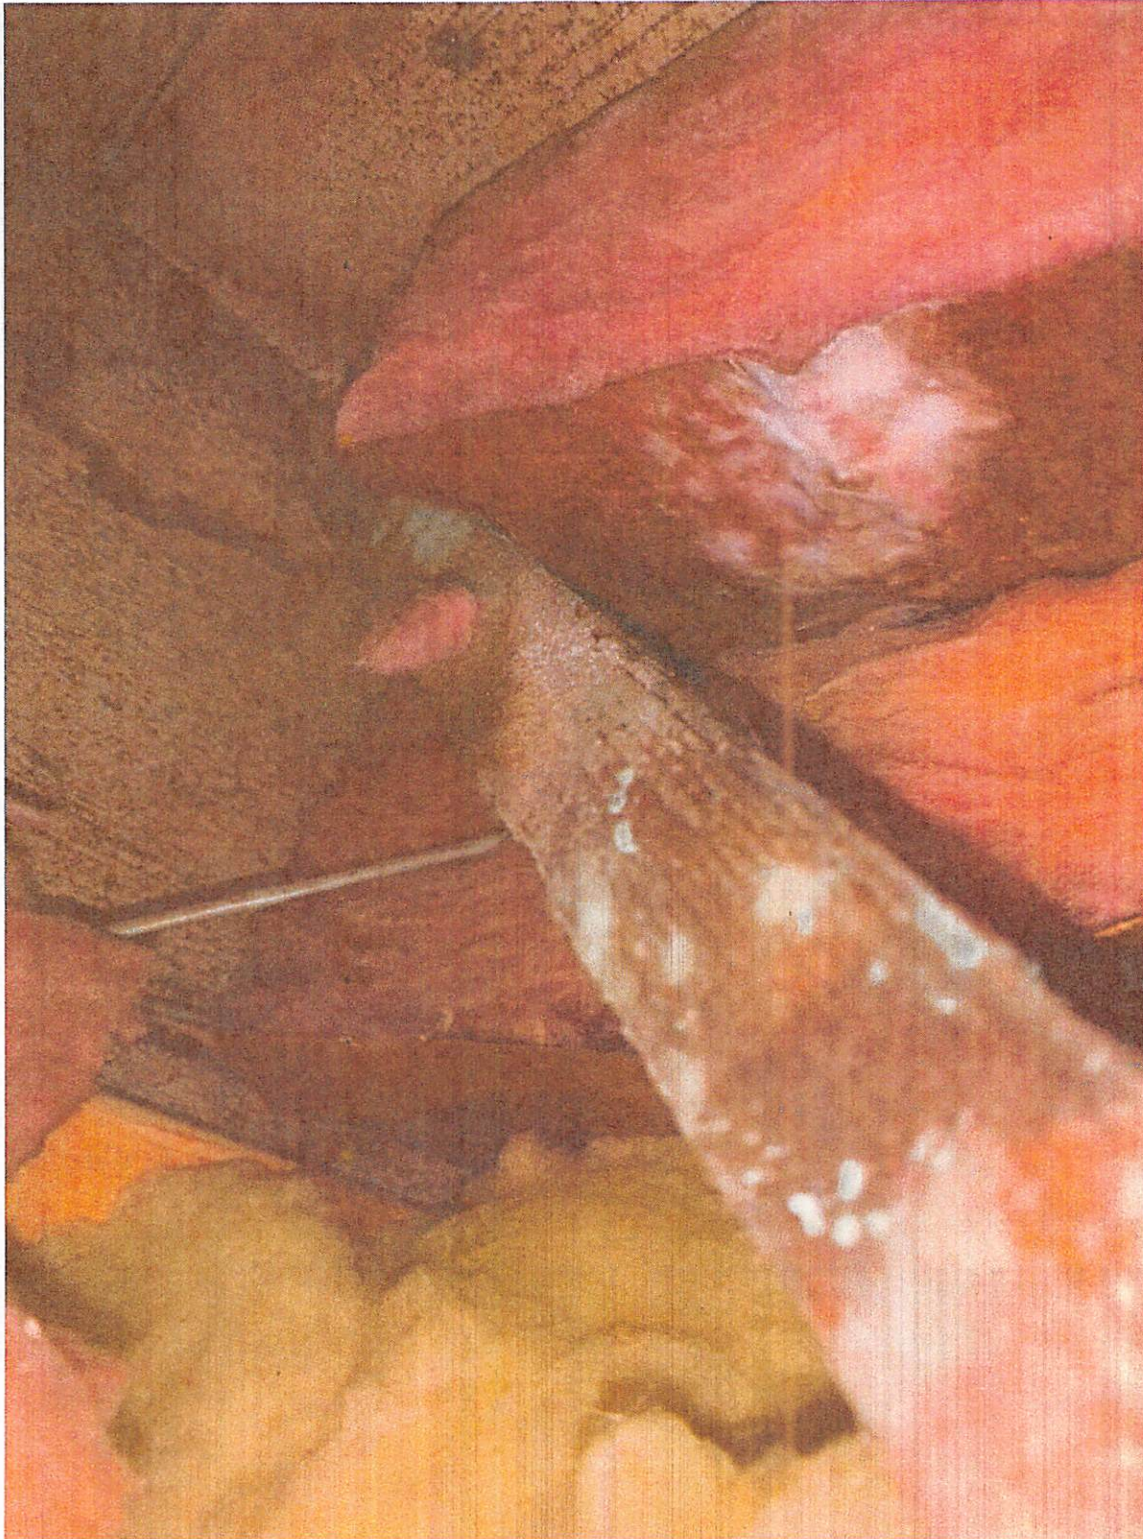
Mold growth on insulation and wood joists on the underside of the floor above

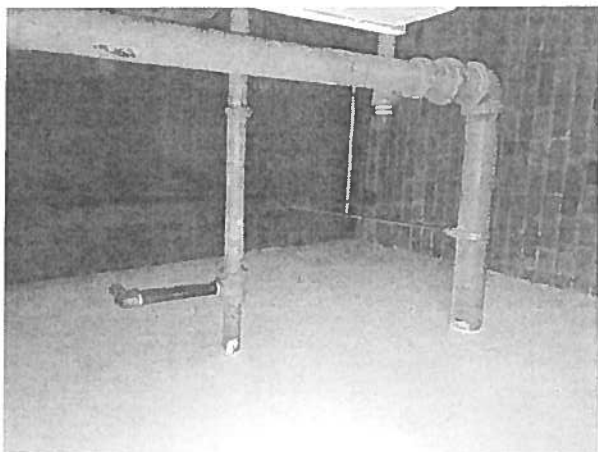
**Above: Sprinkler head that caused the pipe burst in October 2020 in the apartment above.**

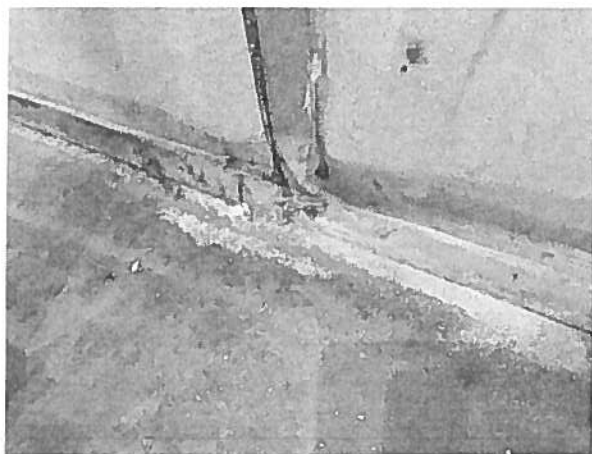
**Above Left: visible microbial growth in living room north wall**

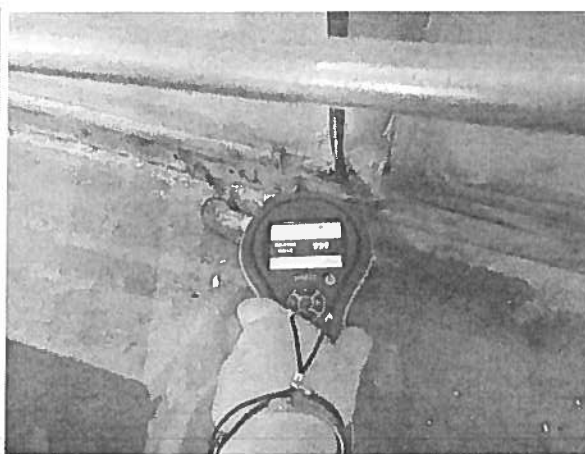
**Above Right: Moisture meter measured the concrete floor as wet near north wall in living room**

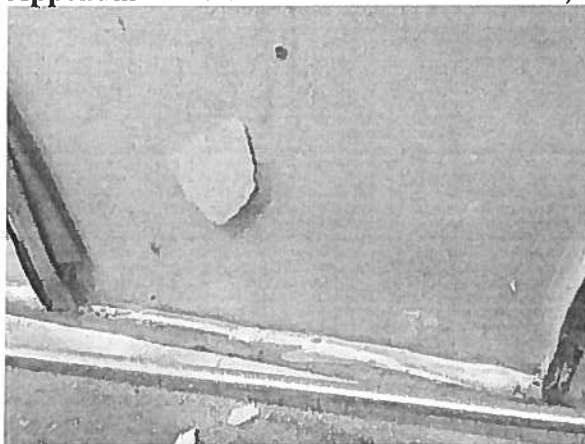
**Above left: Water damage drywall on north wall in living room**

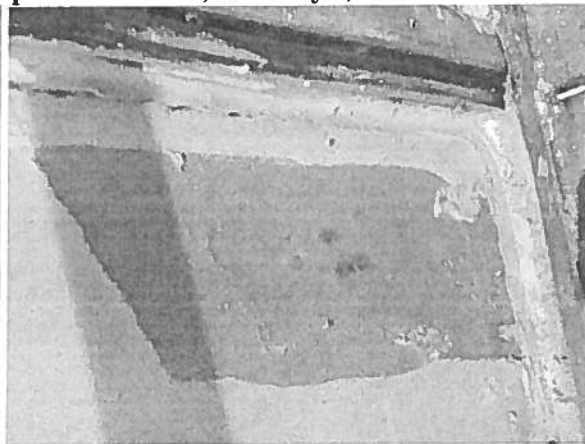
**Above right: Visible microbial growth on drywall north wall in living room**

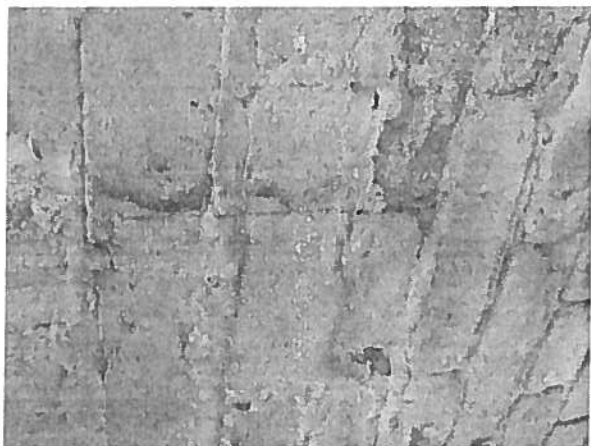
**Above left: Brick west wall in living room was wet to touch**

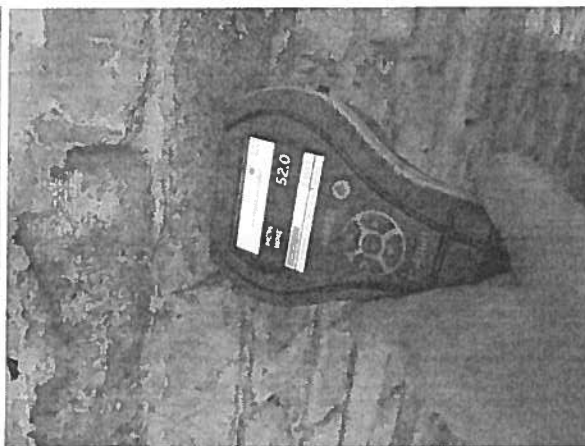
**Above right: Brick west wall in living room measured wet by pin measurement**

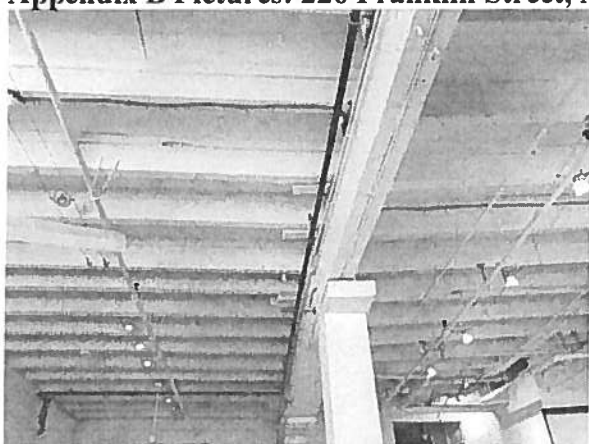
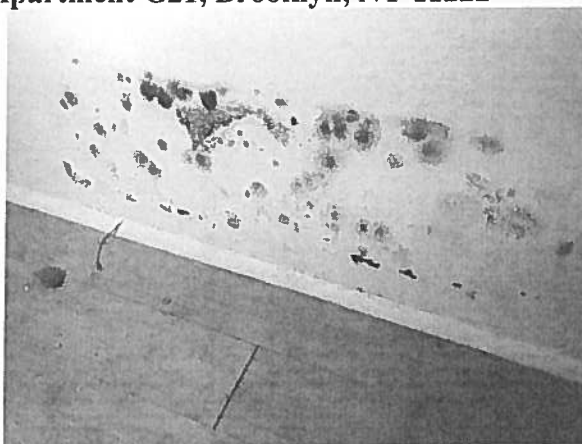
**Above left: Living room ceiling with sagging ceiling joists and support beam cracking**  
**Above right: Visible mold in studio room 2 west drywall wall**

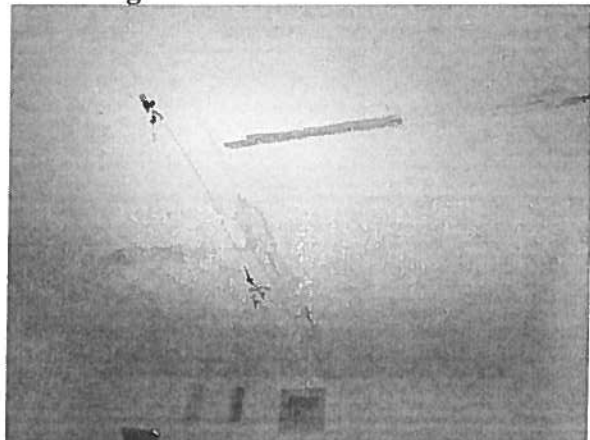
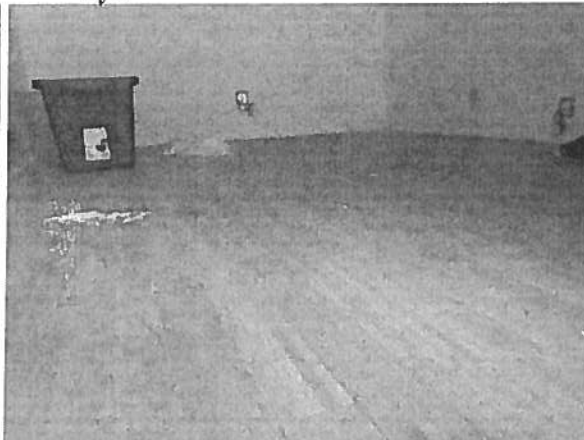
**Above left: Water damaged ceiling in studio room 2**  
**Above right: Water damaged bamboo floor in studio room 2**

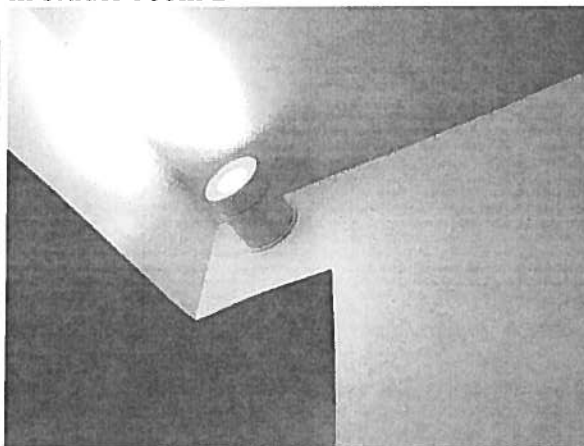
**Above left: Water damaged ceiling in hallway**  
**Above right: Water damage, paint cracking on hallway ceiling**

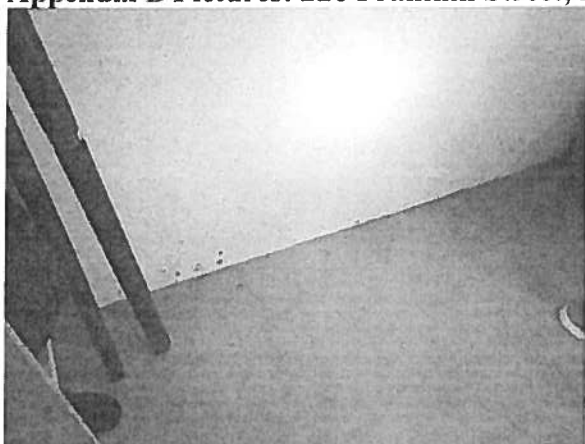
**Above left: Visible microbial growth on hallway drywall north wall**

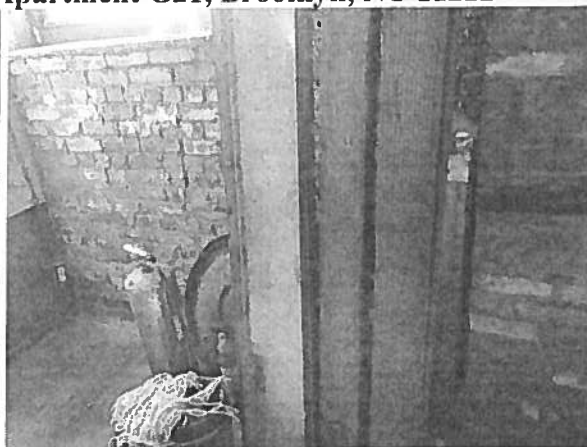
**Above right: Over view of foyer brick south wall, measured wet**

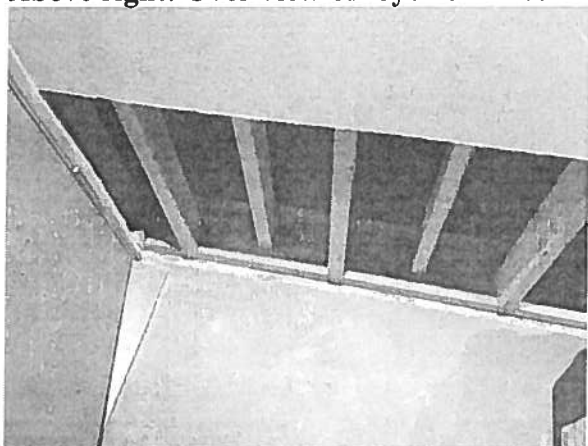
**Above left: Water damage and visible microbial growth in hallway south wall**

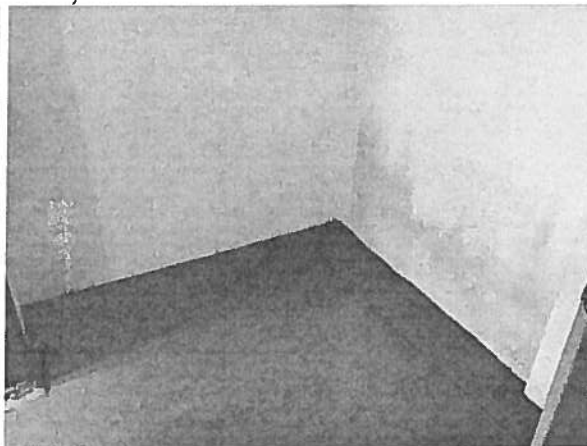
**Above right: Visible microbial growth on east and south wall in studio room 3**

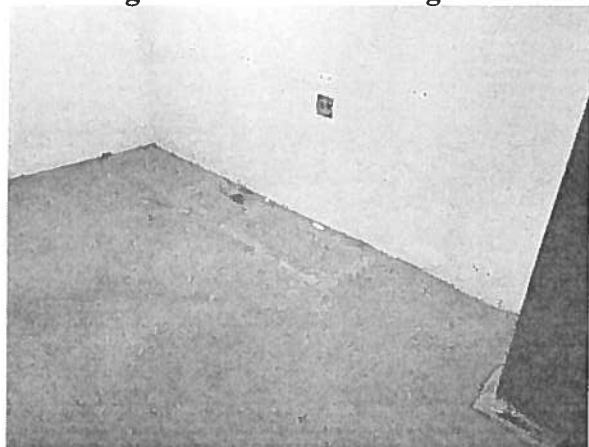
**Above left: Water damage and visible microbial growth on drywall north and east wall, and water damaged carpet in studio room 3**

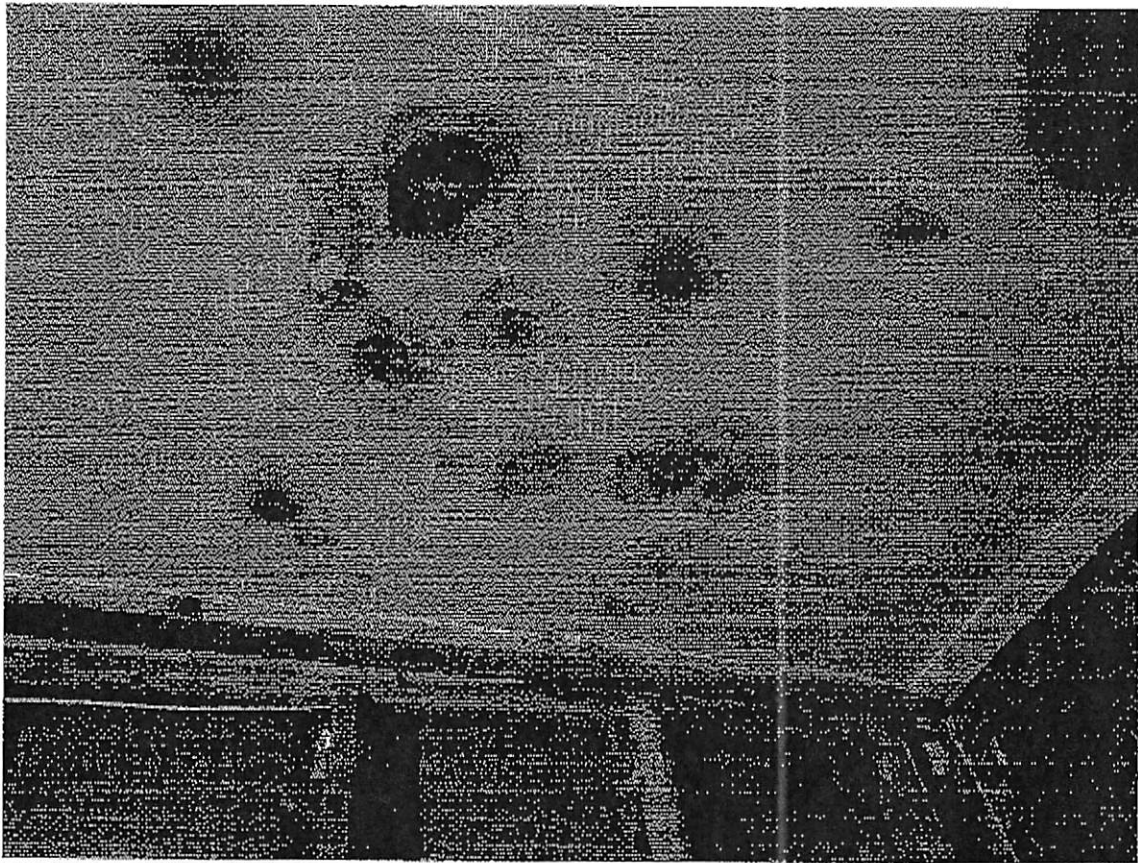
ROOM 1 CEILING behind foam panels that were removed during this survey

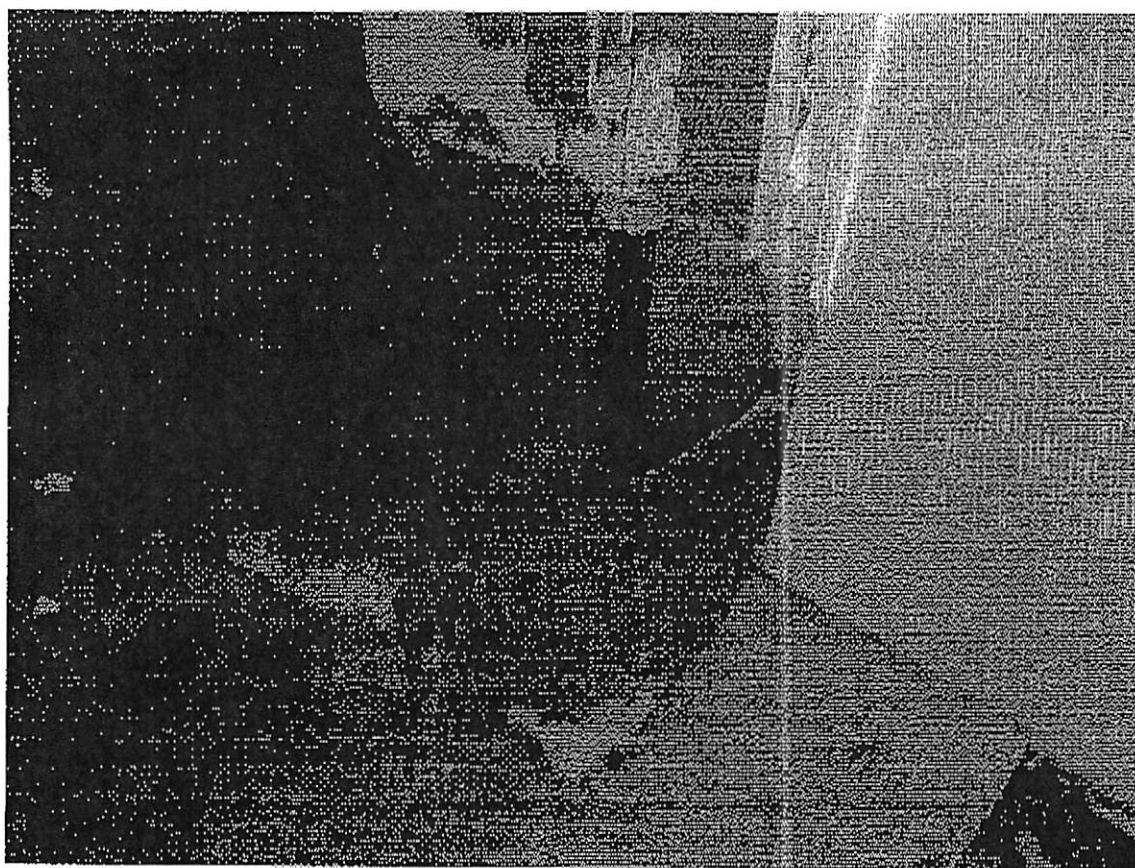
Bathroom wallboard has mold in the wall cavity

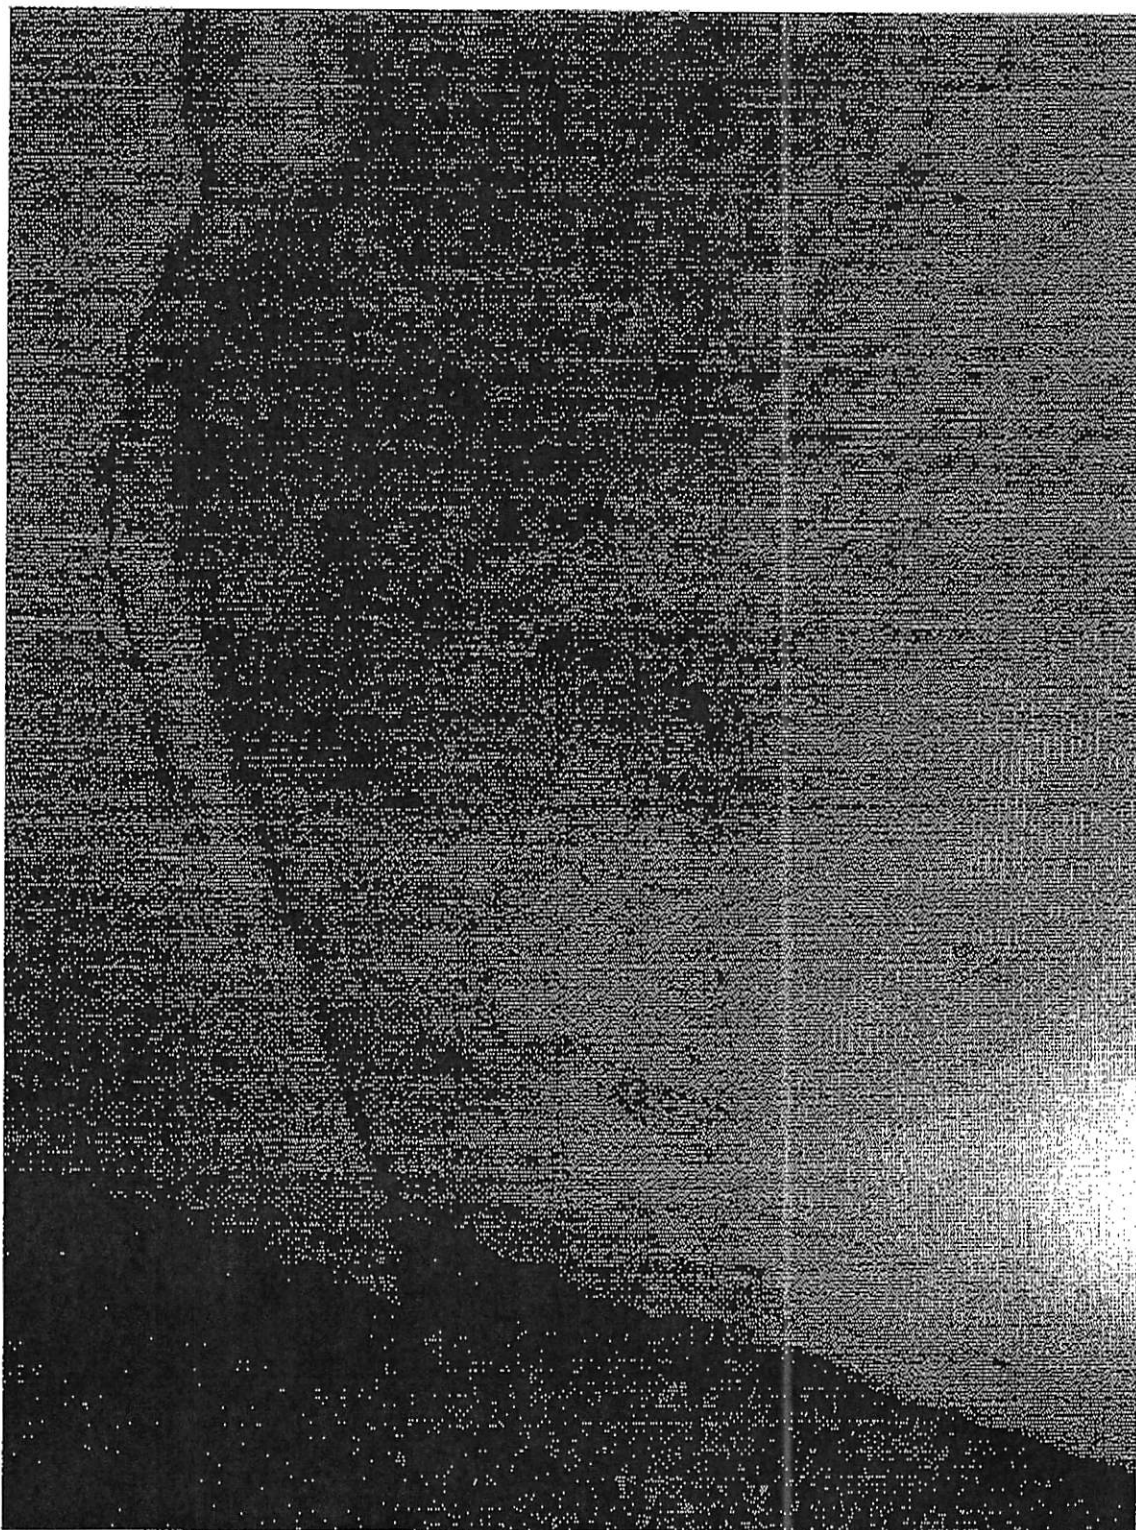
Wall outside room 2 has visible mold

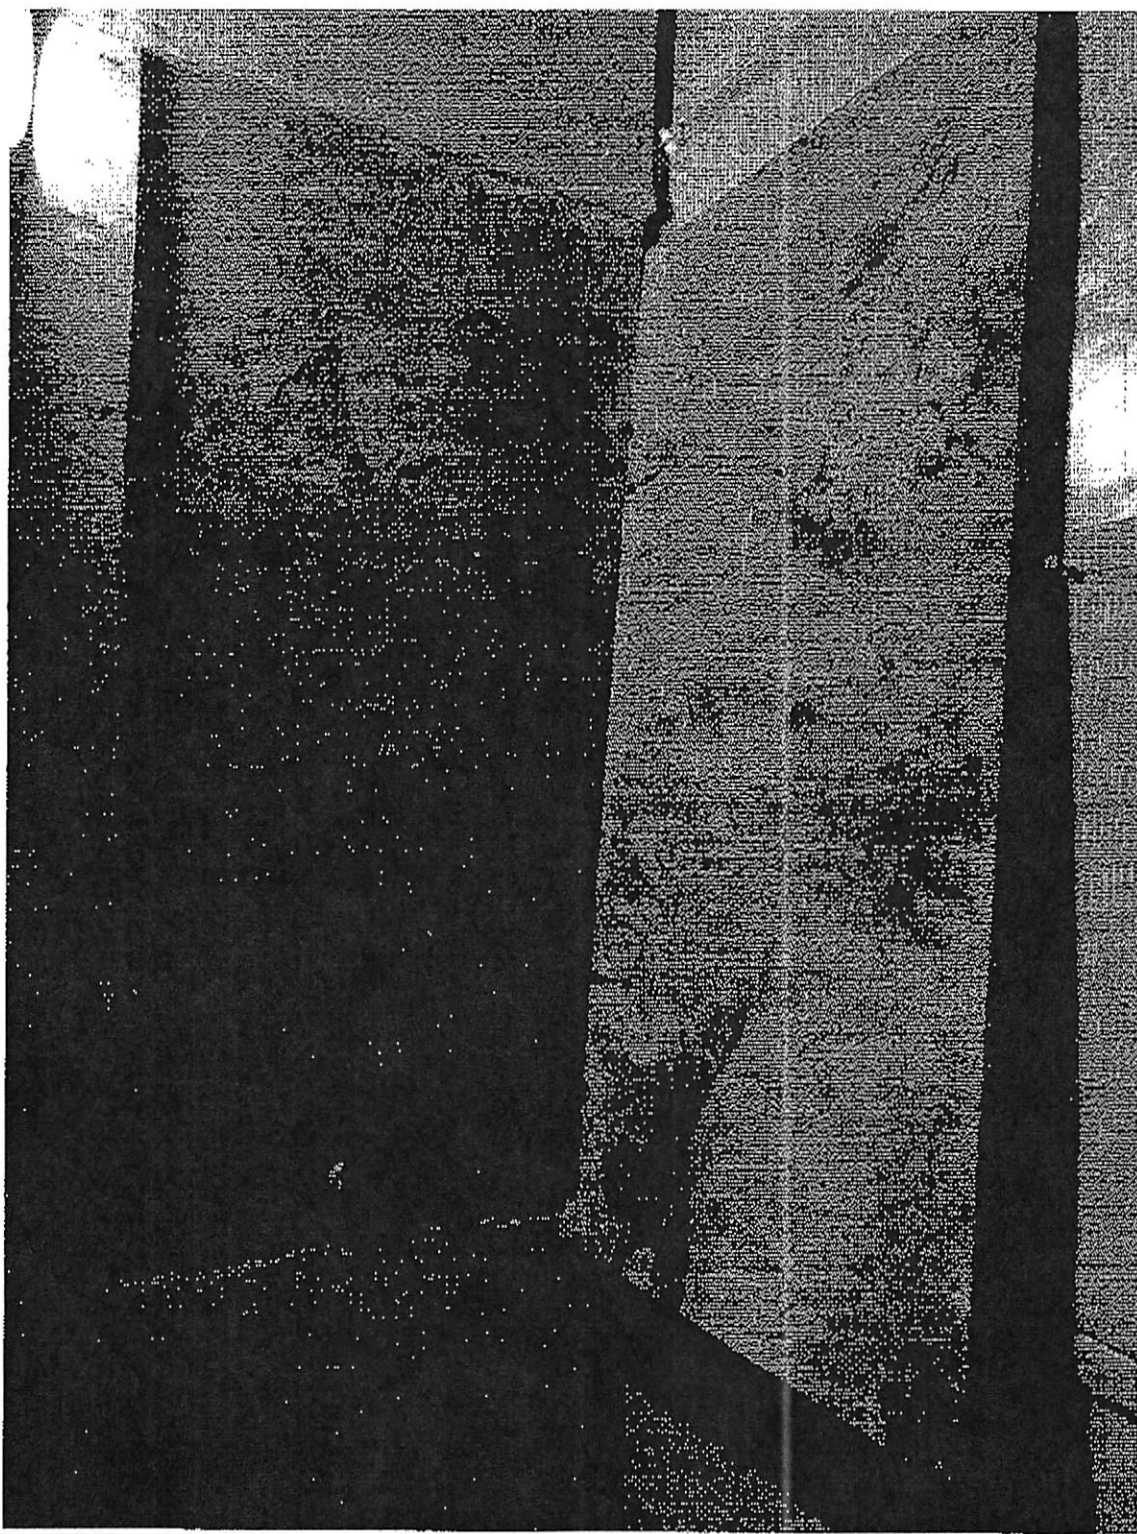
Underside of the OSB floor and the press wood subfloor are wet and moldy
