CIVIL COURT OF THE CITY OF NEW YORK  
COUNTY OF KINGS

Index No.  
006086/20

NOTICE OF MOTION

Edward Olmsted, CIH, CSP conducted a mold inspection in unit # G21 at 97 Green Street in Brooklyn, NY. The survey was done on June 15<sup>th</sup> to evaluate the apartment for the presence of mold growth due to a catastrophic flood caused by a sprinkler head bursting on the floor above. The flood occurred on October 23<sup>rd</sup>, 2019 and the space sat for many days with standing water on the floor and soaked walls and ceilings. The survey included the following:

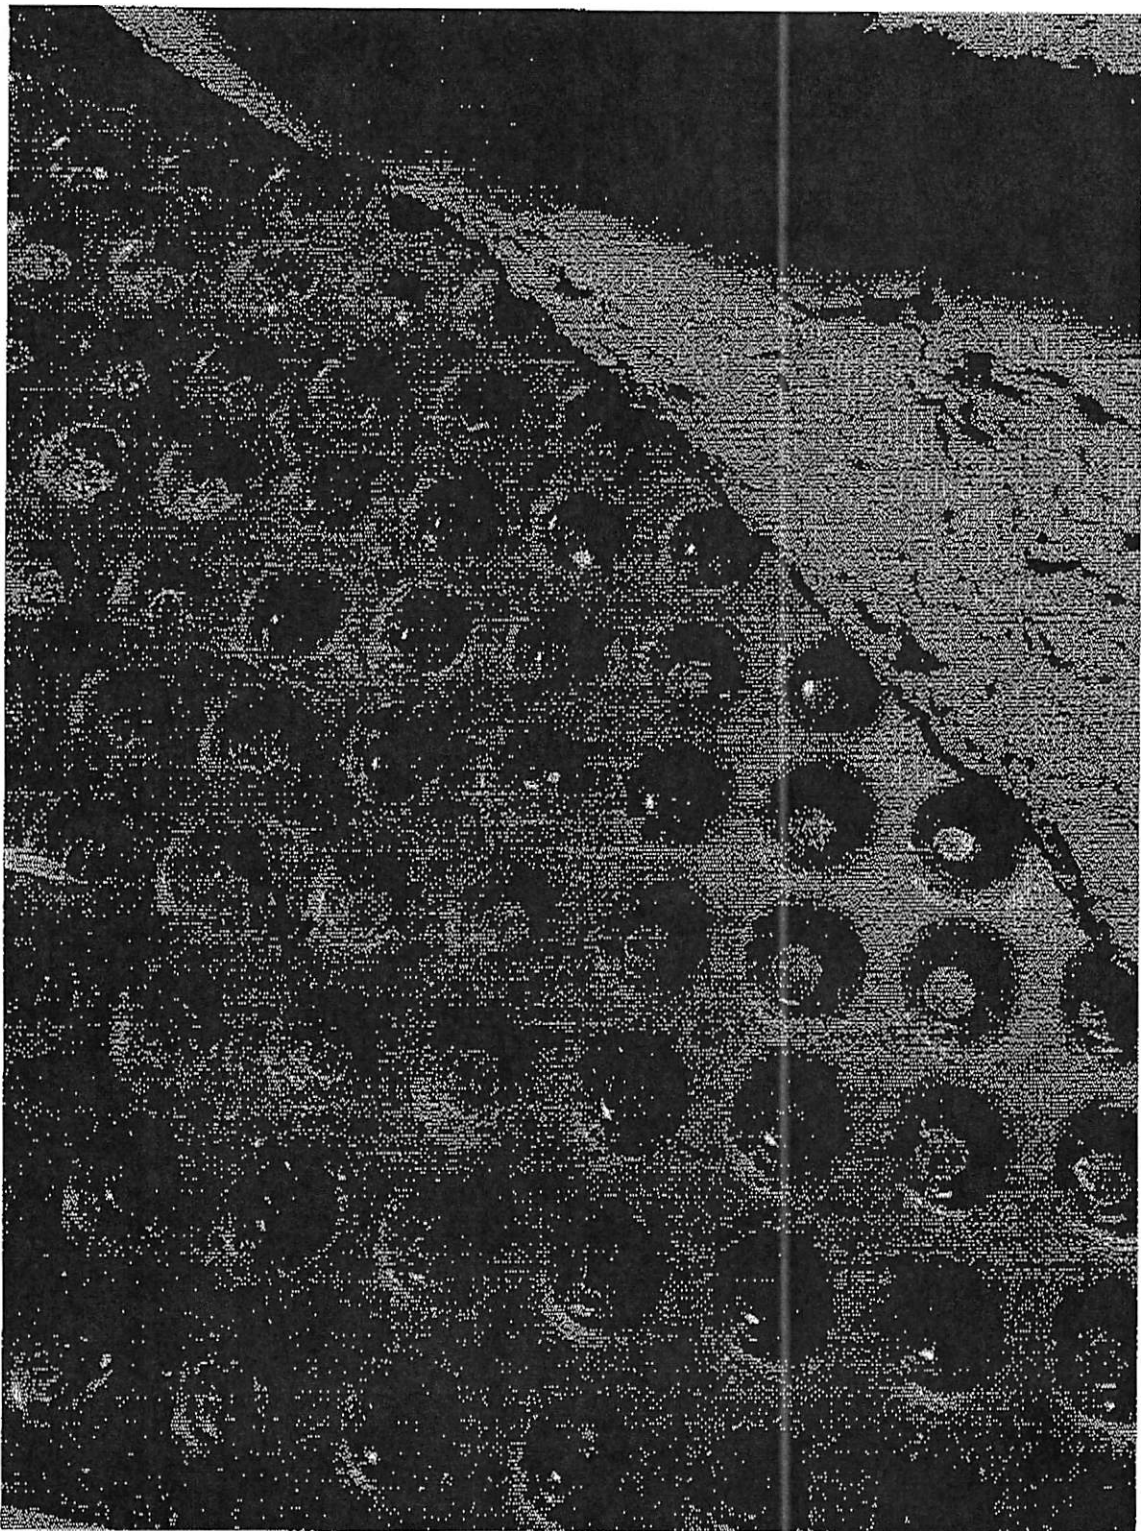
There is water under the press wood subfloor

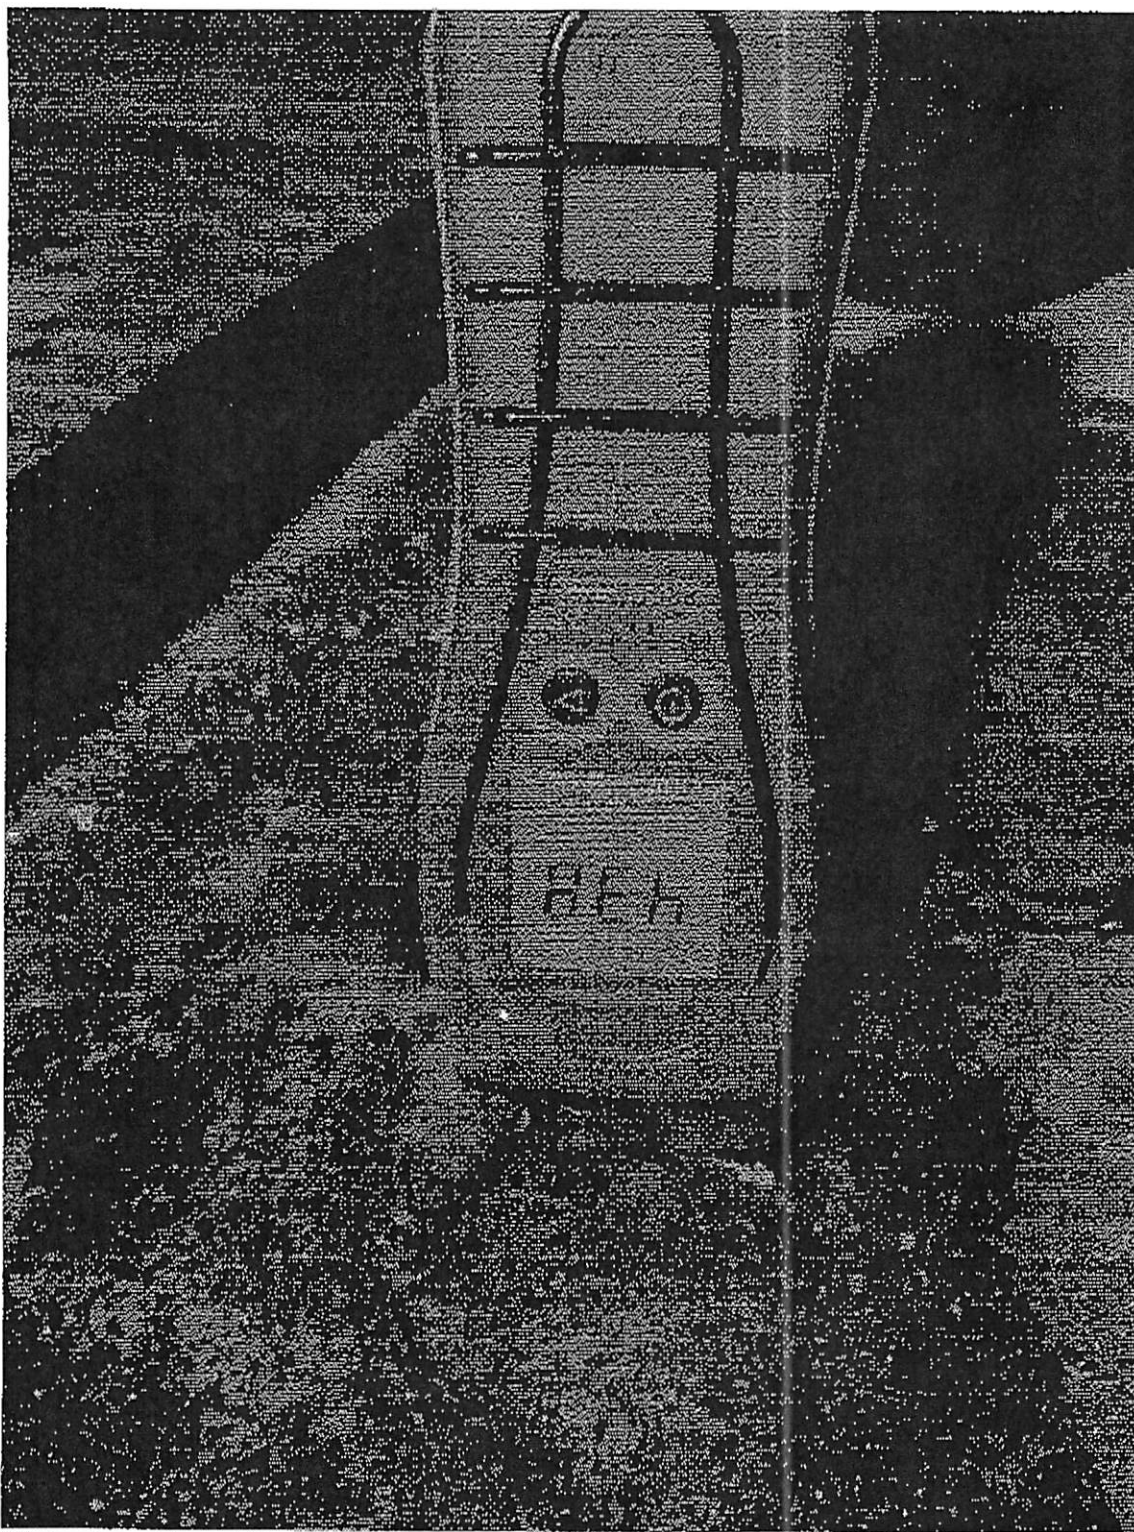
Wet and moldy subfloor
