OLMSTED ENVIRONMENTAL SERVICES, INC

Subject: Scope of Follow-up work
97 Greene

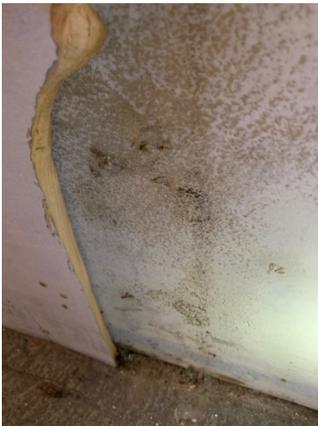
1. The hallway wall outside room 2 has wood paneling on the lower part. The wall should be removed up to the base of the window. If visible mold behind the wood remove it.

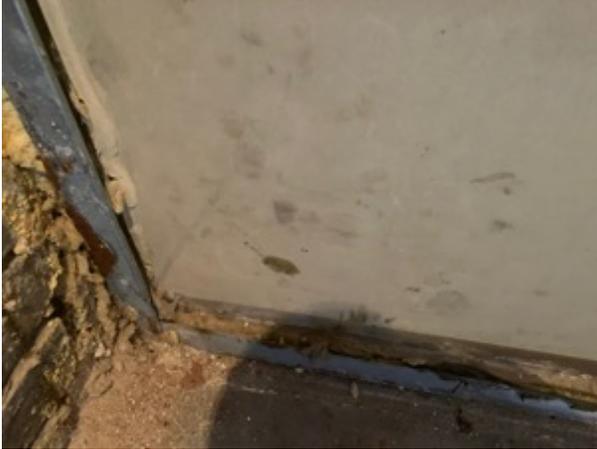
3. In the living room a wall probe would include the bay closet to the exterior masonry where there is visible mold
